Coho Drive Residential Shoreline Protection Project

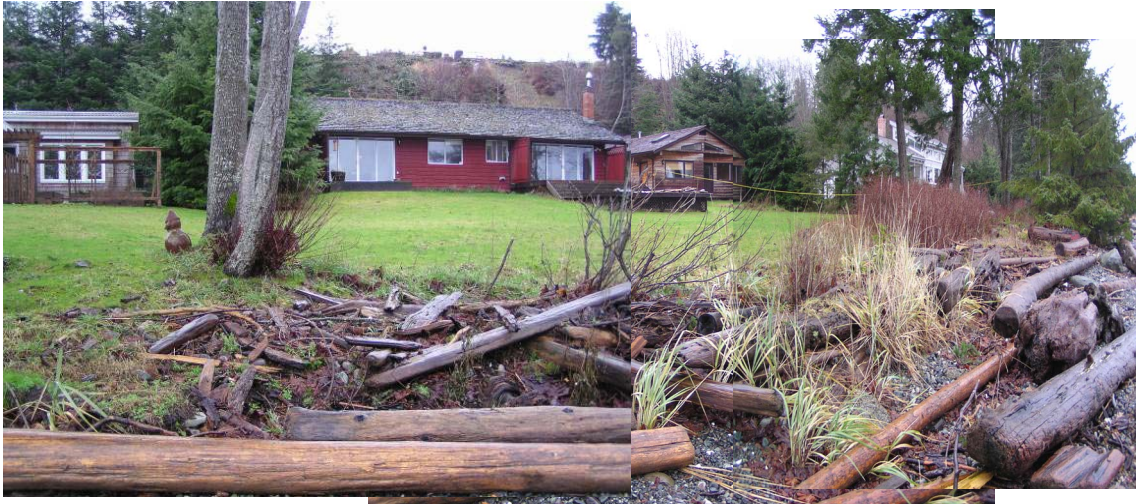
**Figure 2. View of the Duncan Property from the foreshore.
Coho Drive is between the house and the coastal bluff in the background**

The present owner occupied the property shortly after a series of severe winter storms occurred in December 2002 and early January 2003. The adjacent property on the south side has visible signs of extensive erosion of overlying landfill (with grass lawn) at the high tide mark (visible on the extreme right hand side of figure 3). The owner is concerned about future erosion and expressed a desire to undertake measures to protect the property in a way that would be compatible with ecological values of the site.

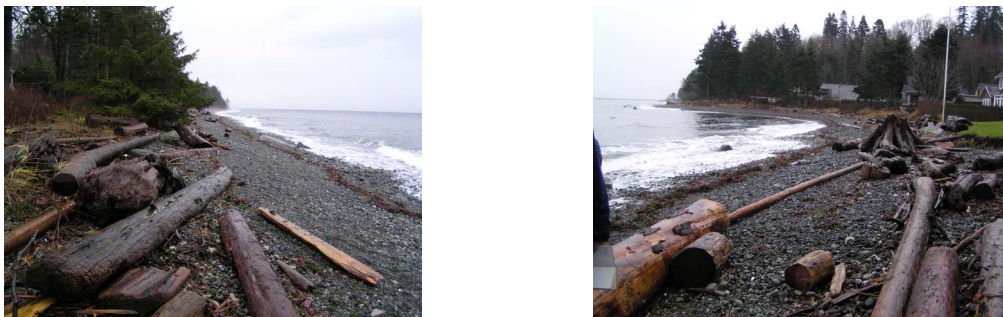
The property is fronted by a coarse sand, gravel and cobble beach which occupies the mid to upper portion of the intertidal zone. A vegetated cobble and boulder zone is reported to exist in the mid to low tide zone and a wide, fine sandy tidal bench exists at the low tide mark. The bench was visible from the high tide line during the site visit due to the clarity of the water. There is a small headland to the immediate south of the residential properties (visible in the background of the right hand image in Figure 3).

Figure 3. Views of the high tide portion of the foreshore looking north (left) and south (right)

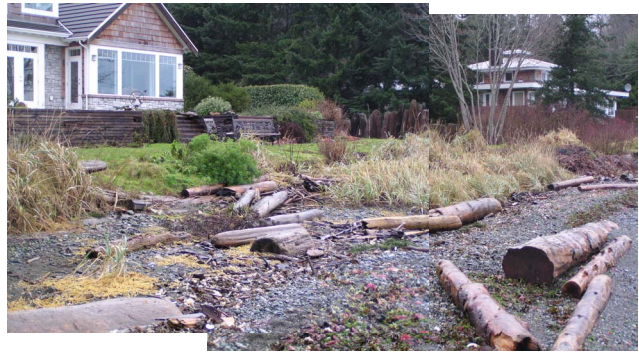
Figure 4. Example from Coho Drive area demonstrating the preservation of the coastal riparian edge, the upper tidal zone and incorporation of a setback retaining wall³

In some cases, adjacent property owners had already undertaken measures to provide protection to the residential property while preserving the ecological values of the area (Figure 4)². A nearby road right of way, where no measures (landfill, landscaping or sea defences) were present, also showed no signs of erosion.

² The wooden wall, between the house and the lawn is likely not designed to act as a sea defence, but retro-fitting to withstand an extreme event could be undertaken.

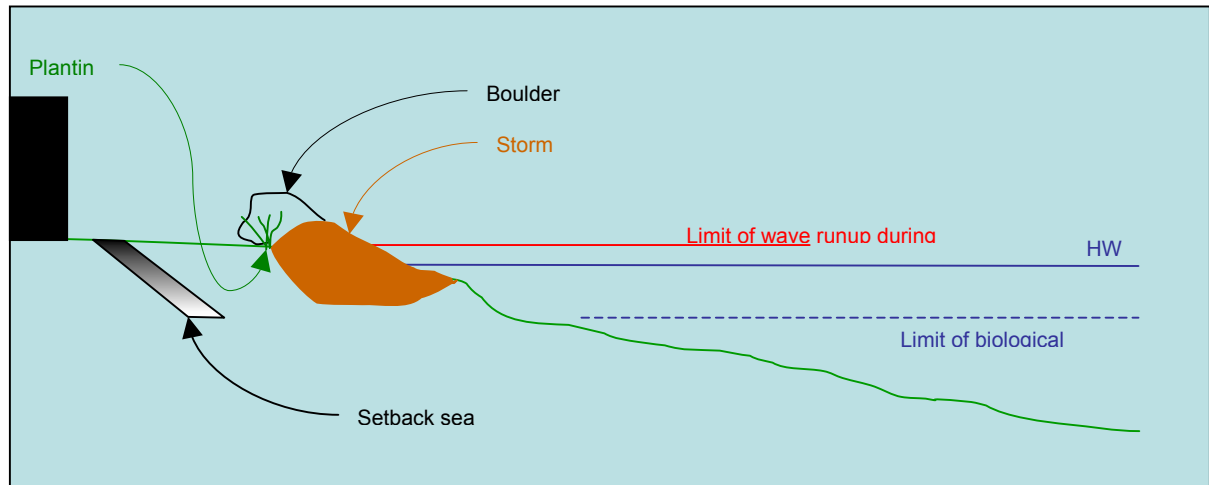
Figure 5. Shore profile showing possible design alternatives

1. Do Nothing³.
2. Construction of a hard sea defence.
3. Enhancement of the existing log and boulder defences by restraining logs with tie backs and seeding boulders above the high tide line to form occasional hard spots for accumulation of debris.
4. Construction of a feeder storm berm, containing imported cobble, gravel and coarse sand material, sufficient in volume to withstand an appropriate number of extreme storms⁴.
5. Construction of a hard sea defence (typically a seawall) setback within the upland area of the property to provide a line of defence for the upland physical property asset (home or outbuildings).
6. Planting of mature trees in the coastal riparian zone to assist in dissipation of the wind driving force in the breaking wave zone.
7. A combination of Alternatives 3, 4, 5 and 6.

A sketch arrangement of these alternatives is shown in Figure 5.
