Resilient Coasts for Salmon:

Green Shores Feasibility Inventory for the Gorge Waterway and Portage Inlet, Victoria, BC

2 February 2022

Prepared by:
Sara Stallard, BSc., ASCT (#22338), Envr.Tech.
Fish-KW Environmental
Victoria, BC

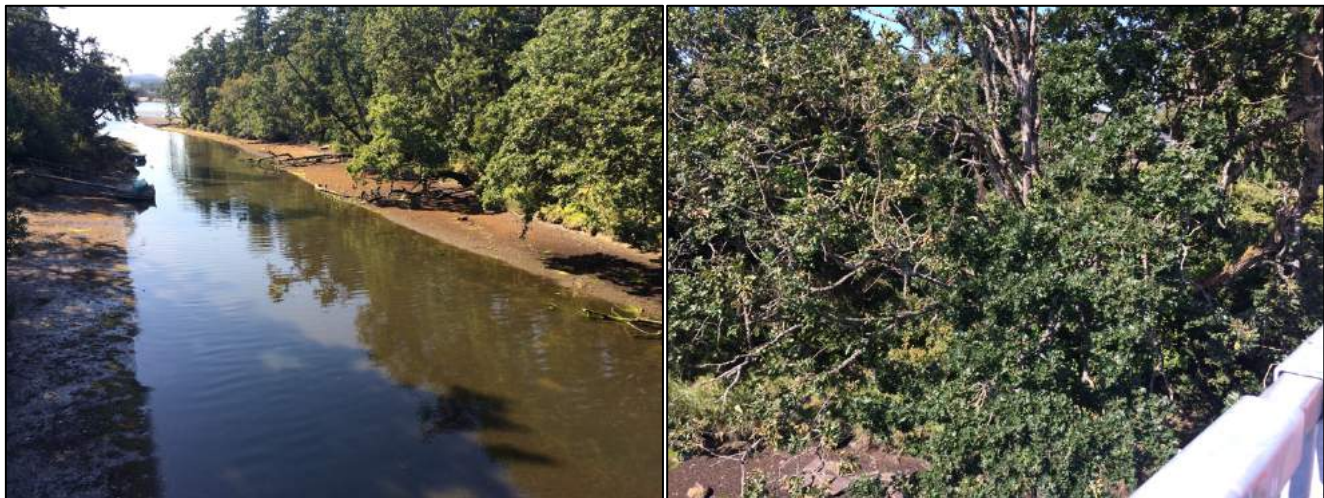
S05- Colquitz Park – north shore west of Admirals Rd bridge, view northwest along intact shoreline.

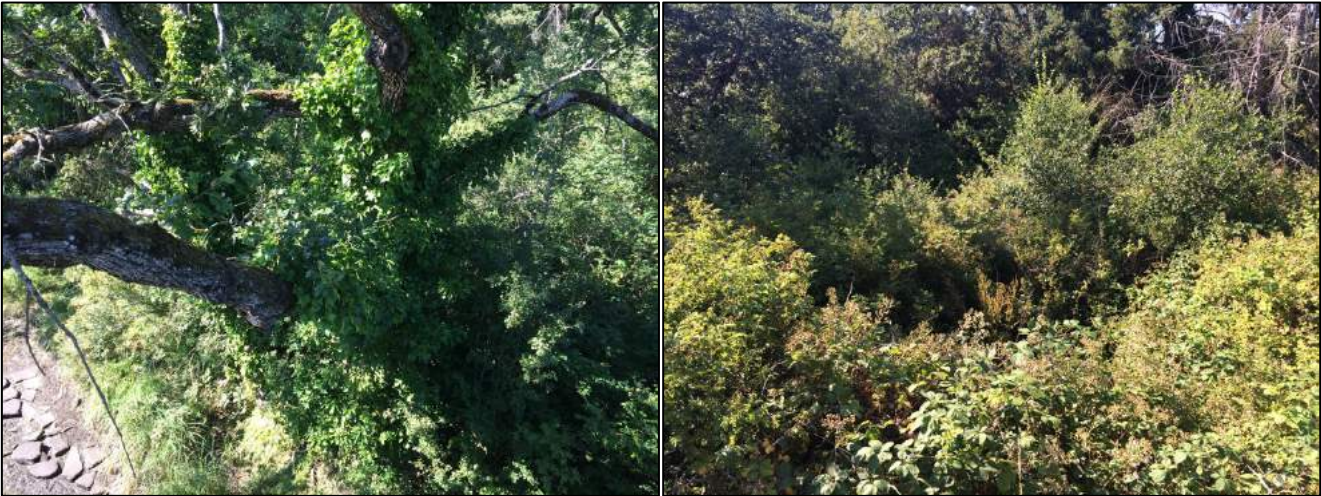
S05- Colquitz Park – west of Admirals Rd, English ivy on Garry oaks (left) & low vegetation at recent construction (right).

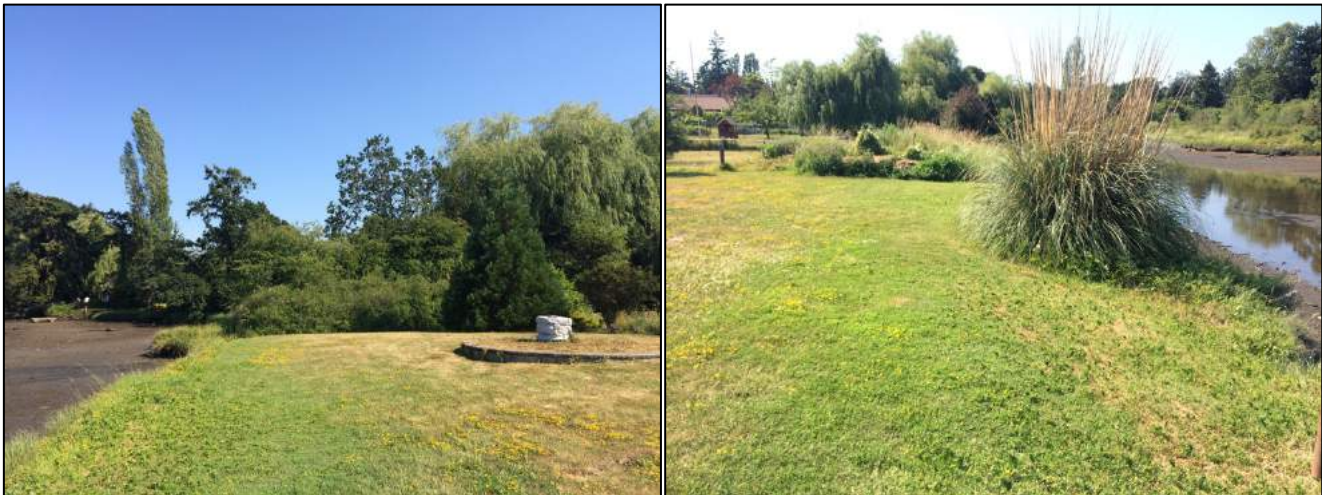
S07- Colquitz Park at Austin/Newbury, former 3104 Austin Ave lawn toward dense ROW vegetation (left) & 3104 Austin view toward former 714 Newbury Rd yard & garden waste and lawn.

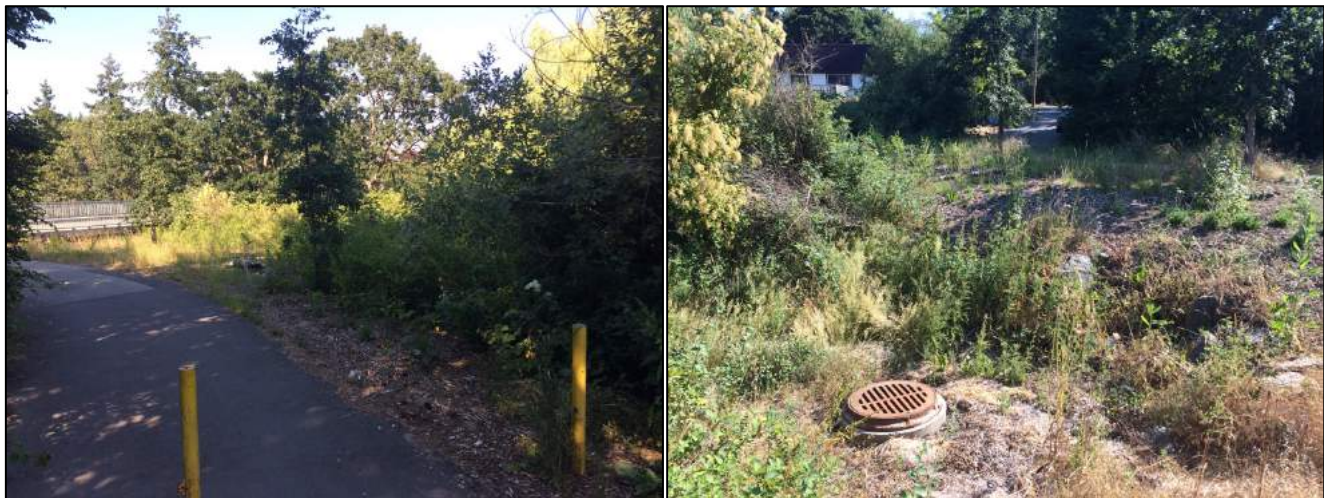
S08- Colquitz Park @ Colquitz Ave ROW & pedestrian/cycling access (left) & raised stormwater drain and weedy bed (right).

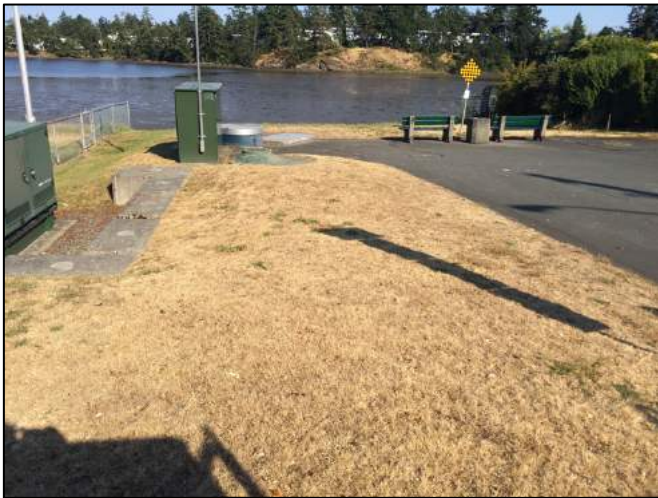
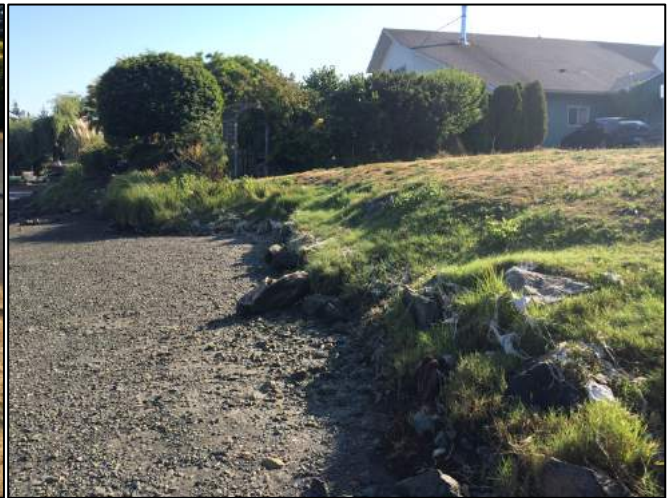
VR10 – Midwood Place room for raingarden and mostly mowed shoreline

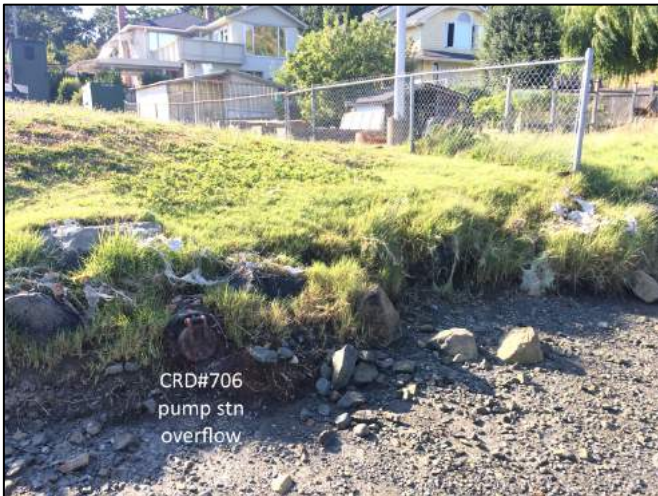
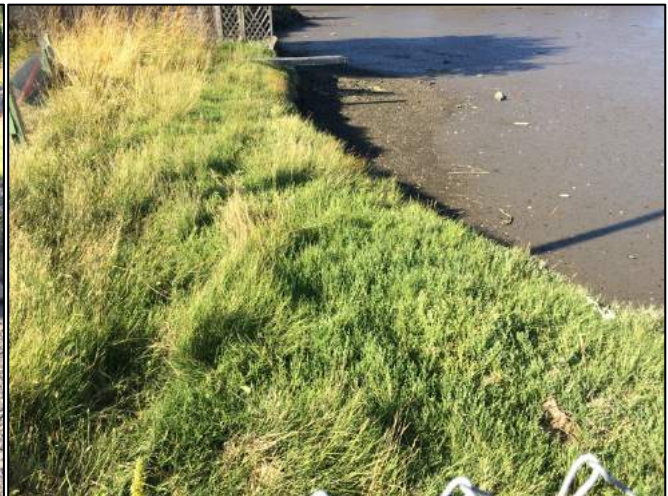
VR10 – Midwood Place pump station overflow #706 (left) and ‘park’ (?) shoreline native meadow (right).

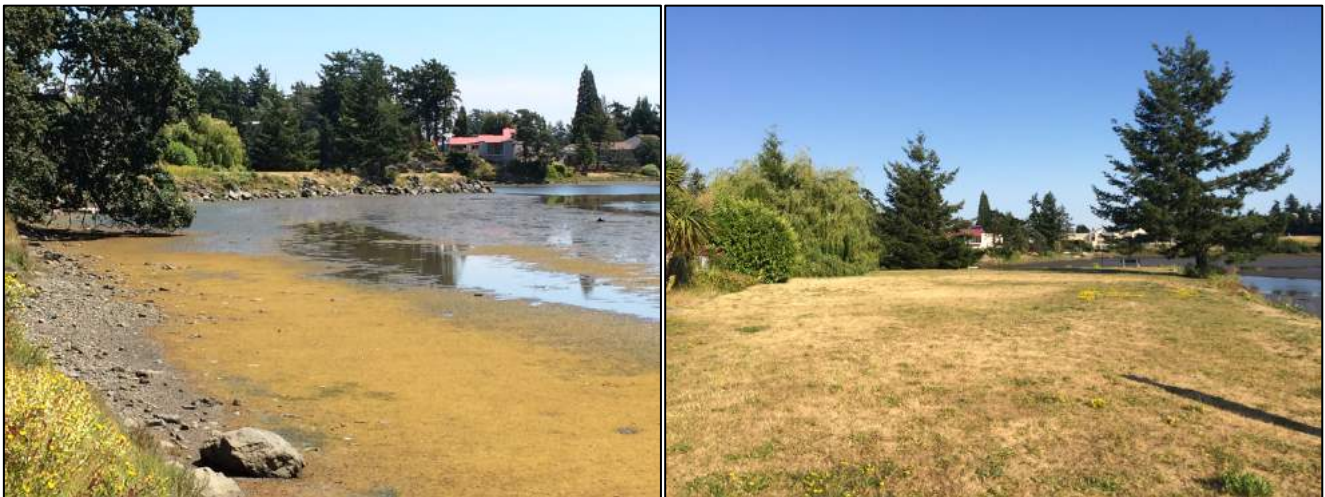
VR11 – Seabird PI shoreline as seen from Caton PI (left), mostly mowed with very little shrub or tree vegetation (right).

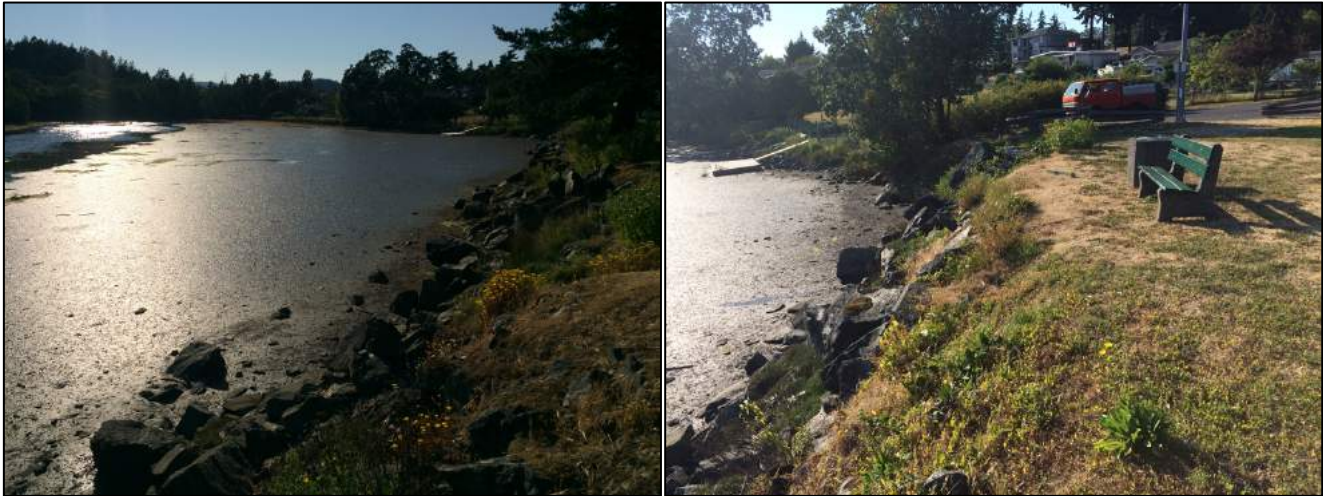
VR11 – Seabird Pl riprap shoreline adjacent to Craigflower Creek estuary mudflats (left) and ROW (right).

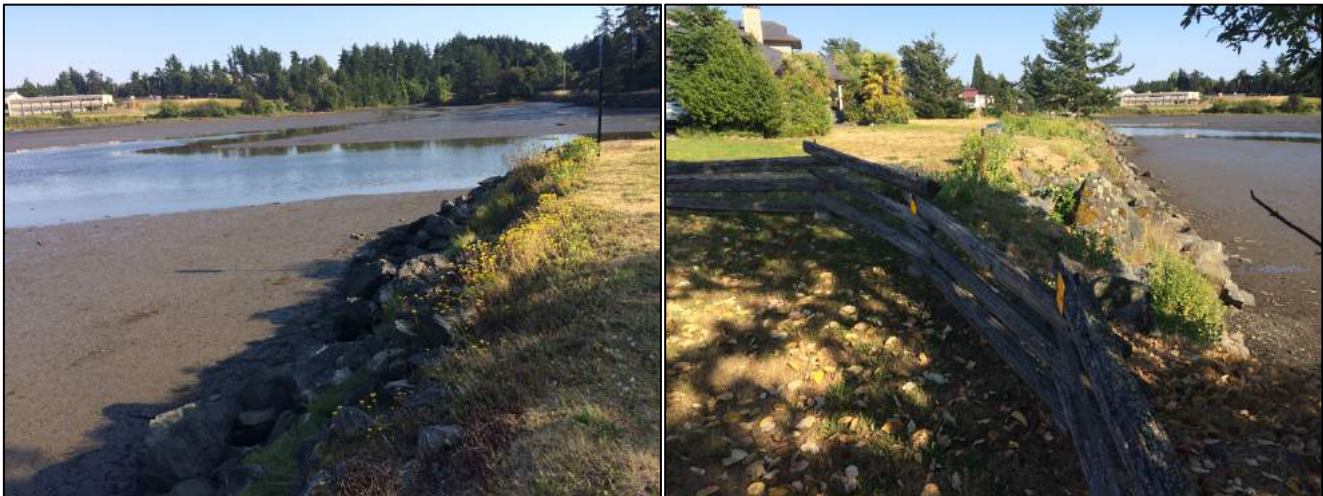
VR11 – Seabird Pl riprap shoreline adjacent to portage Inlet (left) and ROW (right).

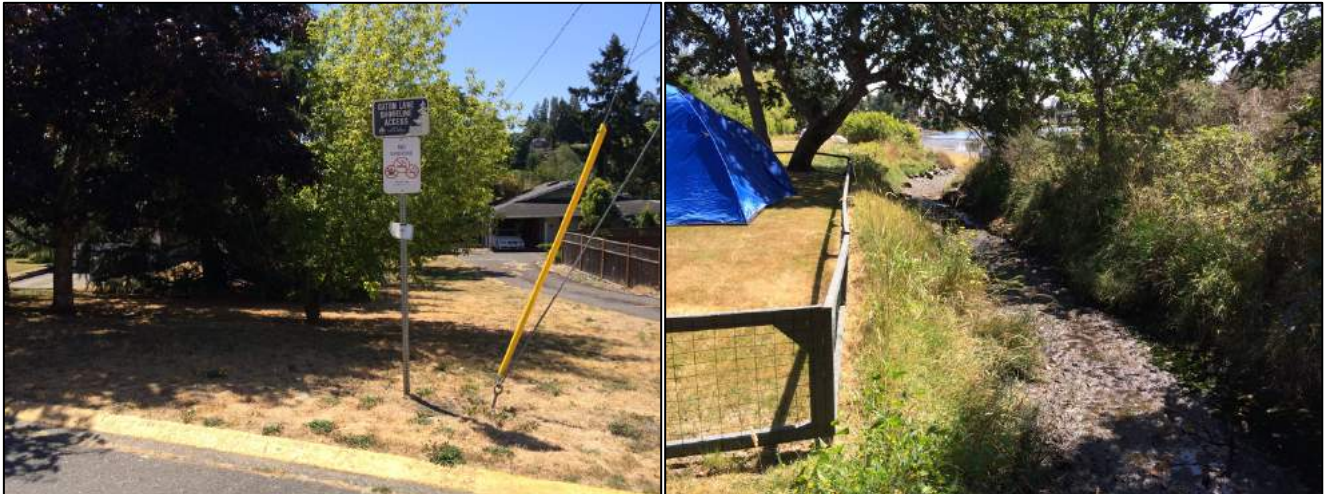
VR12 – Caton Place Shoreline Access sign at ROW and homeowner use of ‘park’ along dendritic channel.

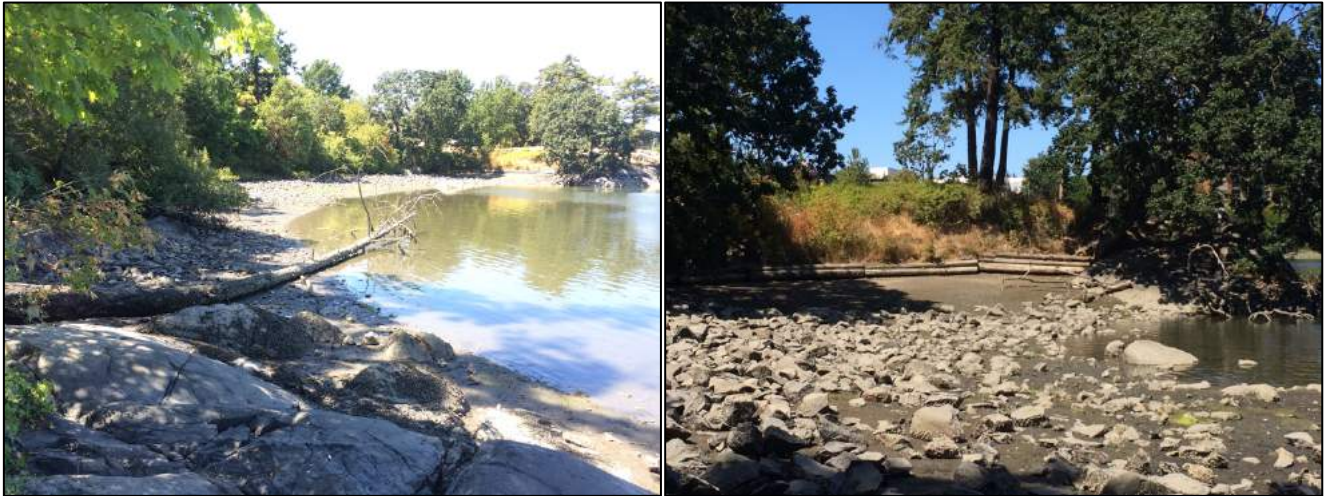
V01 – Banfield Park western cove. Riprap covers most of beach, but not slopes. Previous bioengineering on some slopes.

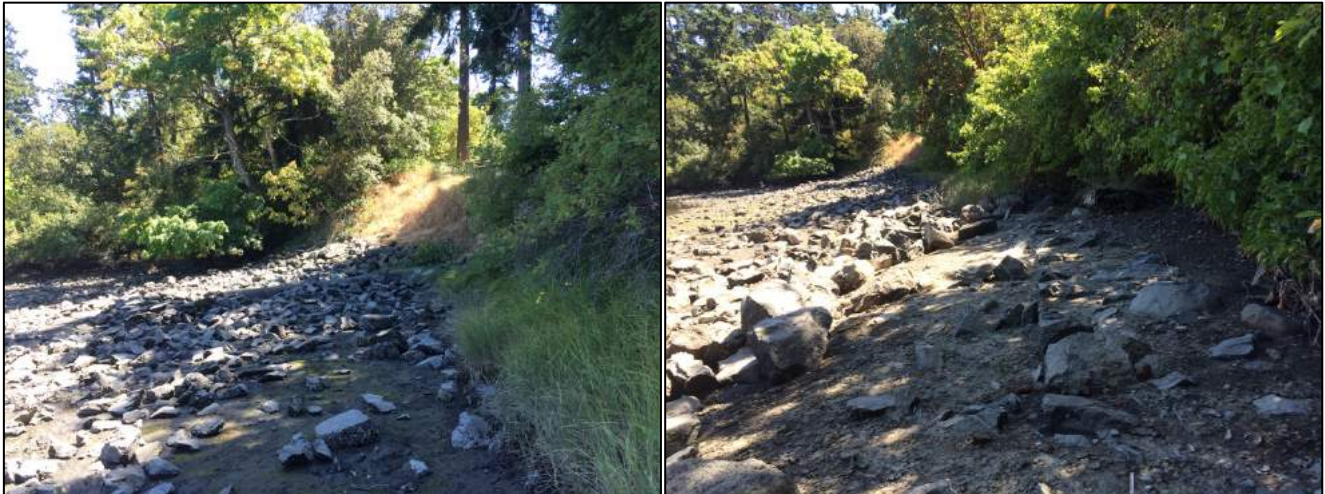
V01 – Emergent shoreline vegetation present under native overhang, but missing under ivy and daphne vergrowth.

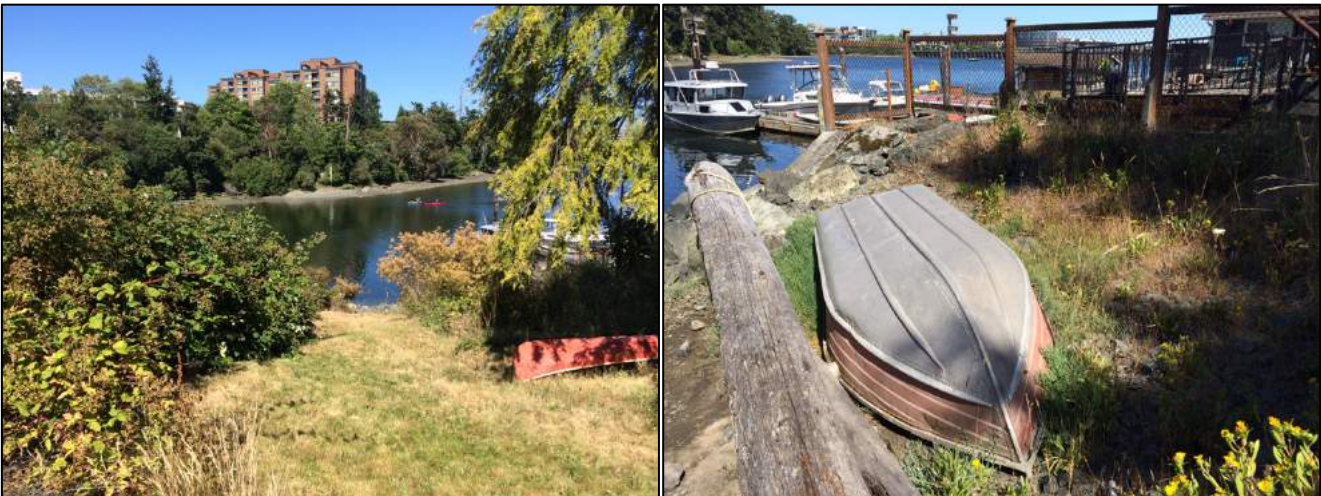
V02 – Ongoing maintenance required: invasive species removal, additional native planting, and alternative boat location.

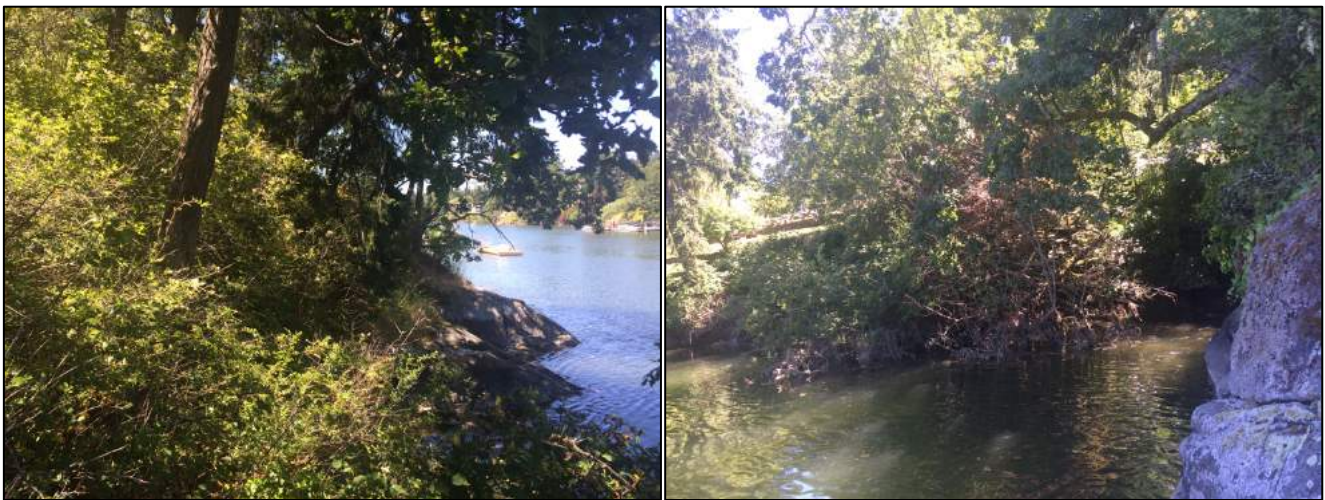
V03 – Native vegetation on bedrock (left) and pocket cove with slumping banks and overhanging vegetation (right).

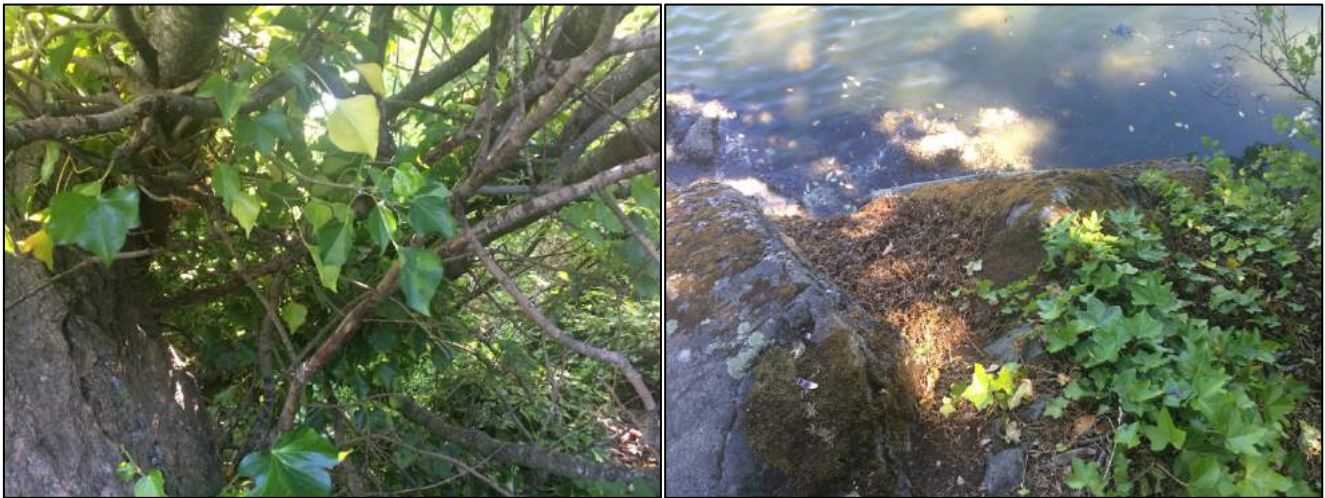
V03 – English ivy is bringing down trees (left) and contributing to slope destabilization. Ivy on shoreline is displacing licorice ferns and mosses (right).

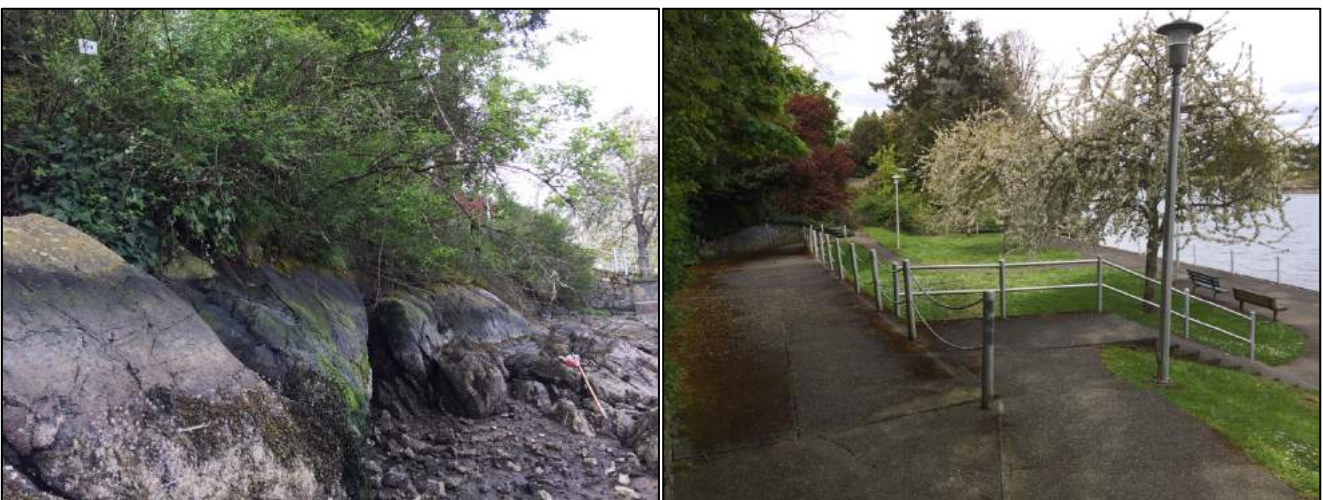
V04/E01 – Mostly natural shoreline with ivy overgrowth (Victoria, left) and hardened shoreline park (Esquimalt, right).

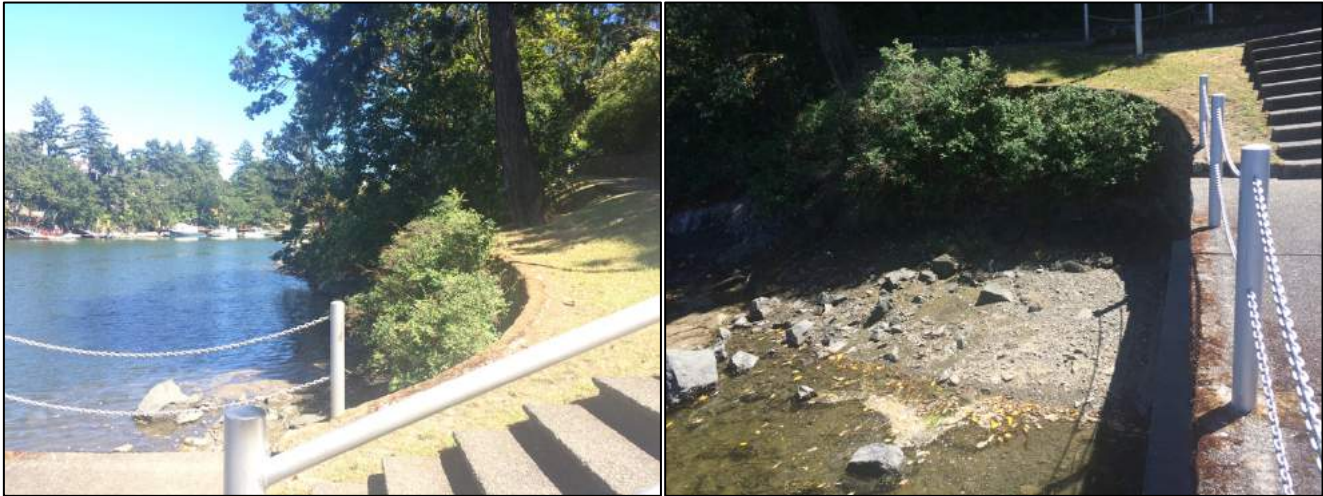
V04/E01 – There is no shore access and vegetation is destroyed by informal paths (beyond photo). A pedestrian/personal watercraft access from the existing promenade and replanting the shoreline would help alleviate this impact.

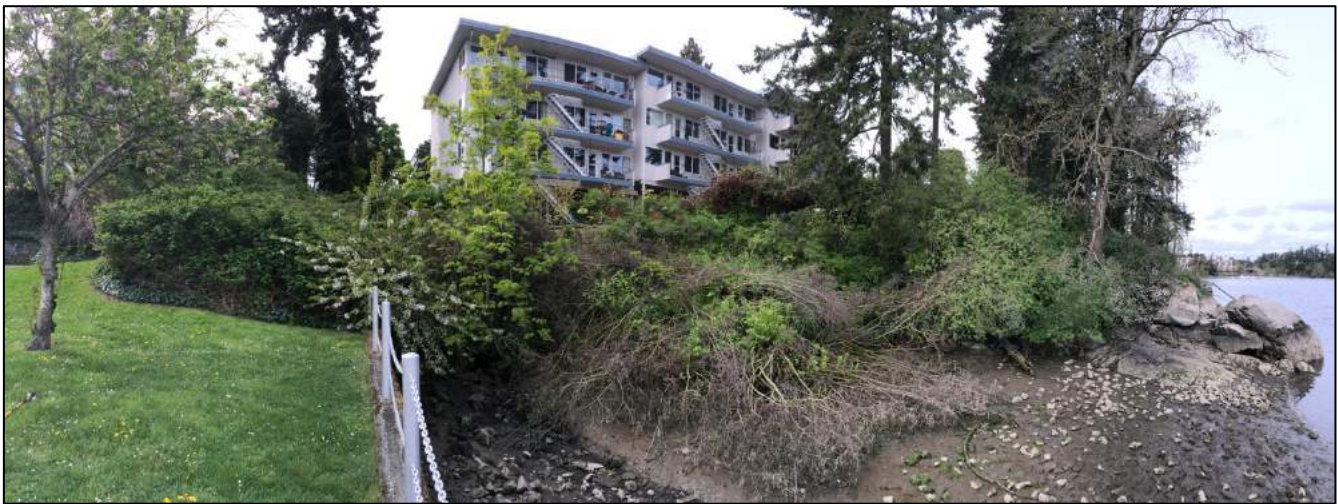
V04/E01 – Overhanging vegetation would help create habitat in this pocket cove on the far west of the park (left). Education of private landowners could provide additional habitat through management of fallen trees from invasive vegetation and yard & garden waste disposal.

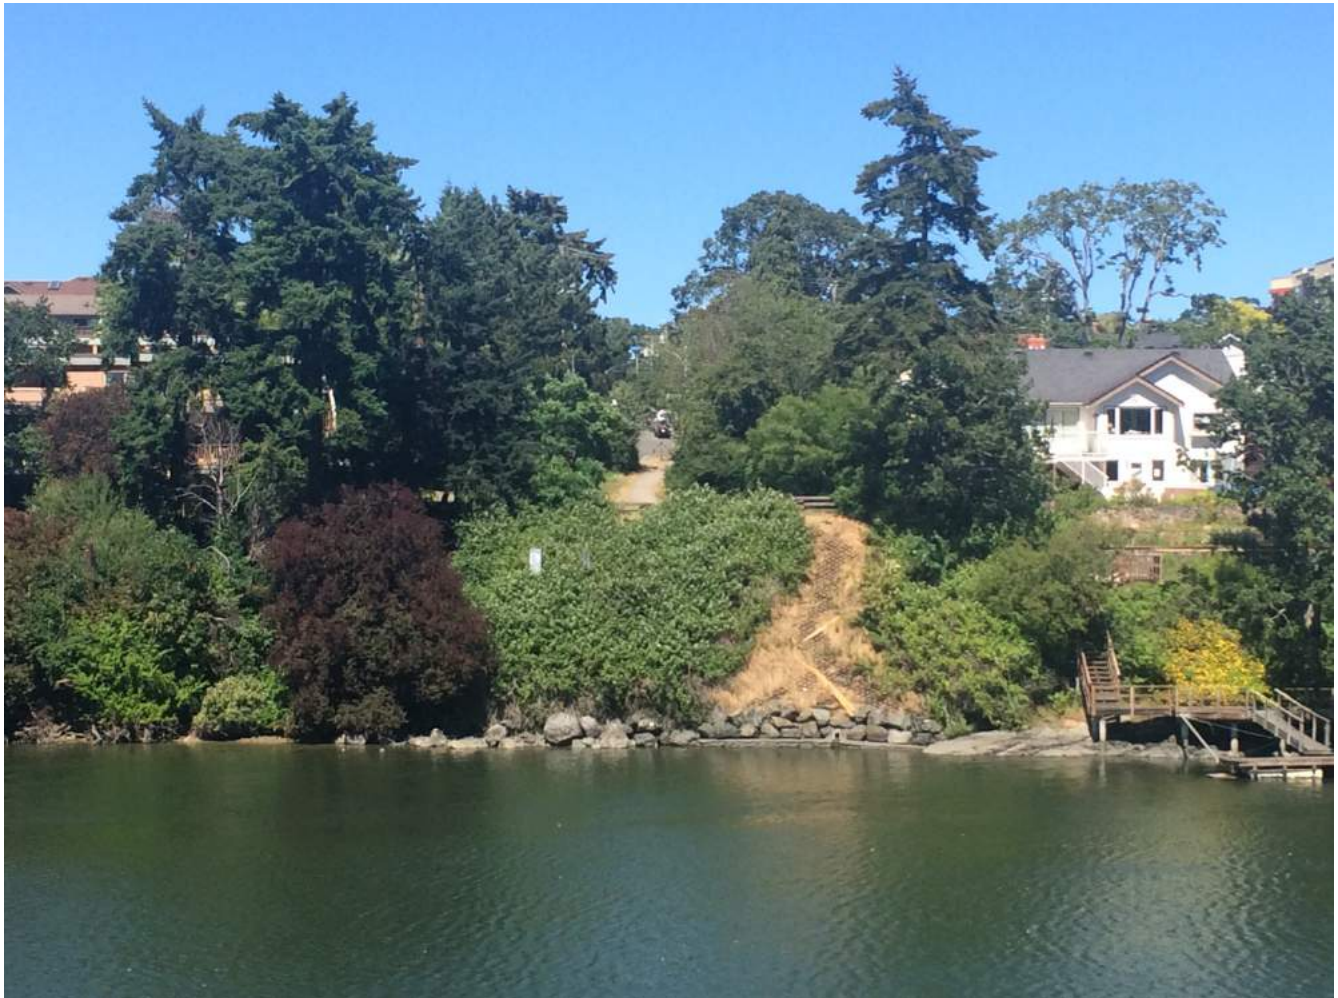
V05/S24 –This road end slope failure repair is covered in invasive species, with no evidence of native plantings, if any were planted. The Saanich shoreline (left) is heavily vegetated, but invasive species control is needed.

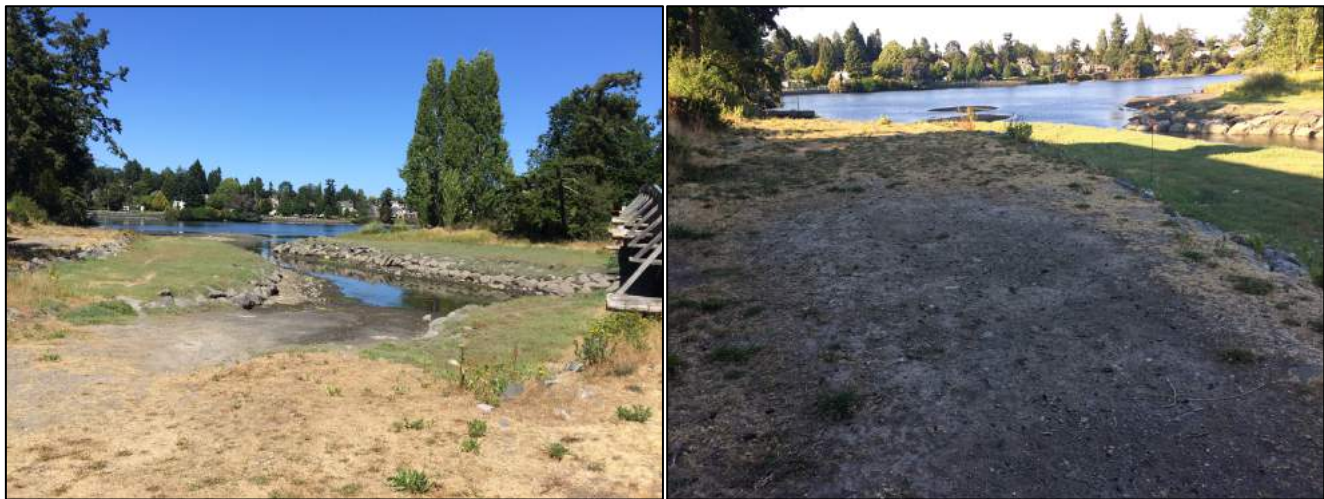
E05 – Sioux Place boat ramp and unsuccessful emergent planting bench has been reduced to dirt, possibly due to heavy Canada Goose browsing.

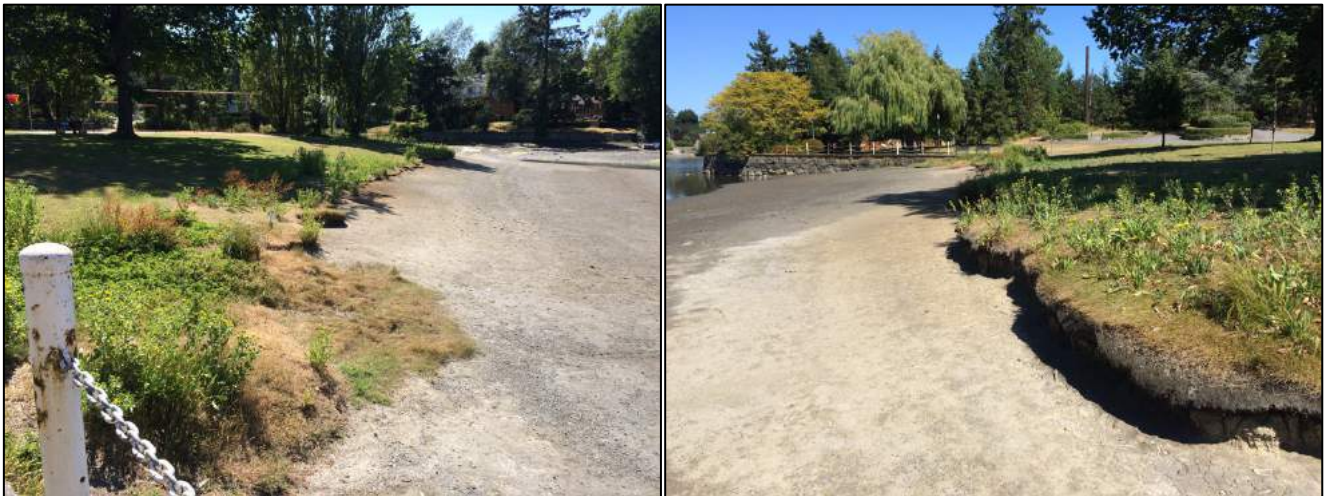
E05 – Gorge Esquimalt Park heavily used beach area could be planted with shoreline vegetation.
