Synopsis

A GREEN SHORE DEMONSTRATION PROJECT CONCEPT MILNER GARDENS

Milner Gardens Property - Shore Assessment

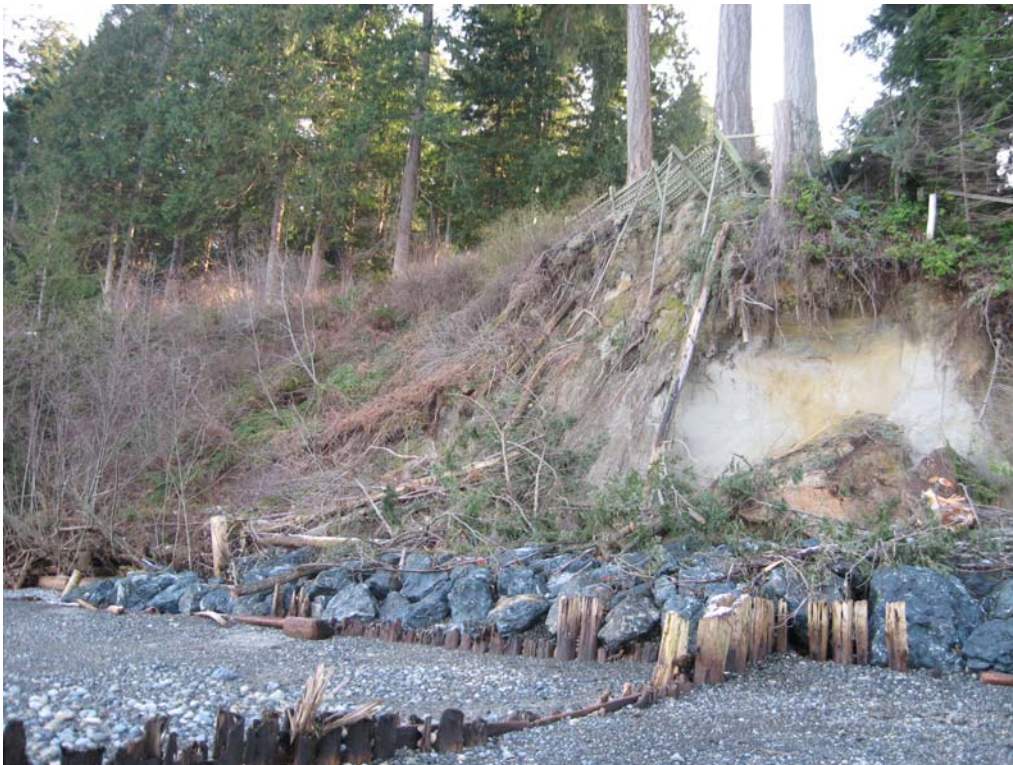
Figure 1: View of Milner Garden exposed area, January 2008

(note: double posts below 3 trees has a surveyed elevation of + 5.7 m CD)

Erosion of the bluff and undermining of the large trees that existed at the edge of the lawn at Milner Gardens occurred during recent winter storms, Figure 1, and as a result Milner Gardens has placed interim rock toe protection at the base of the cliffs as shown in Figure 1.

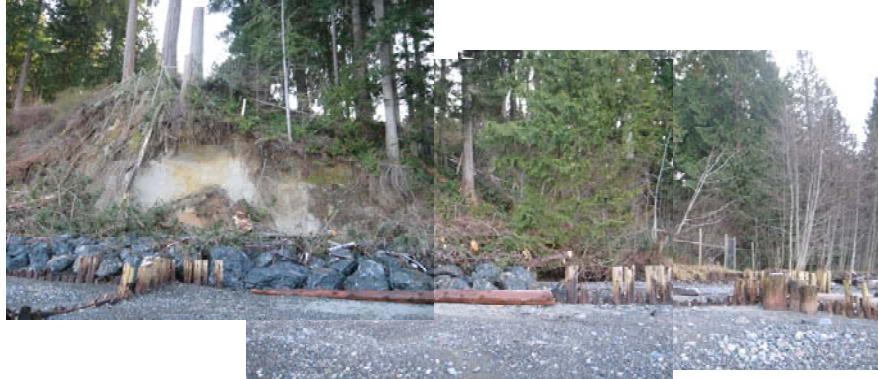
Figure 3: View of Shoreline Showing Remnants of Cedar Seawall

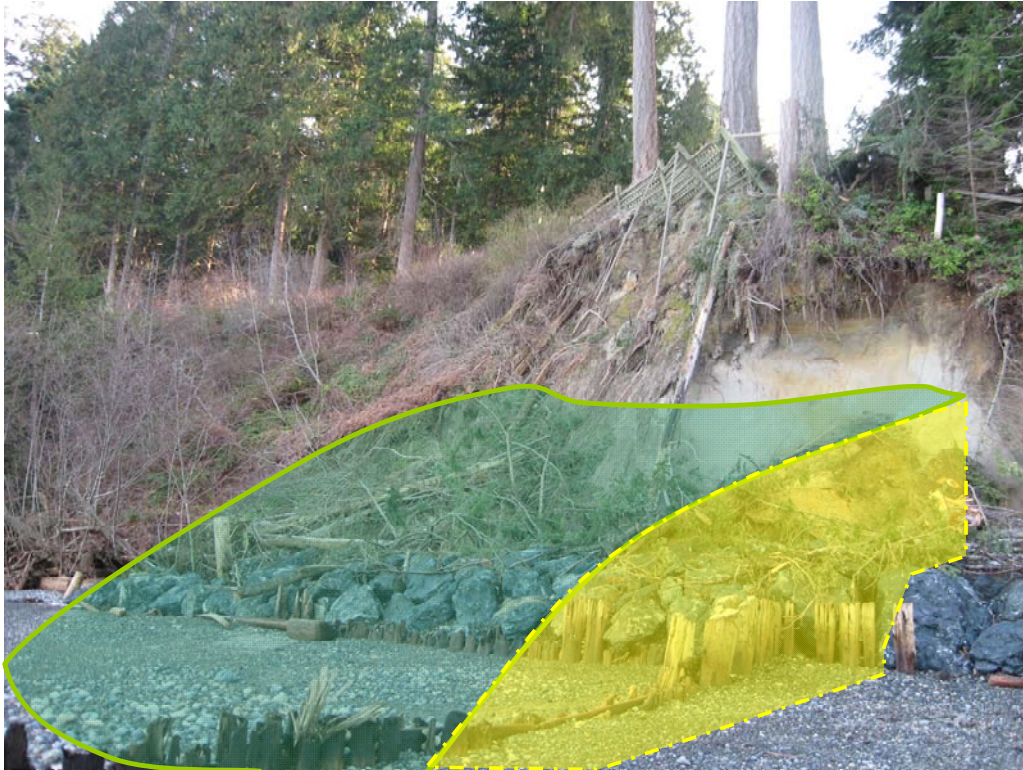
Figure 4: Sketch of Storm Berm for East Portion of the Property
Note: Possible Riparian Vegetation not shown for clarity

The storm berm portion of the work would consist of a mixture of sand, gravel and cobble that would be expected to erode, and then be replenished, during the occurrence of large storms and high tides. A sketch of the “storm berm” portion of the work is shown in Figure 4. Along the storm berm portion of the work, riparian planting could be included to demonstrate the potential benefit of such vegetation in slowing the erosion rate of the storm berm.

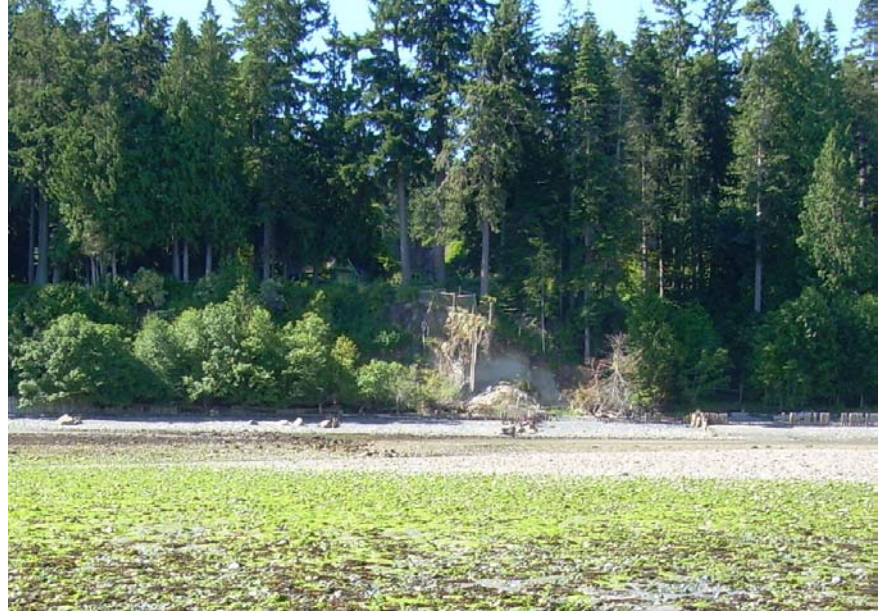
Figure 2 Photo of the Milner Property, looking westward across the intertidal zone. While most of the cliff is covered with trees and shrubs, the bare portion in the centre has recently failed.

The property sits approximately 20m above the beach level. The substrate at the site is unconsolidated glacial till and outwash sediments. Wave erosion has created a cliff along the much of the shore in this area. For the most part, this cliff is vegetated and stable. However, the cliff has recently been over-steepened at the Milner Gardens site and is failing (Fig. 2). Large trees located on the upper cliff edge are likely to topple down in the near future.

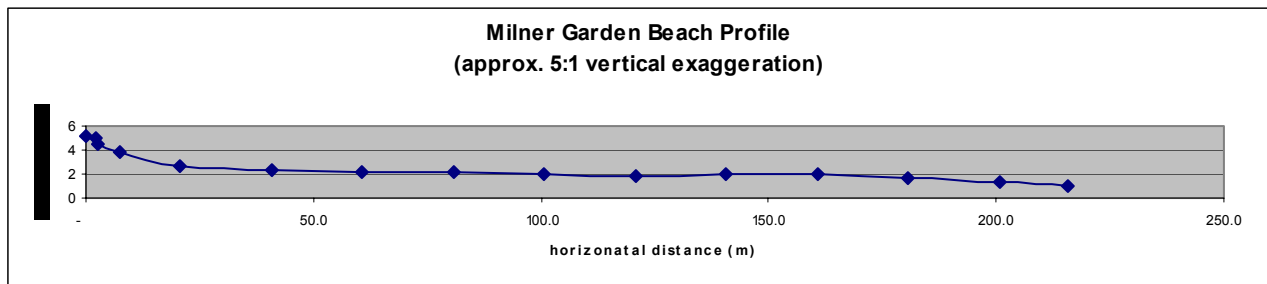
Figure 3. Surveyed profile of the intertidal zone from the Milner Gardens beach site. The tidal flat is approximately 200 m in width and the beach face (steeper section to left) below the sea wall is slightly less than 20m in width. The base of the scarp was measured at 5.2 m above tide datum (predicted maximum tidal level for this area is 5.1 m).

The intertidal flat width is 98m and the beach face approximately 20m (Fig. 3).

Although no direct observations were made of the waves at the site, one can make a few assumptions about probable nearshore wave conditions. The extremely wide intertidal zone (Fig. 3) will tend to reduce wave energy levels at the high water line because a significant amount of energy is lost as waves shoal and break across this wide tidal flat. As such, wave energy levels in the upper intertidal are likely to be considerably reduced from offshore, deep-water energy levels.

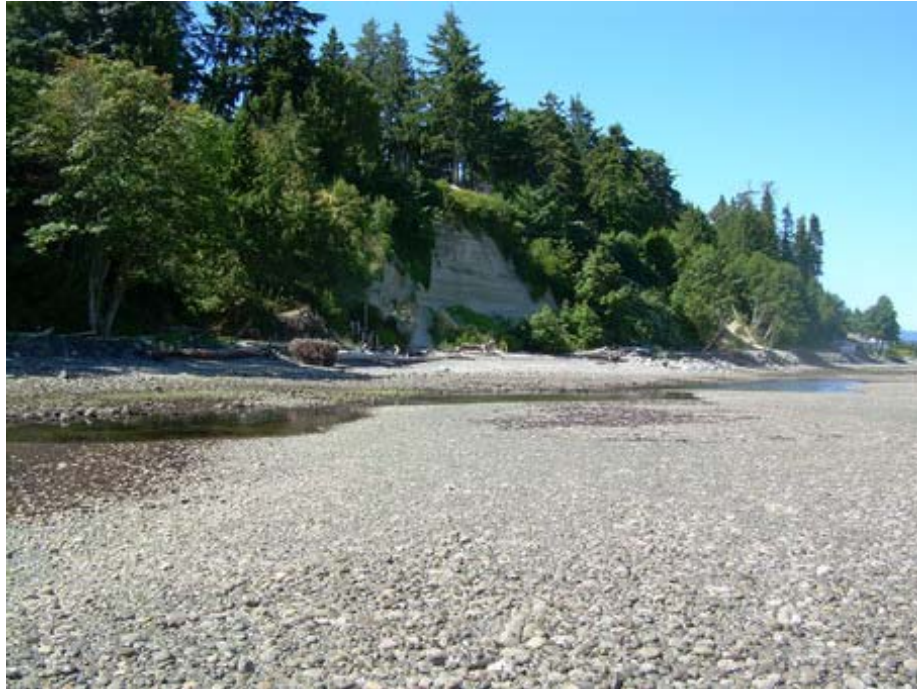
Figure 6. Photo of cliffs to the west of the Mewburn property. Rip-rap placed in the supratidal and intertidal below some of the properties (right portion of photo) to stabilize the cliff toe.

Shore protection in the form of a wooden bulkhead (vertical logs) was apparently placed on the upper beach several decades ago in attempt to stabilize the shoreline (Fig. 4). Other man-made modification has occurred in the intertidal zone. Bulldozers appear to have been used to clear away cobble and boulders from the beach at properties both east and west of the Milner Garden site (Fig. 5; see also air photos shown in Figure 7 and 8). Recent construction of rip-rap and concrete bulkheads to the west of the Mewburn property was noted (Fig. 6).

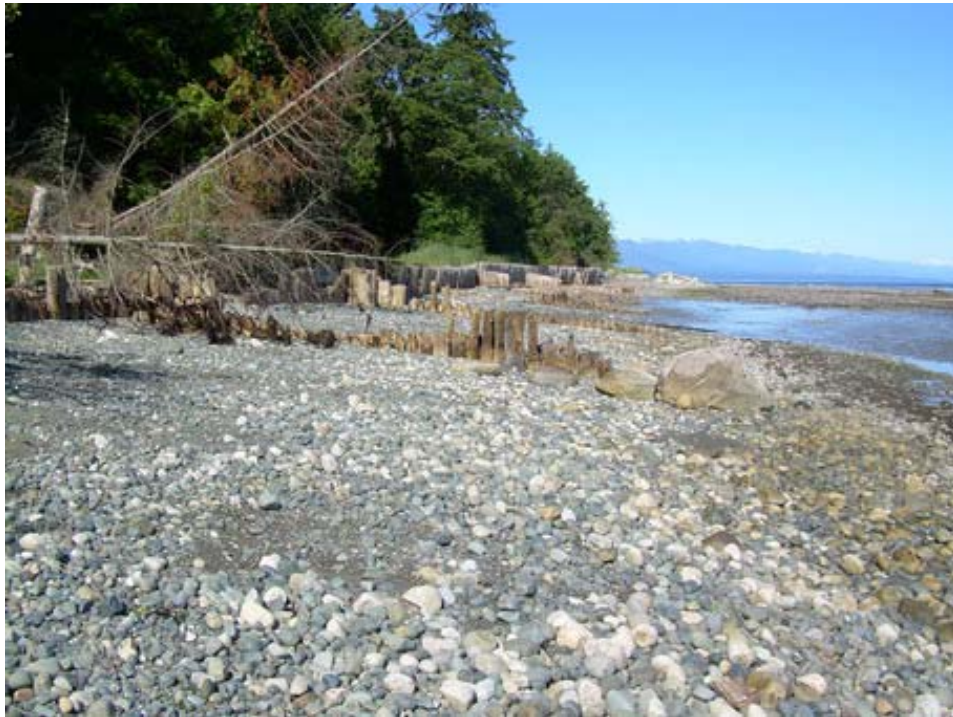
Figure 4. An photo of the beach at Milner Gardens looking alongshore to the northwest. a wooden seawall and groins are visible to the left. The cobble veneer over the beach face is also evident.

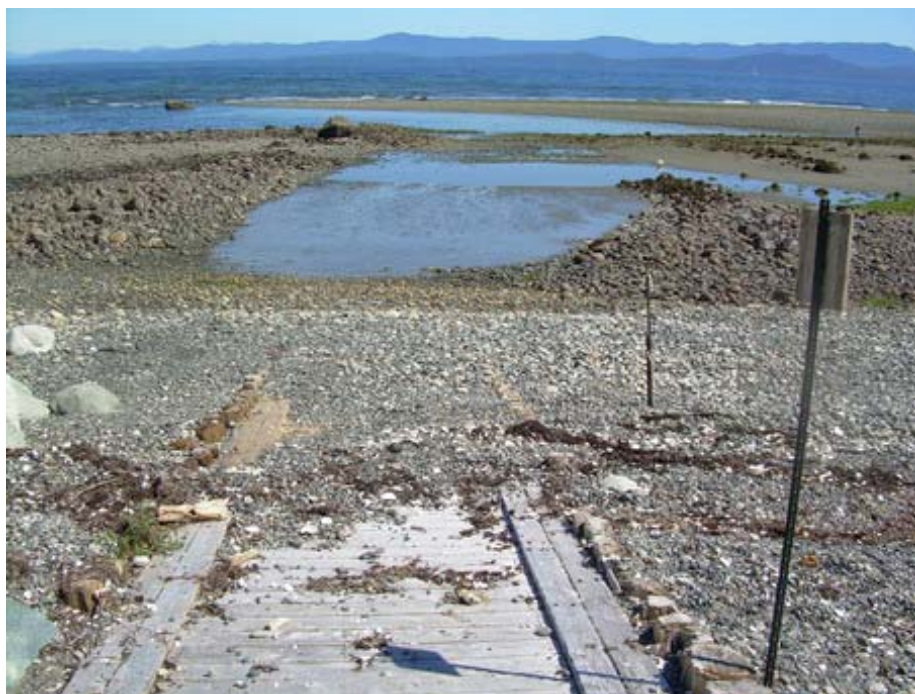
Figure 5. An photo from the Mewburn property looking north across the intertidal zone. The large trough area was probably created by bulldozers moving boulders and cobbles into groin-like features in attempt to create a boat launching/mooring area below the boat ramp. Such clearing are common along this stretch of shoreline and probably date back to the 1950s and 1960s.

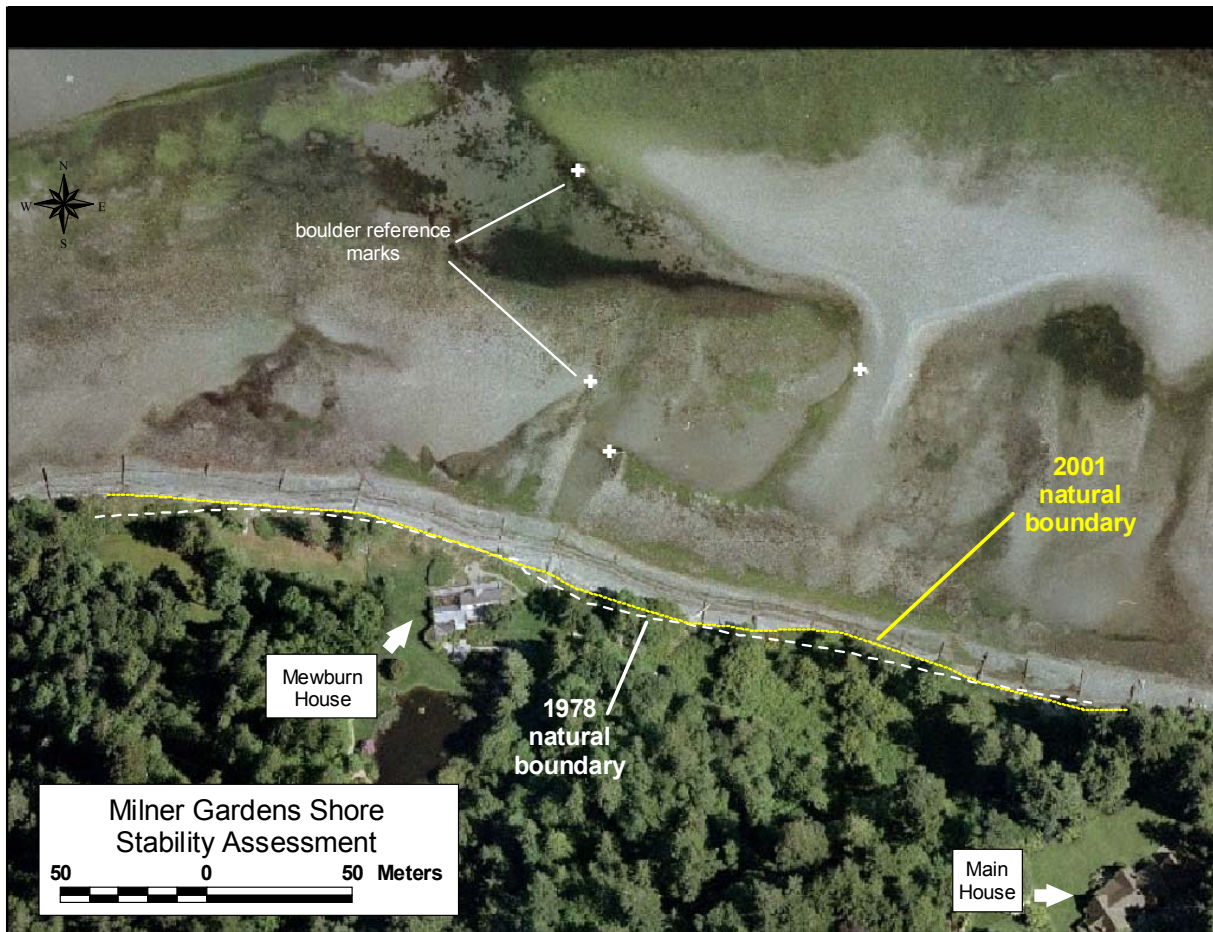
Figure 9. Interpretation of the natural boundary position from the 1978 air photo and from the 2001 air photo. There is no significant difference between the boundary positions. The interpretation of the natural boundary position is complicated by tree overhang in the cliffed section of the property and is regarded as approximate.

The interpretation of the natural boundary and the lower beach face are shown in Figures 9 and 10. Tree overhang significantly complicates the interpretation of the natural boundary (Fig. 9). No significant overall trend is apparent in the natural boundary position over time, and the section of shoreline immediately seaward of the Milner Gardens house is obscured by trees and can not be interpreted. The position of the lower beach face appears to have been displaced seaward in some places and landward in other places; no significant overall displacement of the lower beach face is evident in the photos (Fig. 10). The comparisons of these two features suggests that overall, the shoreline has remained relatively stable during the 23 year photo interval.

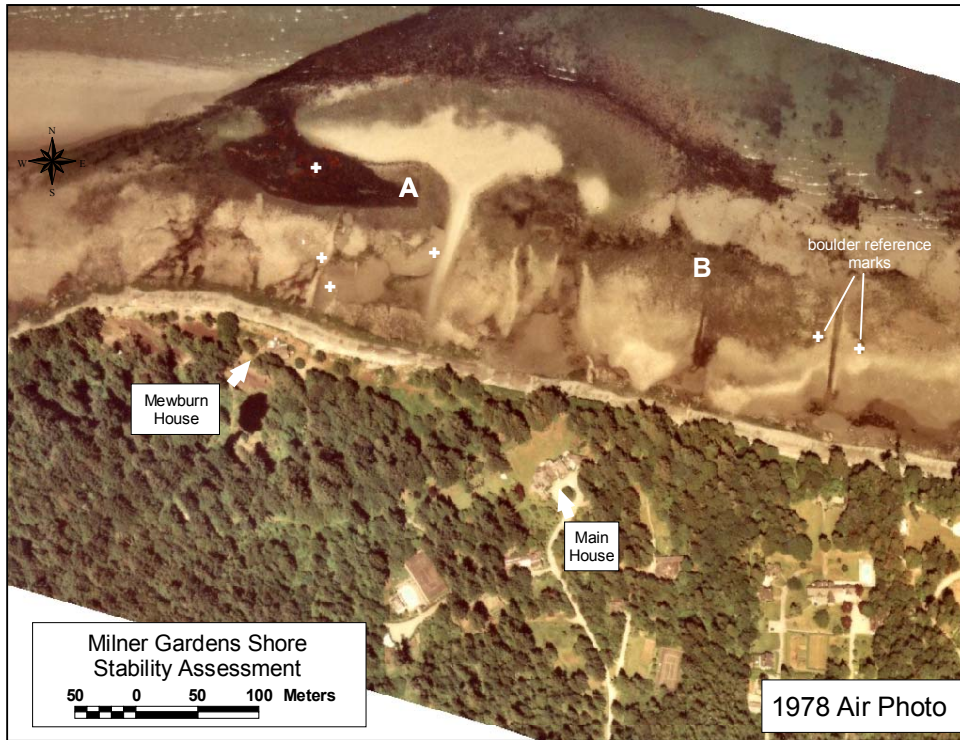
Figure 7. 1978 low-tide vertical air photo showing major shore features relative to the Milner Gardens property. Small white crosses mark large boulders, which were used to co-register the photos. Locations A and B are locations where significant sedimentation patterns have occurred over the photo interval (1978 to 2001).

In order to assess the shoreline stability of the Milner Gardens site, air photos were reviewed to evaluate the changes to the shore system over time. Two photos were selected for analysis: a 1978 vertical air photo and a 2001 vertical air photo (Fig. 7 & 8). Both are high resolution photos (scale of 1:10,000 or better) and both were taken at or near extreme low tide during the summer months. The photos were somewhat challenging to georeferenced in an absolute grid but the presence of very large boulders in the intertidal zone were used to reference the photos to each other. The comparative photos were used to assess the stability of the natural boundary (break between the terrestrial vegetation and the marine zone), the stability of the beach face and changes in patterns of sedimentation.

The two photos (Fig. 7 & 8) can also be used to compare morphological changes on the shore. There are a number of troughs and swash bars evident on the photos and these features have remained remarkably similar over the 23 years between photos. Two features that have changed include (a) the landward margin of the large swash bar (Fig. 8, Location A), which has migrated landward about 30m and (b) the large sand sheet (Fig. 8 Location B), which was not evident on the 1978 photos. This sand sheet was observed during the July 2007 site visit.

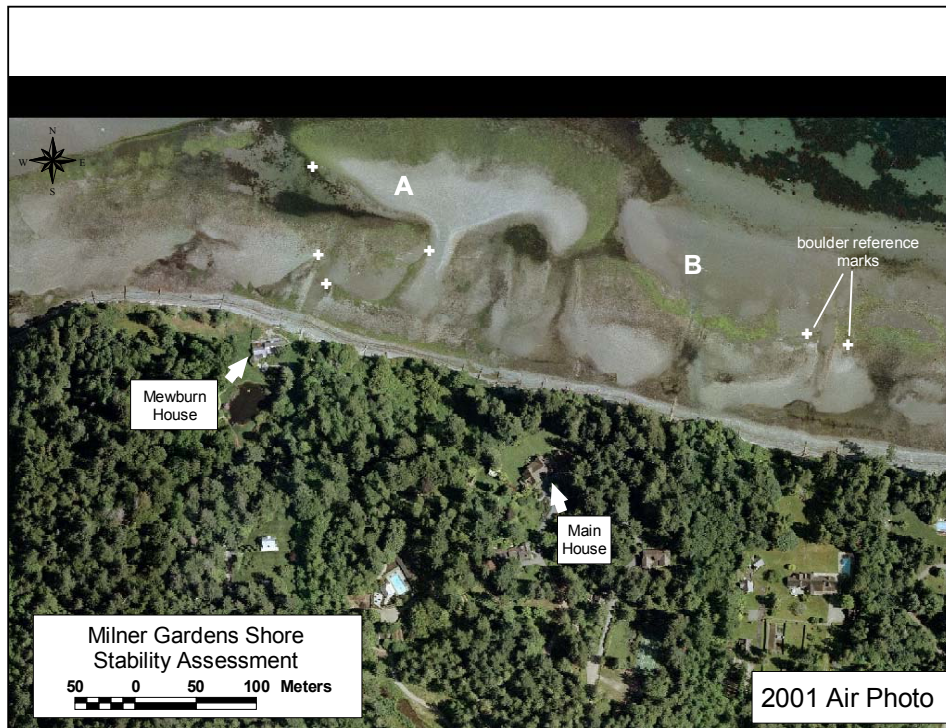
Figure 8 .2001 air photo of the same location, carefully referenced to the same boulders visible in the 1978 photo. The large swash bar (A) has undergone a shoreward migration of 30-40m. A large sheet of sand (B) is also present in the lower intertidal zone that was not present in the 1978 photos. Other intertidal bars have remained relatively stationary over the 23 year interval between photos.

There is some evidence of accretionary features near Milner Gardens. A seasonal accretionary berm was observed to the east of the property and a large swash bar in front of the Mewburn property was shown to migrate landward, indicating that sediment was captured in this bar over at 23 year period (see Fig. 8, Location A). A large sheet of sand appears to have accumulated directly seaward of Milner Gardens over the same 23 year period (Figure 8, Location B).

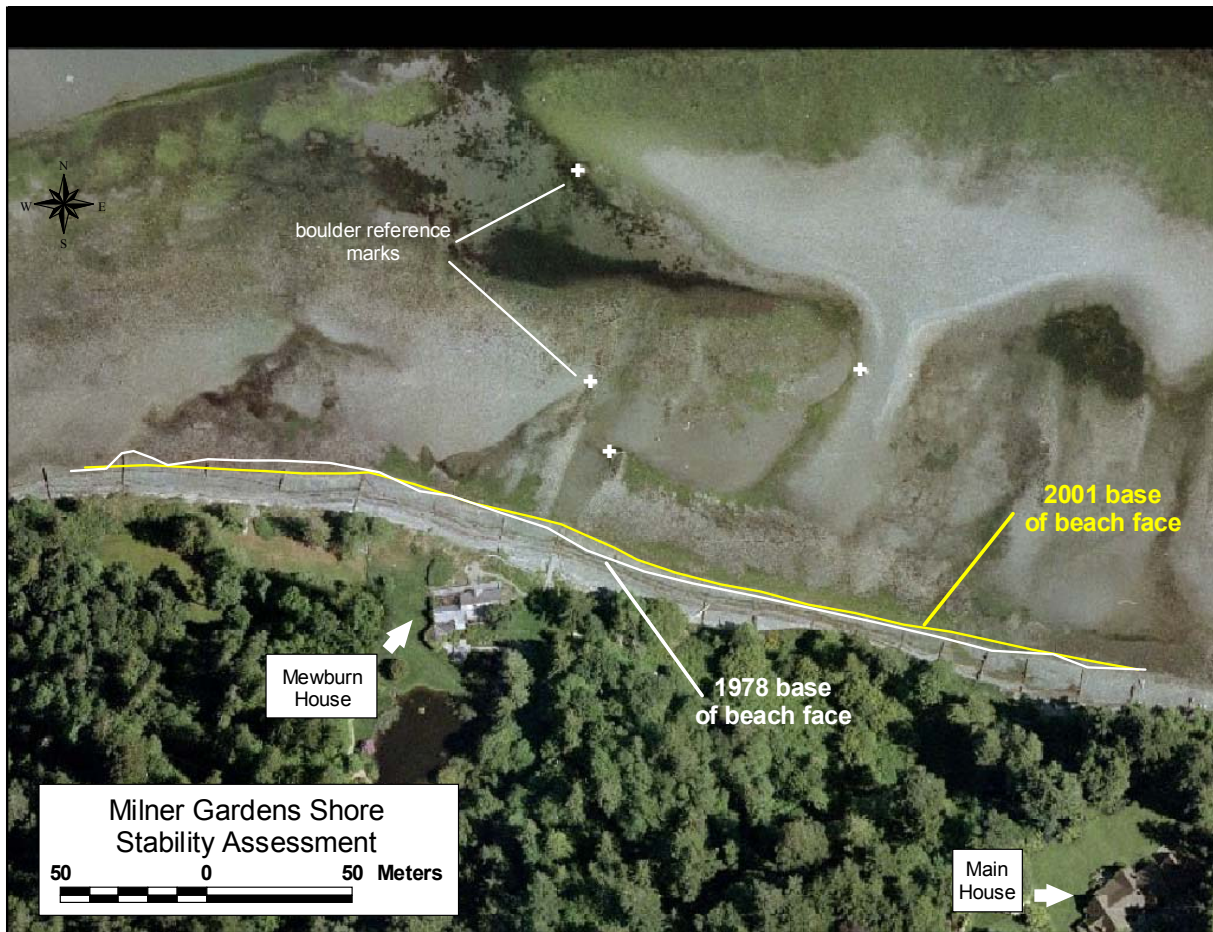
Figure 10. Interpretation of the base of the beach face from the 1978 air photo and from the 2001 air photo. The difference between the two positions is within interpretative error and not regarded as significant.

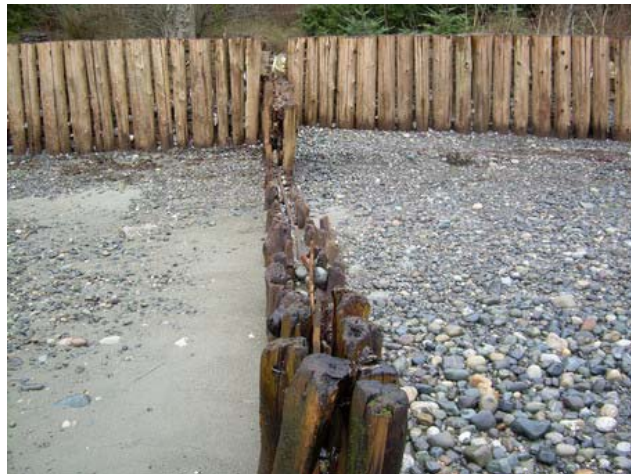
Figure 13. Photo of build-up on right side of groin (west side) indicating right to left sediment transport (to the east) was occurring at the time the photo was taken (March 2007).

Most sediment transport is typically generated during winter storms when large waves are generated within the Strait of Georgia and when storms are more likely to combine with periods of high spring tides. The dominant storm wind is generally considered to be from the southeast (Fig. 11) and normally would generate longshore sediment transport to the northwest. However, review of air photos and of beach conditions at the site provide no morphologic indication of dominant sediment transport direction. The morphology of a large swash bar in the intertidal zone suggests a more or less neutral sediment transport, as indicated by the swash bar “tail” (Fig. 8), which is directed directly *toward* the shore. Photos of sediment build up on the wooden groins during March shows a weak indication of southerly transport at the site (Fig. 13).

Most of the intertidal zone is armored with a veneer of boulders, cobbles and pebbles. While pebbles and sand may be transported during most moderate wave energy events, cobbles and boulders are only likely to be transported during the highest energy storm events. The armored surface of the tidal flat looked highly stable and supports a luxurious epibiota (Fig. 2, foreground). The upper intertidal zone consists of a comparatively steep beach face with an armor of small cobbles and pebbles (Fig. 13). This zone appears to be more mobile than that of the lower intertidal zone.
