NANOOSE SHORELINE PROTECTION PROJECT

PROJECT OBJECTIVE

PROJECT LOCATION

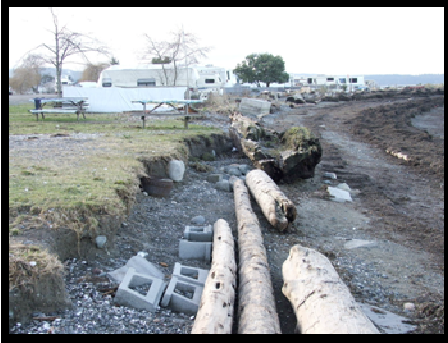
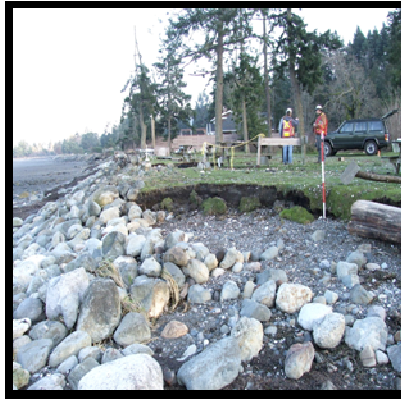
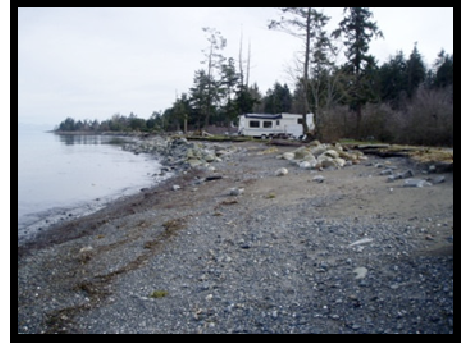
Pre-Construction

Since 1878 approximately 13 m of the shoreline fronting the Nanoose campground eroded due to high tides and large storm events, threatening a sanitary outfall pipe running across the shoreline in front of the campground and out to Nanoose Bay. The pre-existing beach was gravel in the upper intertidal area with extensive (600m) sand flats below. Upland soils were compacted and the riparian vegetation had been destroyed due to the campers being allowed to park right up to the shoreline. There is a 600m breakwater at the western end of the project area. Intertidal clam beds are located 400-600m from shore.

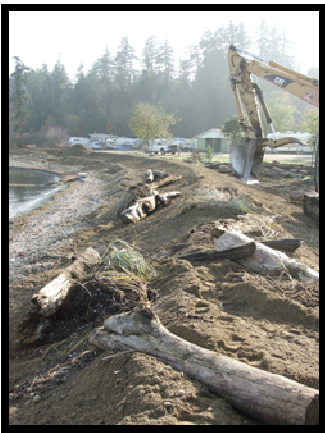
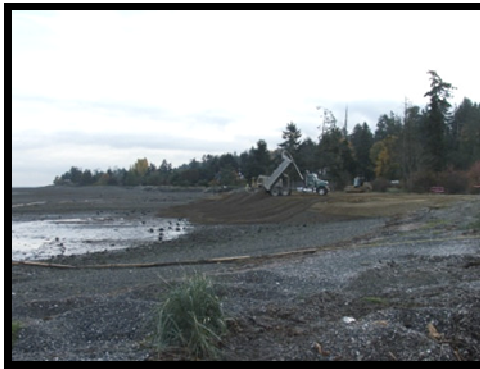
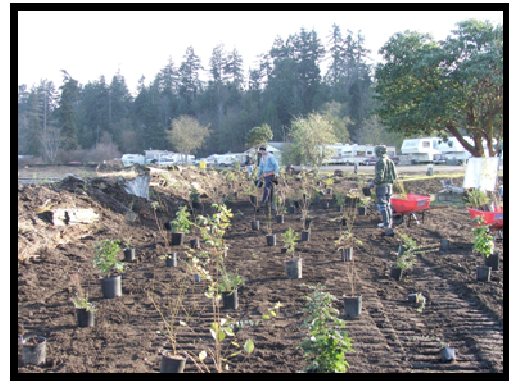
Construction Phase

A 300m floating silt curtain was constructed to enclose the work site to control sediment dispersion during construction of the new upland and beach gravel area. Silt fencing was also installed at the toe of the berm; however, this fencing was destroyed by wave action and a small amount of beach gravel was build up at the toe of the berm to contain fines. This alternative method worked well.

The key challenge was project timing. Due to delayed approval, the project had to be constructed in late fall in poor tide conditions and a short work window. Erosion and sedimentation control was therefore more challenging. The work schedule was affected and it was at times necessary to work at night with the available low tides.

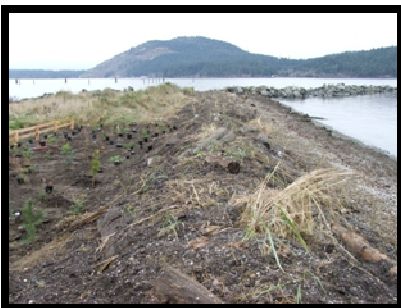
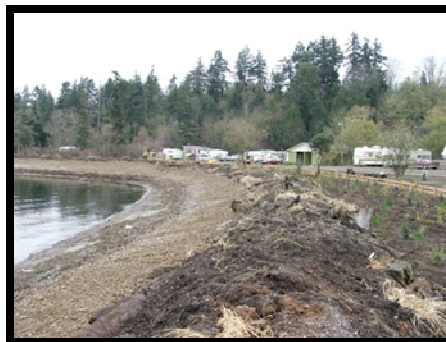
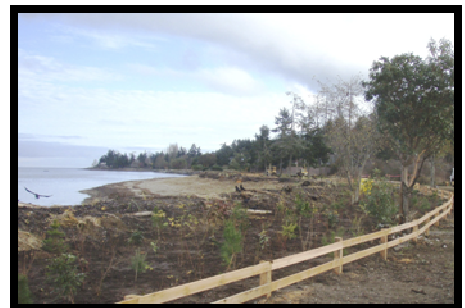
Post-Construction

Project construction was completed in 2008. Initial performance has exceeded expectations, and will be monitored for 5 years. A natural crest began to form through the first winter season. A small amount of sand is accreting eastward of the groyne that may contribute to the formation of a small pocket beach fronting the adjacent property.
