POINT ELLICE PARK SHORELINE REHABILITATION

PROJECT OBJECTIVE

PROJECT BACKGROUND

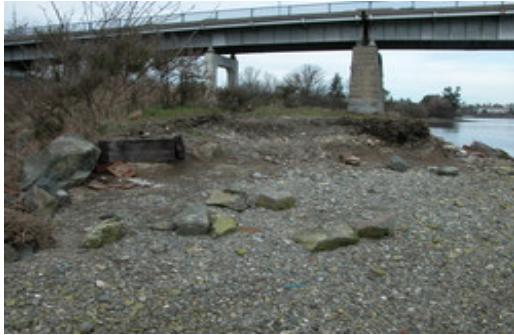
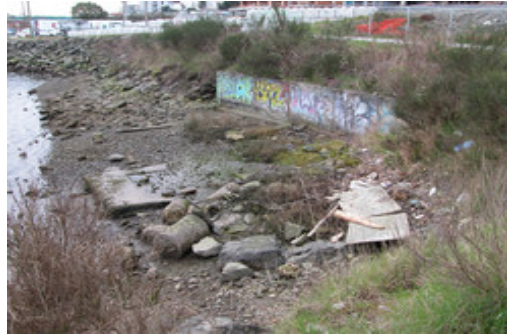
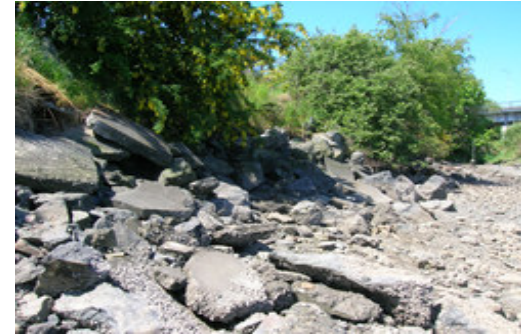
Pre-Construction

The site is former industrial land built on foreshore fill. The fill was failing in many areas along the shore and invasive plants, particularly Himalayan blackberry, dominated the upland. As part of the master development agreement, Dockside Green rehabilitated approximately 250m of the shore zone of Point Ellice Park and upgraded a section of the popular Galloping Goose bike and walking trail.

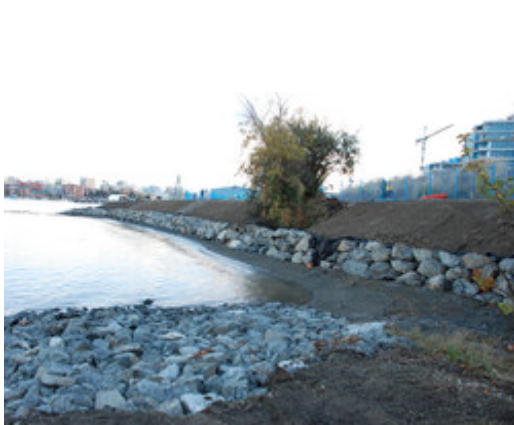
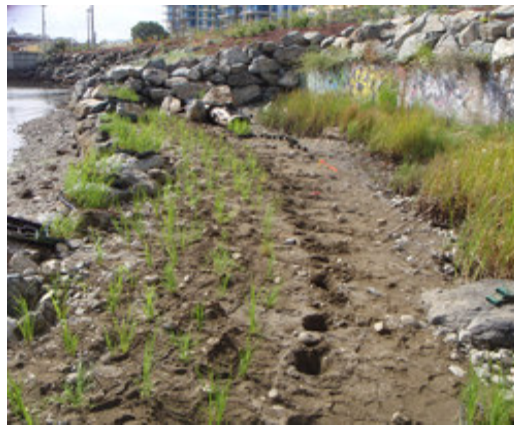
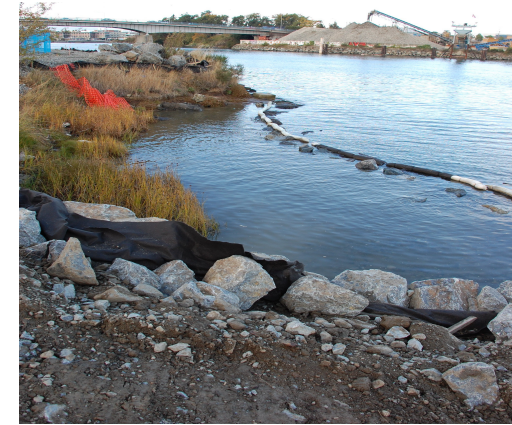
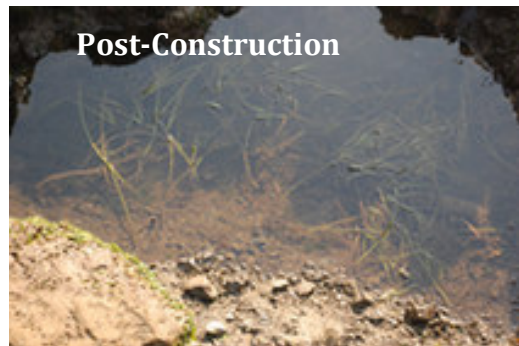
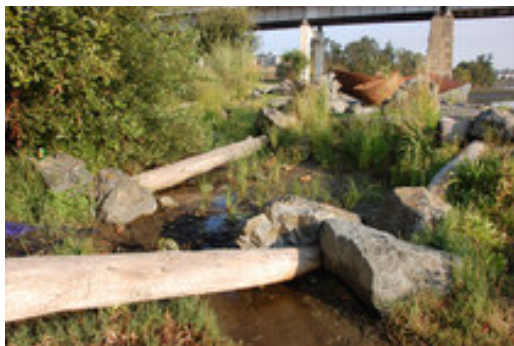
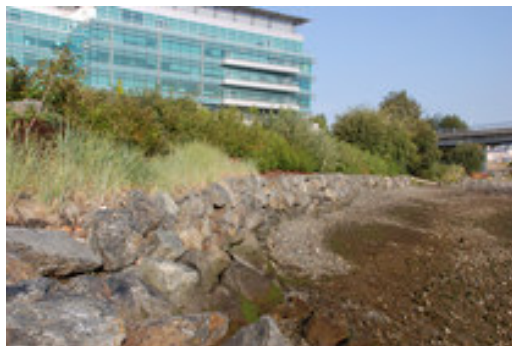
Construction Phase

All intertidal work was done during daylight low tides. A floating silt curtain was used to contain the worksite. The silt curtain was kept buoyant at the surface with an oil spill absorbing boom, thereby ensuring both sediment and spill containment.

It was valuable to have a design team working closely with a committed construction team. For example, during a routine site visit, a landscape architect and foreshore biologist concluded that the rock toe at the beach face was higher than necessary. The contractor willingly removed a layer of rock, resulting in a more functional and visually pleasing riparian zone.
