## 508 Selkirk Ave. Shore Restoration Project

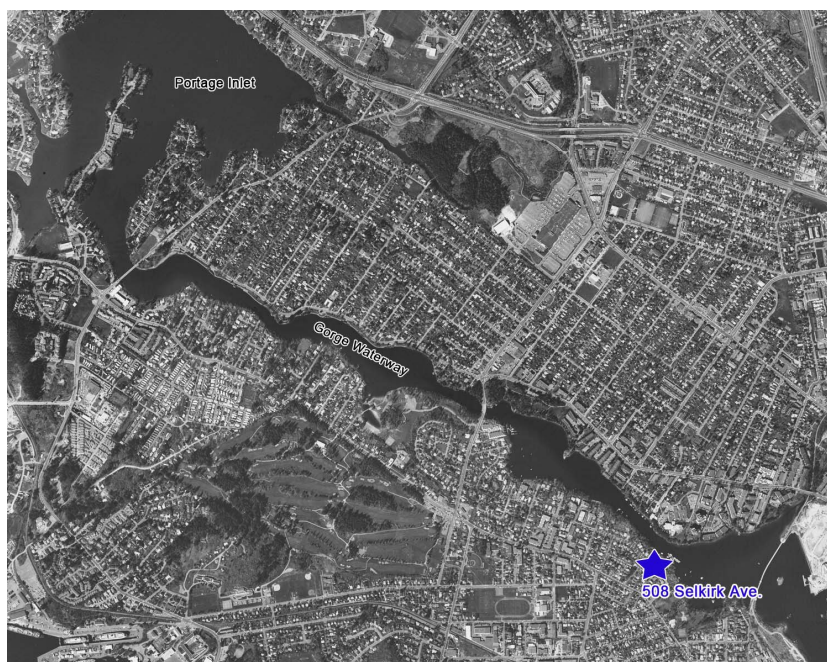
Figure 1. Location of 508 Selkirk Ave. on the Gorge Waterway (blue asterisk)

508 Selkirk Avenue is located at the southeastern end of the Gorge Waterway; a shallow, narrow inlet extending northwest of Victoria Harbour (Figure 1). The Gorge is strongly influenced by tidal currents, especially at the narrowest constrictions. Portage Inlet, a shallow basin at the upper end of the Gorge Waterway, receives freshwater drainage from the Colquitz River and Craigflower Creek, major watersheds of the municipality of Saanich. The Gorge is well protected from wave action, but some sections of shore are subject to erosion due to boat wake. Suspension feeding organisms (sponges, ascidians, bryozoans) are abundant in subtidal areas of the Gorge due to the high current regime. The Gorge and Portage Inlet also support the largest eelgrass beds in the Victoria and Esquimalt Harbour region.

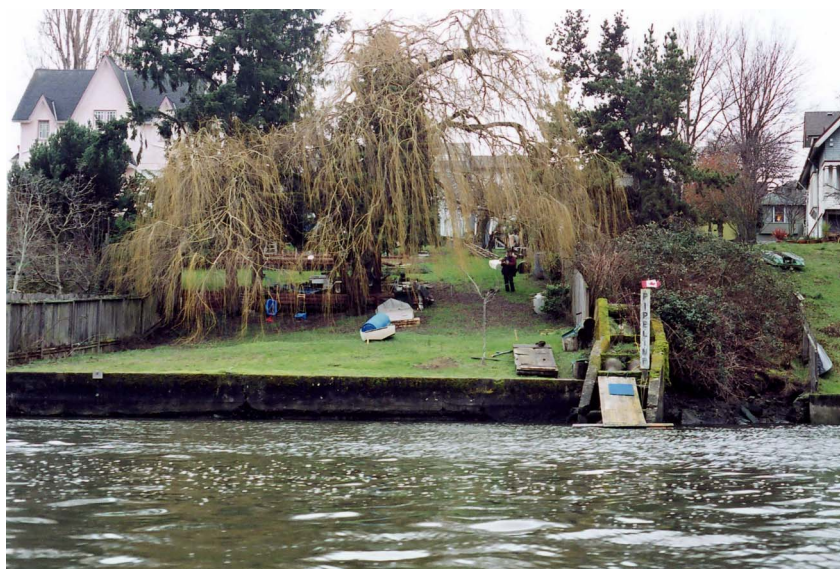
Figure 2. Property at 508 Selkirk Ave showing seawall at mid tide and sewer truck corridor (right side).

The shore of 508 Selkirk is approximately 20m in length and formed entirely of a concrete seawall (Figure 2). The property is bounded by a sewage trunk line to the west and a retaining wall running perpendicular to shore (part of a former boat haul-out) to the east. Historic air photos suggest that infilling and construction of the seawall occurred prior to 1930. The seawall was last replaced in 1979.

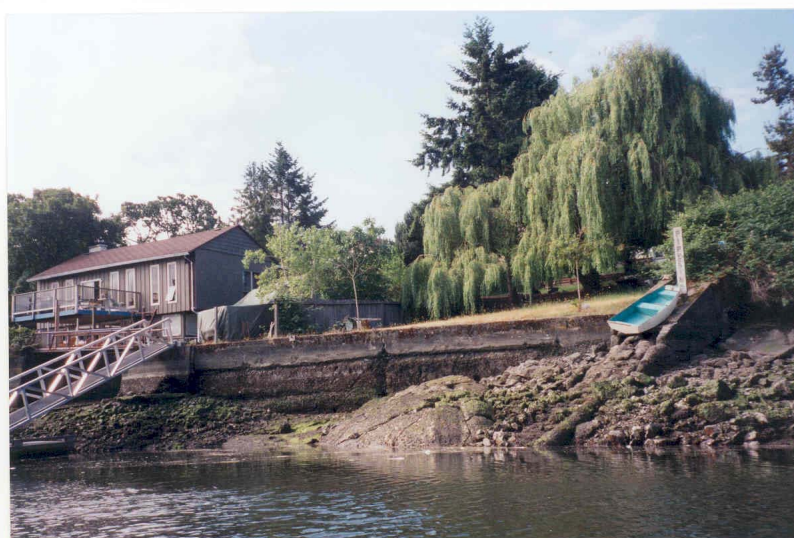
Figure 3. Property at 508 Selkirk St at low tide, showing bedrock outcrop (right) and mixed sediment beach (left).

The base of the seawall (approximately +0.5m elevation relative to chart datum) is a mixed substrate beach formed of broken concrete, boulder, cobble and gravel overlain with a mud veneer (Figure 3). There is a bedrock outcrop at the west end of the property. A small amount of rockweed (*Fucus sp.*) and a few Pacific oysters (*Crassostrea gigas*) grow on this bedrock outcrop. During outgoing tides the current at the base of the seawall forms a back eddy, and the fine sediments overlaying the substrate indicates a depositional environment.

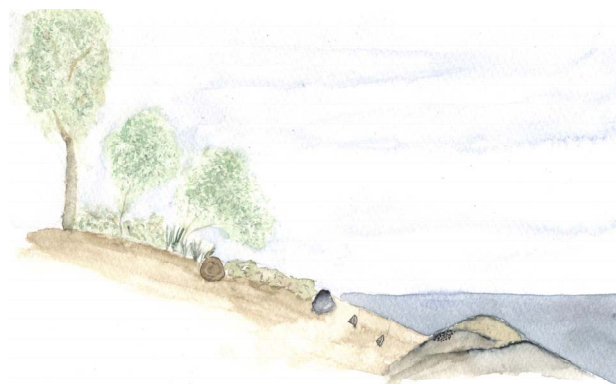
**Figure 4. Restoration Design Concept for 508 Selkirk St.**

The chosen restoration design includes creation of a small intertidal beach area, suitable for intertidal clams and a terraced marsh bench modeled after an existing natural marsh on the opposite side of the Gorge Waterway (Figure 4). In addition the design incorporates plantings of riparian vegetation and use of logs to create the marsh bench and provide the required degree of protection from erosion. Runoff has been directed onto the marsh bed with use of a rock splash pad to minimize the potential for erosion. Most of the seawall has been removed and a new, small section poured at the east side of the site to buttress the boat haul out retaining wall.
