Molega Lake, Nova Scotia

Green Shores for Homes Case Study

Umlah, K. & Giacomodonato, H. (2026). Molega Lake: Green Shores for Homes Case Study.

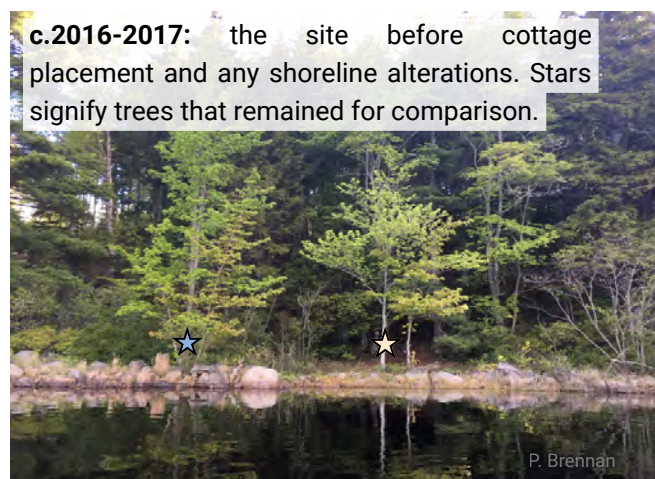
These previous alterations diminished the site's habitat quality. Redroot habitat, for example, was lost or highly damaged through infilling, shoreline hardening, moving rocks, and adding sand material to create an artificial beach. Changing the natural substrate to compacted poor-quality fill may have also reduced the site suitability for nesting reptiles. The homeowners reported that they were unable to grow vegetation in the infilled area over the past six years due to the poor fill quality.

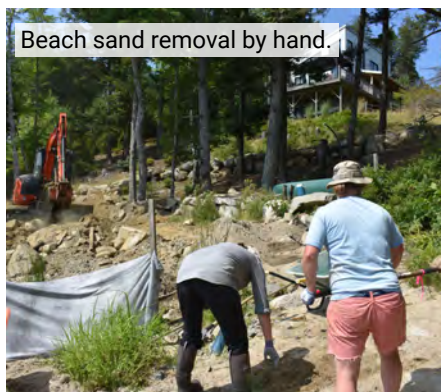
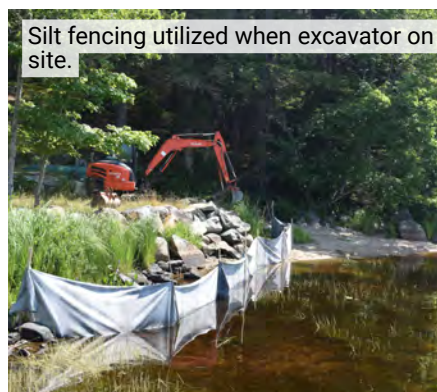
The five days of work resulted in over 76 m³ of low-quality fill being removed from the foreshore and backshore, re-exposing as much of the natural substrate as the excavator could access without damaging the existing overhanging or native vegetation in the riparian zone. In this natural substrate, 207 individual shrub and herbaceous plants were added, with nearly all surviving to the winter despite some grazing from local deer and extreme drought conditions. This newly revegetated riparian zone restored approximately 150 m² of habitat for at-risk reptiles, and recovered the conditions needed for Redroot and other ACPF to re-establish along the previously altered shoreline.

The homeowners monitored the success of plantings within the first few weeks of implementation, and noticed deer grazing on the Joe Pye Weed and some thorny plants. As a result, they took the initiative to add more deer fencing in an attempt to protect the plantings from further grazing, and allow them time to regrow before the weather cooled off.

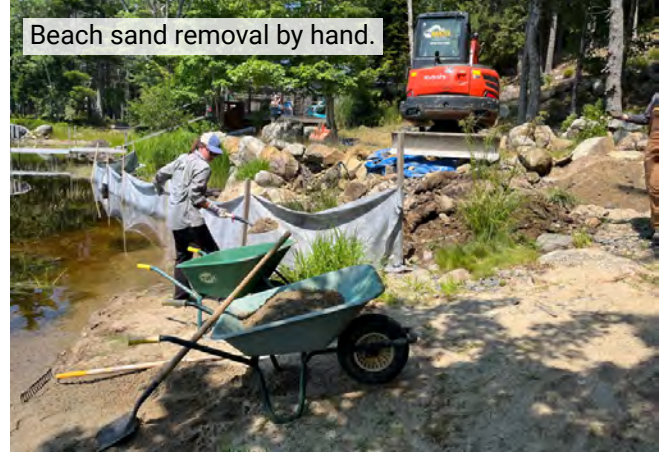
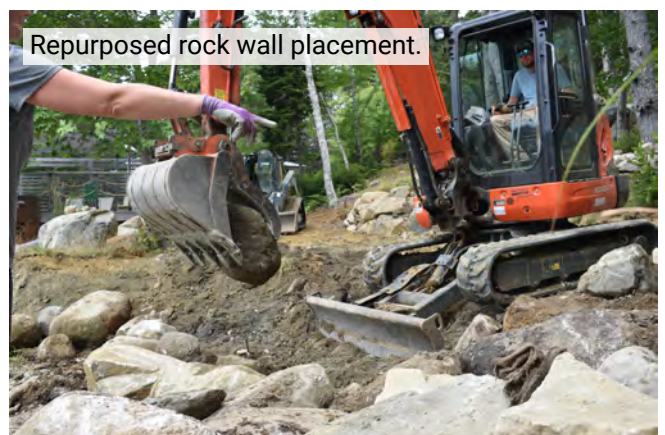
Day 1 – July 30: Removal of imported fill and beach sand began. Manzer Brothers Excavation & Landworks Inc. used an excavator to remove fill above the OHWM while CBWES and TCA staff and the homeowners removed beach sand below the OHWM using hand tools.

Day 2 – July 31: Continuation of fill removal to restore natural shoreline elevation. Manzer Brothers also used the excavator to redistribute large rocks from the rock wall along the shoreline, recreating a more natural, dispersed boulder shoreline under the guidance of CBWES staff.

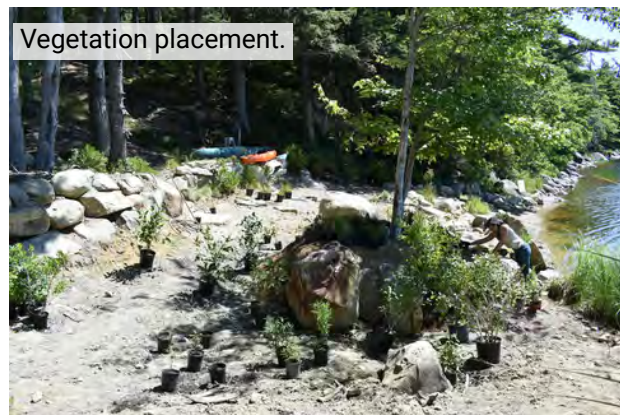
Vegetation placement.

Day 5 – August 7: CBWES, TCA, and the homeowners continued planting activities. About 322 native plants were added to the site including: grasses, rushes, ACPF shrubs, native shrubs, and flowering perennials. Existing woody materials, such as brush and logs, were placed to facilitate plant establishment, provide habitat features, and direct water run-off. Brush and logs were sourced from materials already onsite. Plants that were likely to be impacted by deer were protected with metal caging. The weather during this period was hot and dry. It was important to keep the vegetation sufficiently watered during and after the implementation. The homeowners offered to continue watering the newly planted vegetation for several days after the project was complete to assist with plant survival.

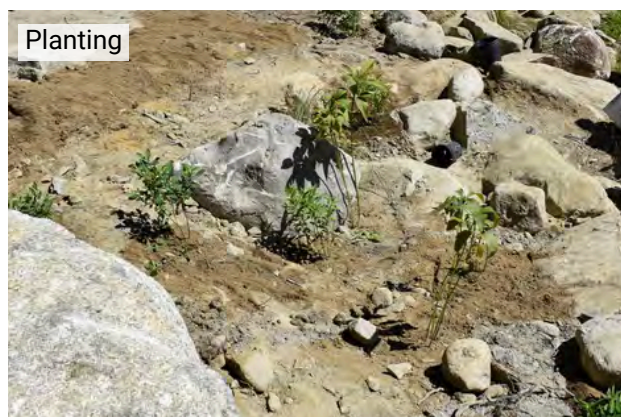
Planting

Day 4 – August 6: CBWES, TCA, and the homeowners began replanting native vegetation in the riparian zone by preparing the substrate, confirming plant arrangements, watering, and planting some of the materials. Due to very hard, rocky, and compacted substrate, many of the holes for plant placement needed to be pickaxed. Shovels and other hand tools were also used.

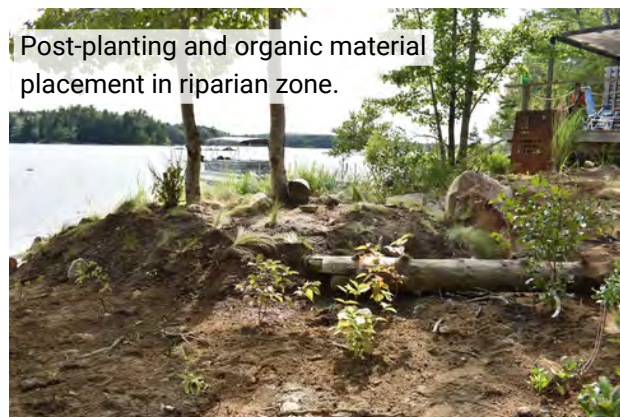
Post-planting and organic material placement in riparian zone.

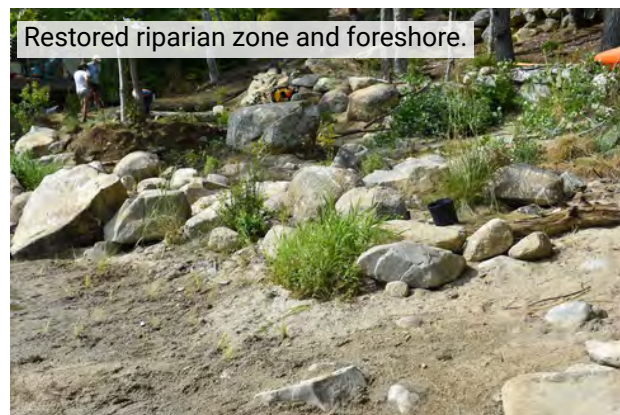
Restored riparian zone and foreshore.
