# Kingsburg Beach, Nova Scotia

## Green Shores for Homes Case Study

Umlah, K. & Giacomodonato, H. (2026). Kingsburg Beach: Green Shores for Homes Case Study.

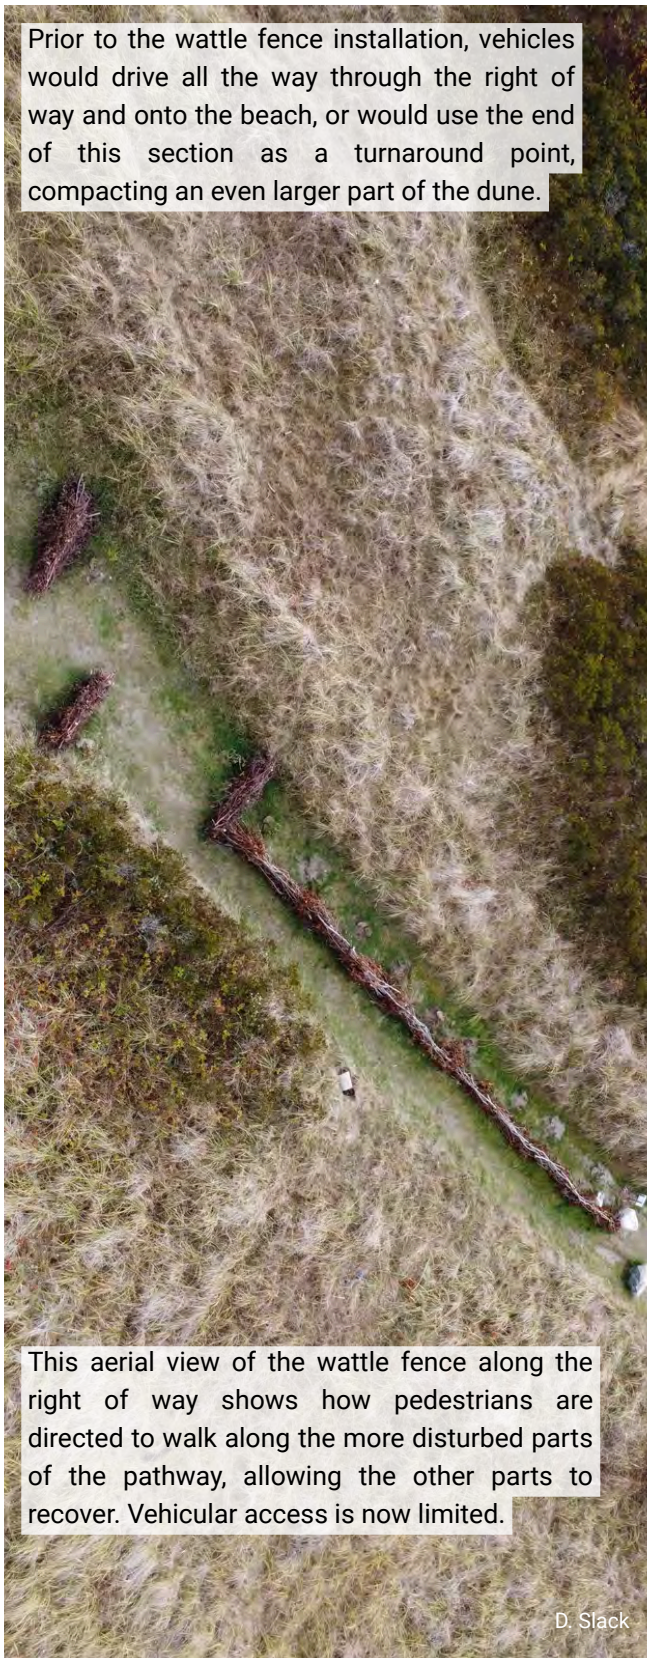
Prior to the wattle fence installation, vehicles would drive all the way through the right of way and onto the beach, or would use the end of this section as a turnaround point, compacting an even larger part of the dune.

This aerial view of the wattle fence along the right of way shows how pedestrians are directed to walk along the more disturbed parts of the pathway, allowing the other parts to recover. Vehicular access is now limited.

- At one end of the right of way, wattle fencing was installed, dissecting the path in half and leaving a ~1.5 m-wide accessible pathway, encouraging human access but excluding motorized vehicles (Property B).

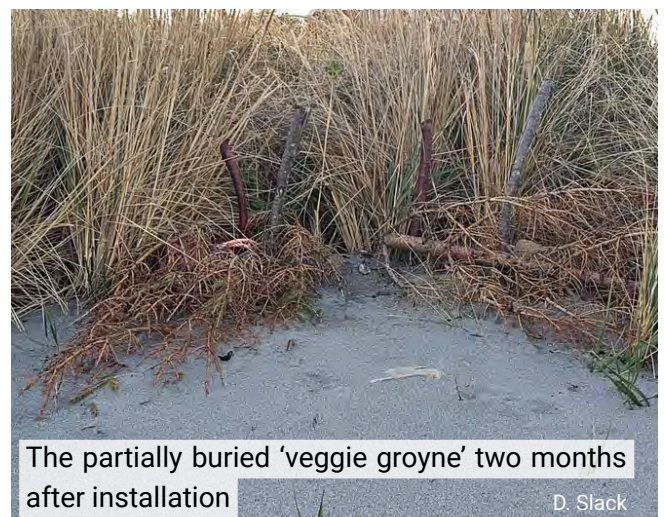
The partially buried 'veggie groyne' two months after installation

- A 'veggie groyne' using small fir trees was installed to facilitate the recapture of sand into the area where the most erosion was observed (Property B).

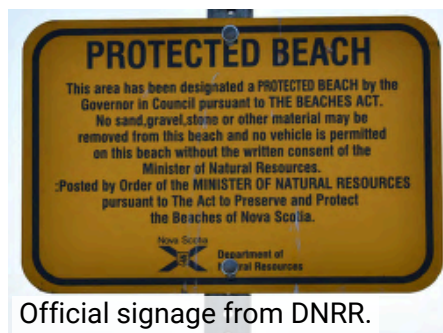
Upon request, the Nova Scotia Department of Natural Resources and Renewables placed a sign at the end of the right of way informing users that the beach is protected, and that it is illegal to drive onto.

Official signage from DNRR.

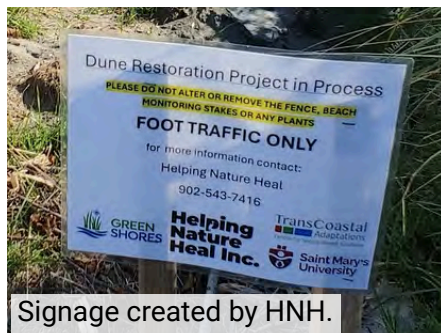
Signage created by HNH.

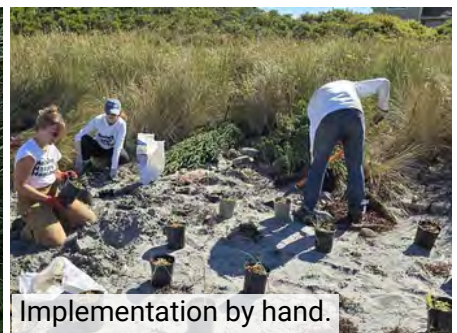
All work took place well above the OHWM so permits were not required for the work. HNH, following GSH guidance, created an environmental management plan to minimize site disturbance and address sediment and pollutant control on the site. For example, hand tools and wheelbarrows were used instead of any heavy machinery, which minimized soil disturbance. This plan also described the SAR in the area and how to avoid negatively impacting these species or their habitat (i.e. working outside of the nesting period). SAR needs were also discussed with SAR biologists during the planning and design phases of the project.

Implementation by hand.

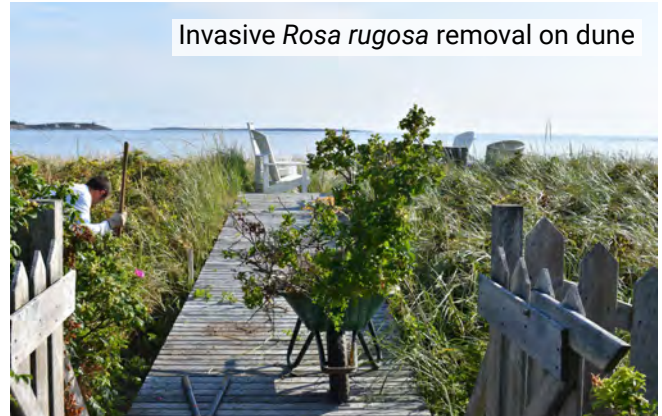
Invasive *Rosa rugosa* removal on dune

- Invasive Rugosa Rose (*Rosa rugosa*) creeping into the dune system was removed, and the dune was replanted with native Virginia Rose (*Rosa virginiana*) (Property A).

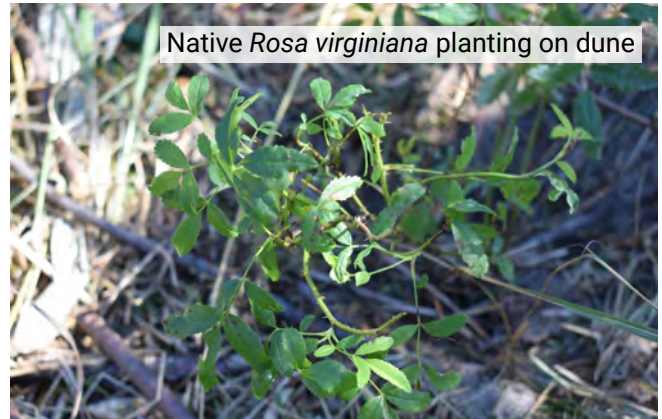
Native *Rosa virginiana* planting on dune

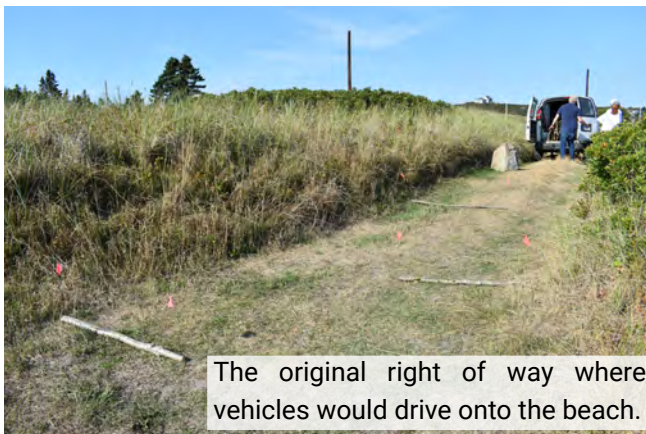
The original right of way where vehicles would drive onto the beach.

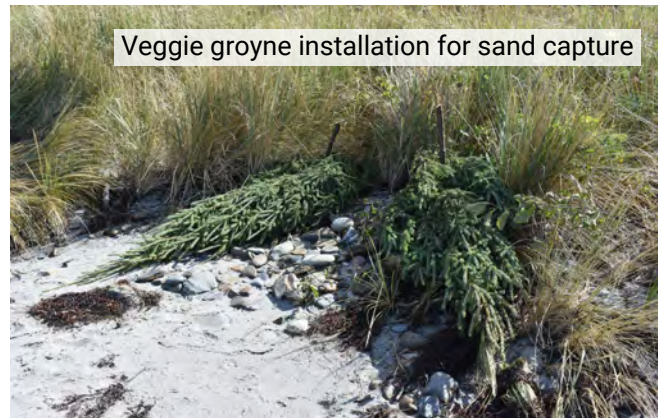
Veggie groyne installation for sand capture

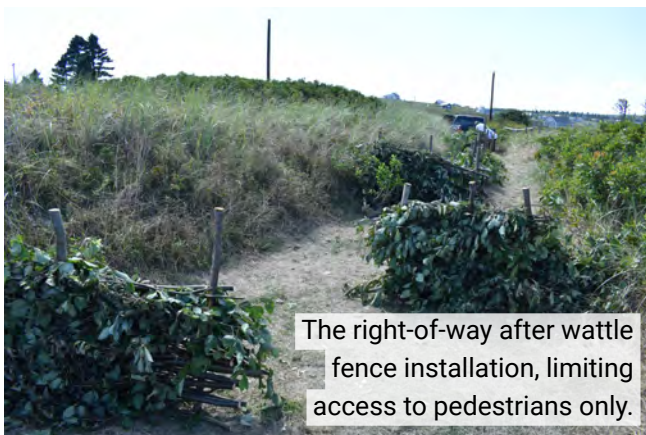
The right-of-way after wattle fence installation, limiting access to pedestrians only.

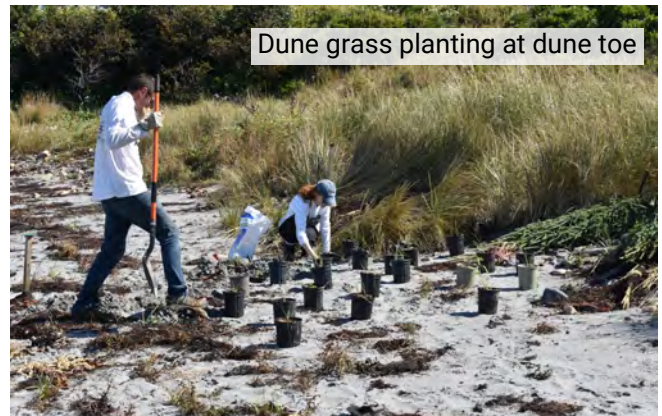
Dune grass planting at dune toe

- Along the whole shoreline, native dune grasses (*Ammophila spp.*) were planted on the seaward side of the dune to promote dune rebuilding following storm damage (Property A & B).

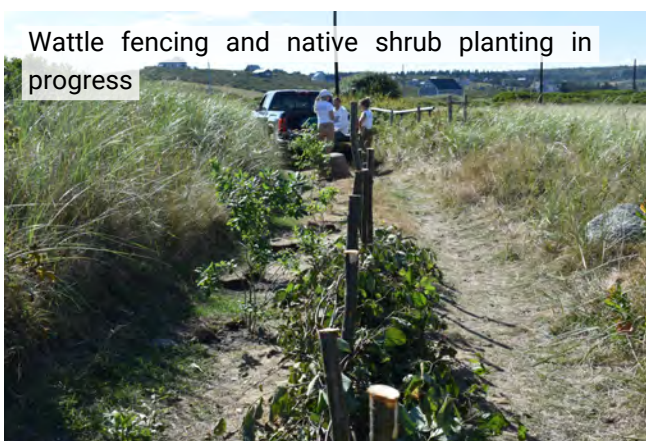
Wattle fencing and native shrub planting in progress

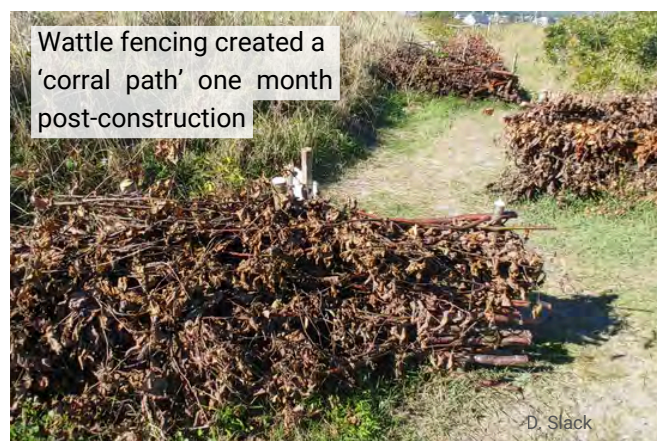
Wattle fencing created a 'corral path' one month post-construction

- At the other end of the right of way, wattle fences were organized in a corral formation to further limit motorized vehicle access (Property B).
- Native shrubs that matched existing species growing on the dune, like bayberry, were planted along the right of way.
