Resilient Coasts for Salmon:

Green Shores Feasibility Inventory for the Gorge Waterway and Portage Inlet, Victoria, BC

2 February 2022

Prepared by:
Sara Stallard, BSc., ASCT (#22338), Envr.Tech.
Fish-KW Environmental
Victoria, BC

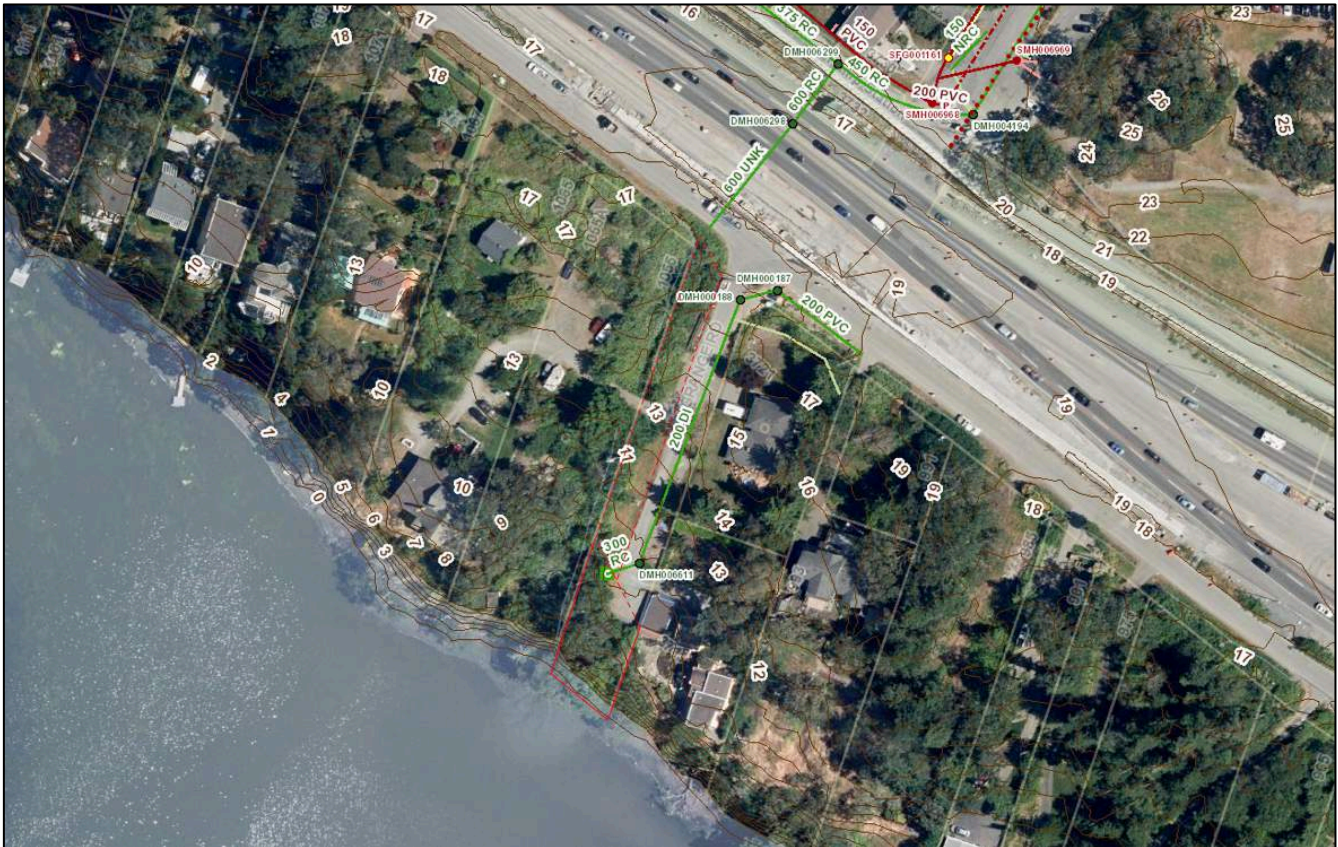
This small segment of shoreline on the north side Portage Inlet is fully vegetated with mature trees and shrub vegetation. Stormwater discharges (CRD#690C) at the west edge of the ROW. The ROW is used for adjacent residential parking. Invasive species removal, particularly the growth of English ivy coverage on riparian trees, is required to protect from tree loss. The ROW is used for yard & garden waste. This location was identified in the UVic Environmental Law report (2017) as a location of private use of publicly owned shoreline (Site 3 in report).

Figure S04 – Grange Road ROW in red.

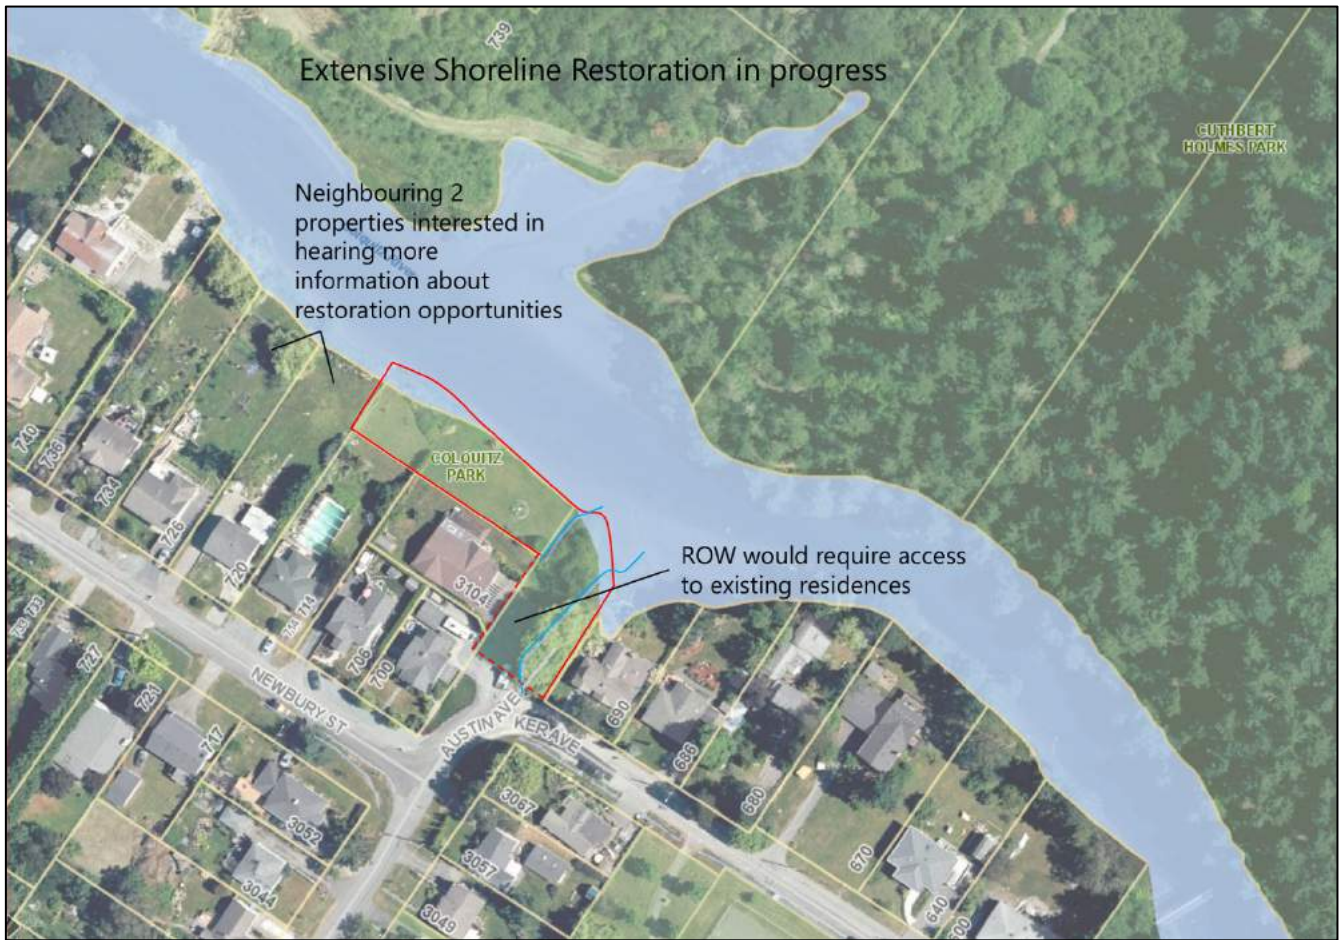
This ROW is fully vegetated at the shoreline, but is currently used for parking on the landward side adjacent to a small watercourse flowing with groundwater. Mowing of the vegetation in the ROW watercourse occurs by neighbouring property owners to prevent historic ongoing flooding that occurs when the vegetation is high. This shoreline park is an undeveloped portion of subdivided residential lots where residential activities are occurring, including mowing up to the water's edge, dumping of yard & garden waste and burn barrels. The inundated shoreline edge is composed of saltwater fringe marsh vegetation. Restoration of this site would be highly supported by Saanich Parks. Restoration could be as simple as invasive species removal and planting of riparian vegetation, or could involve the creation of dendritic channels for juvenile salmonids (as have been created by Sean Wong, MOTI biologist, on the opposite shoreline in 2019). A portion of the ROW could be used for a raingarden to demonstrate filtration of road runoff in stormwater, including the watercourse mentioned above and a small discharge to the west which appears to be stormwater.

Figure S07 – Colquitz Park @ Austin Ave ROW & shoreline adjacent to 3104 Austin Ave & 714 Newbury St.

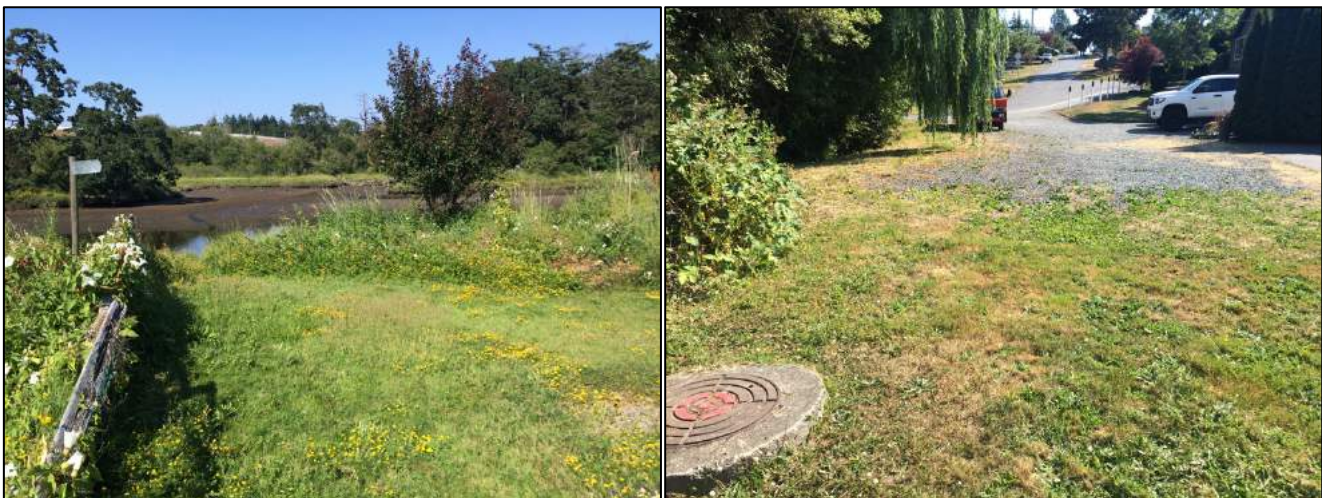
S07- Colquitz Park at Austin/Newbury, view north across former 714 Newbury Rd yard & garden waste and lawn, toward Colquitz tributary shoreline restoration works on opposite bank (left) & Austin ROW, small watercourse on left (right).

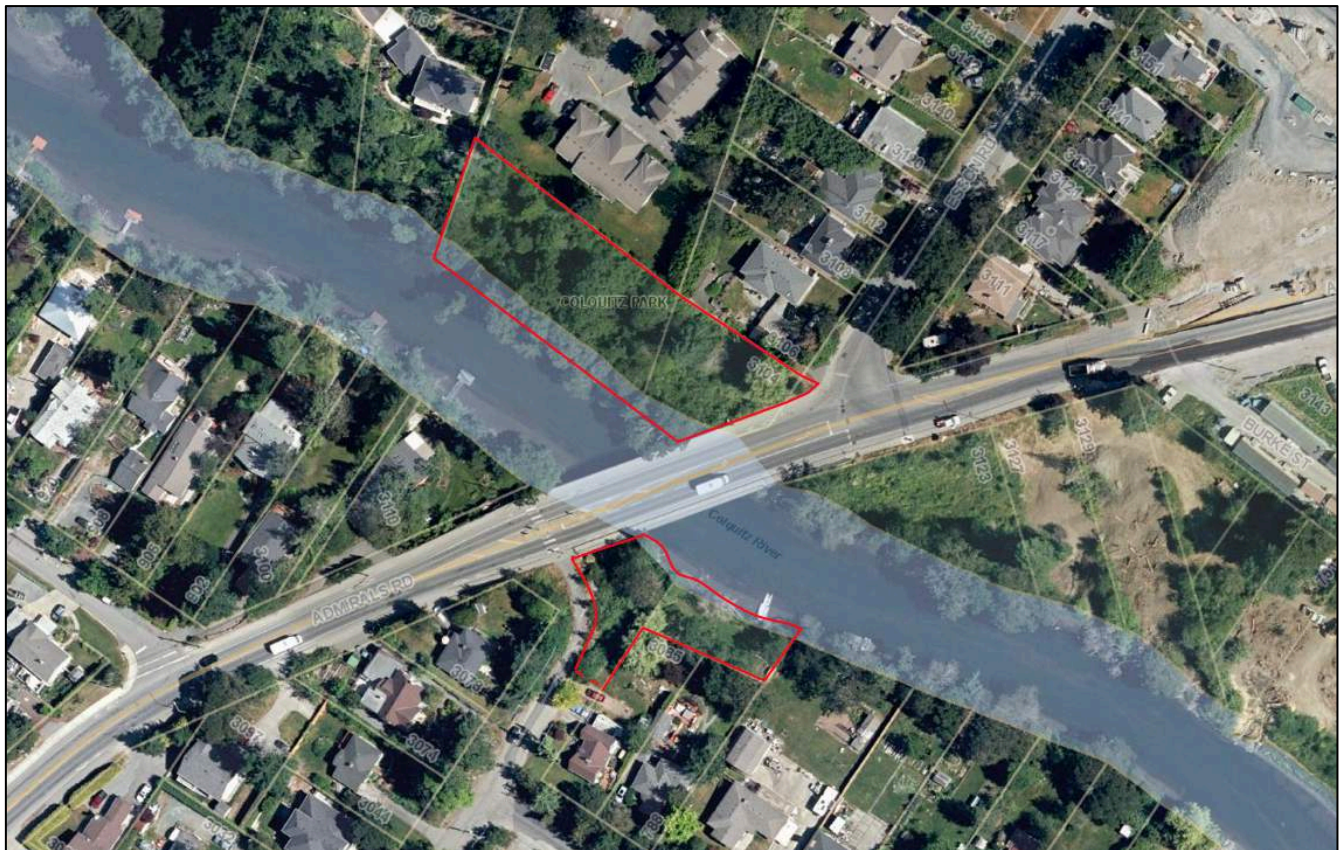
The ROW is fully vegetated at the shoreline and was fairly recently replanted with indigenous vegetation during reconstruction of the road and Admirals Rd bridge. The adjoining shoreline park is an undeveloped portion of subdivided residential lots where residential activities are occurring, including mowing, boat storage and private dock placement. The two docks rest on the mudflats at low tide. The inundated shoreline edge is composed of saltwater fringe marsh vegetation. This site has tree cover combined with lawn. The park portion was not traversed, but was photographed from the bridge. Saanich Parks is open to ideas for restoration of this site. Restoration could be as simple as invasive species removal and planting of riparian vegetation, but may not be as suitable for the creation of dendritic channels for juvenile salmonids (as have been created by Sean Wong, MOTI biologist, on the opposite shoreline in 2019). The ROW is currently configured as partial raingarden to capture some overland flows from the roadway, but a review of the design drawings could reveal some additional opportunities to capture a greater amount of runoff and support emergent vegetation. The site requires general weeding, some invasive species removal and supplemental replanting. The ROW is adjacent to a well-used pedestrian and cycling route and would be an excellent location for educational signage regarding rain gardens and filtration of road runoff in stormwater.

Figure S08/S05 – Colquitz Park @ Colquitz Ave ROW & shoreline formerly of 3085 Colquitz Ave & 788 Newbury St (south polygon) and Colquitz Park @ 3104 Esson Rd & shoreline formerly of 945 Portage Rd (north polygon).

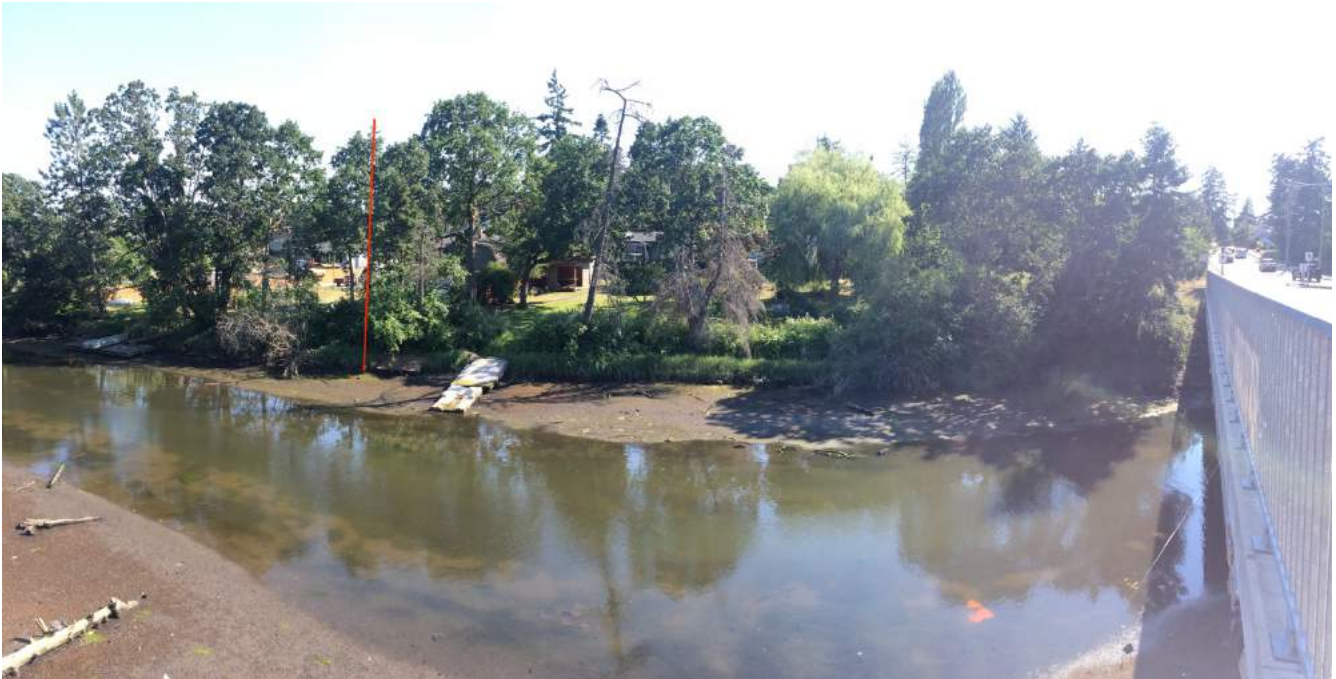
S08- Colquitz Park @ Colquitz Ave ROW (right) and shoreline formerly of 3085 Colquitz Ave & 788 Newbury St (approximate extent shown by red line), view south from Admirals Rd bridge. Saltwater fringe marsh vegetation present. Two docks rest on mudflats at low tide.

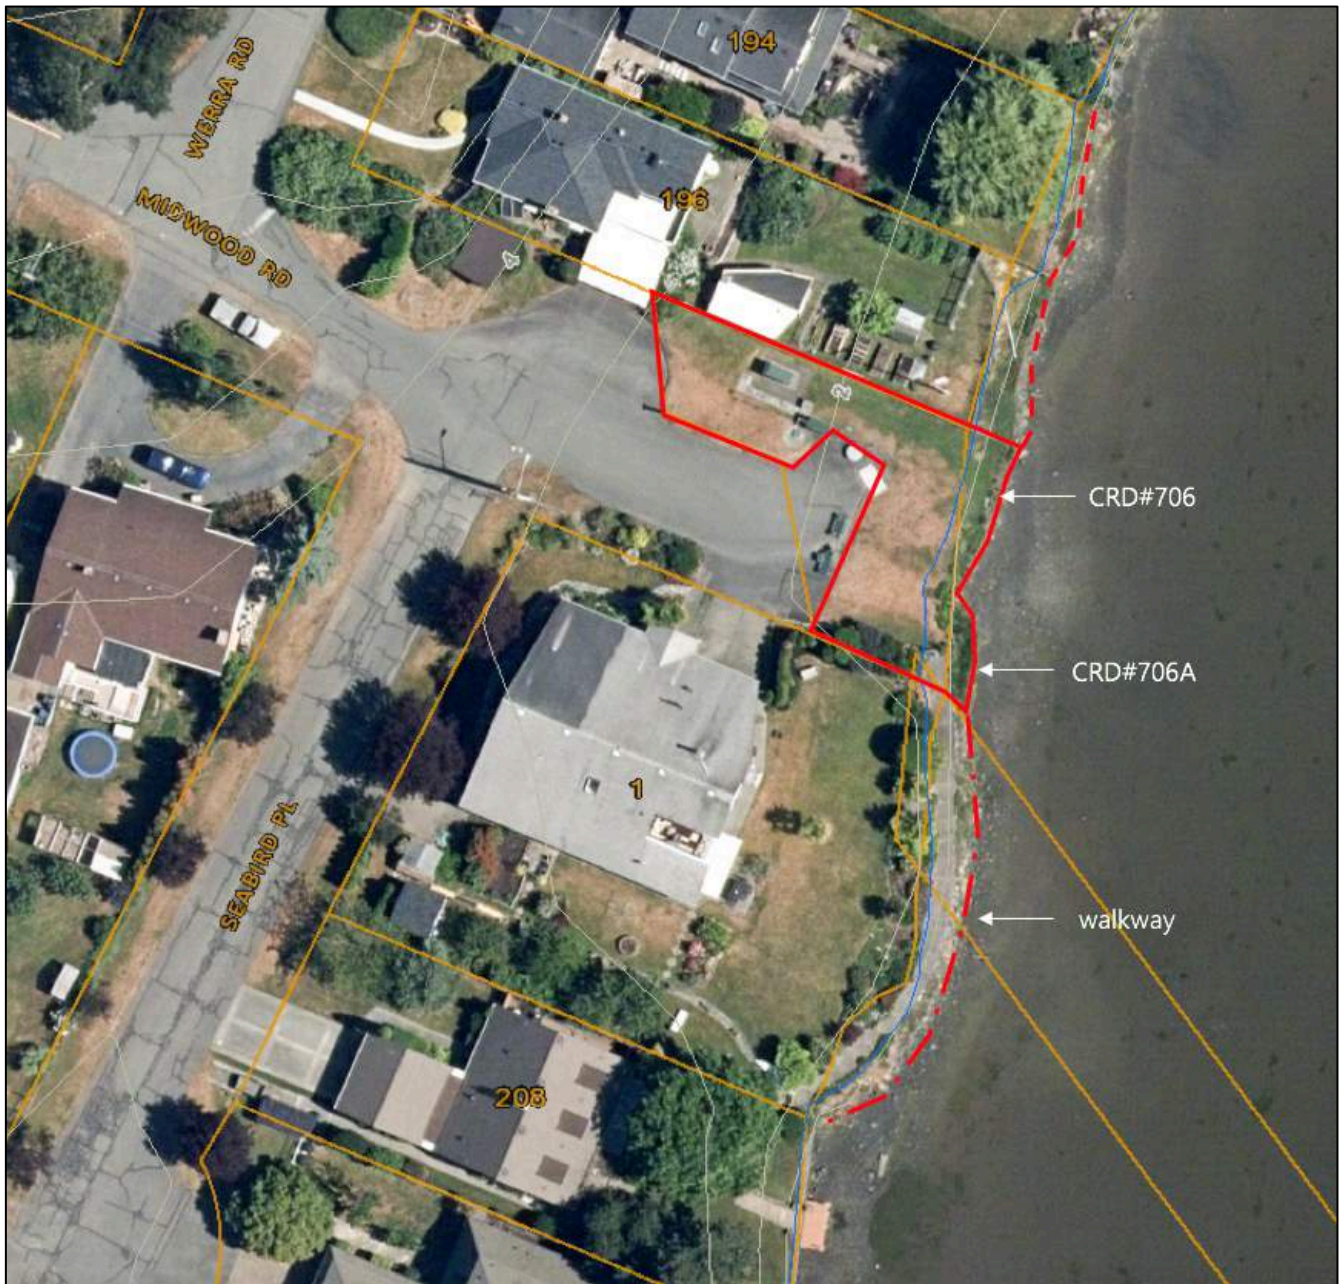
VR10 – Potential restoration area in ROW in red (solid line). The status of the shorelines on adjacent properties (north & south) are unknown, but not noted as park in the CRD Atlas.

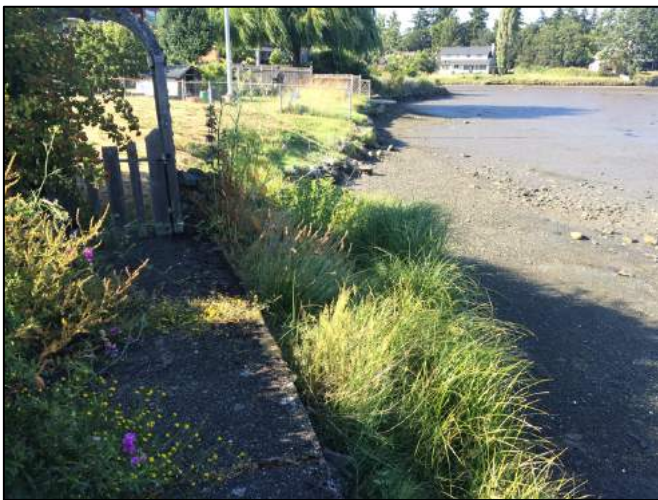
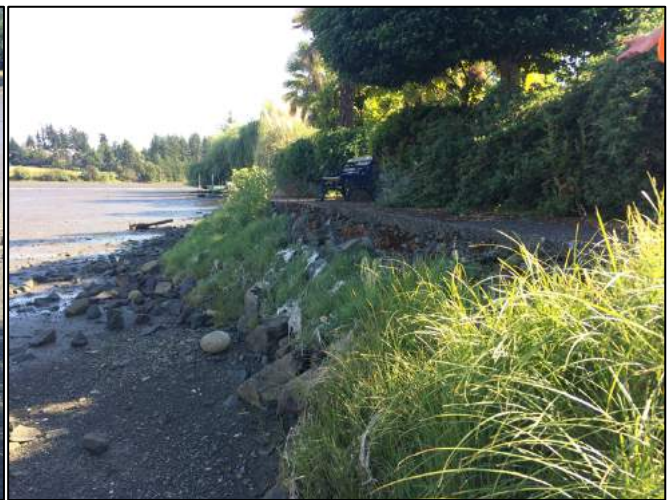
VR10 – Midwood walkway to south, property line to be determined.

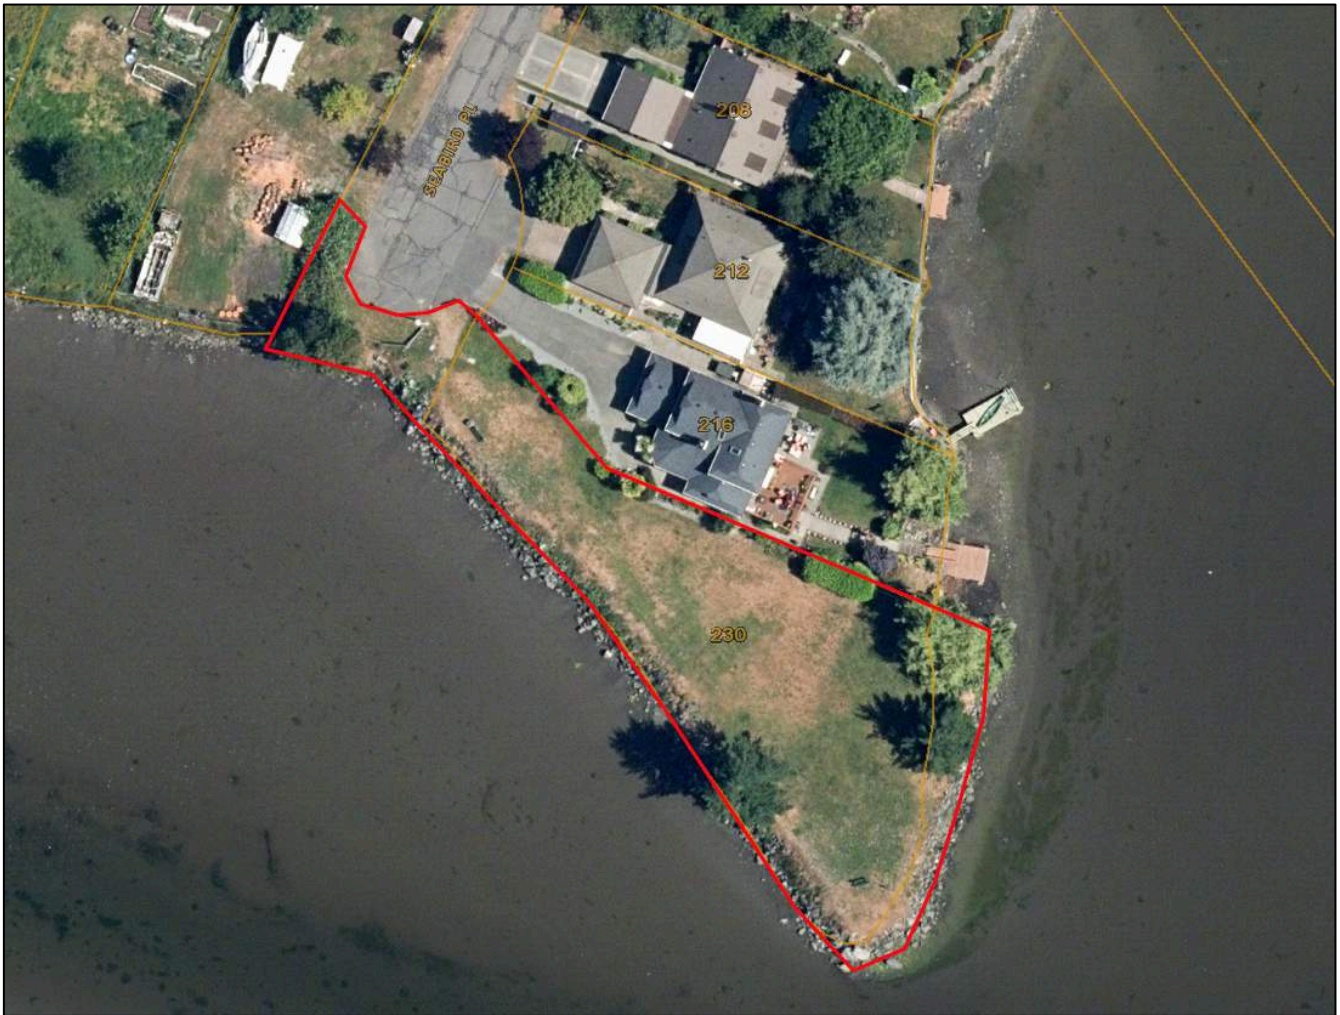
VR11 – Potential restoration area in red. Stormwater discharge CRD#707 is in roadway alignment.

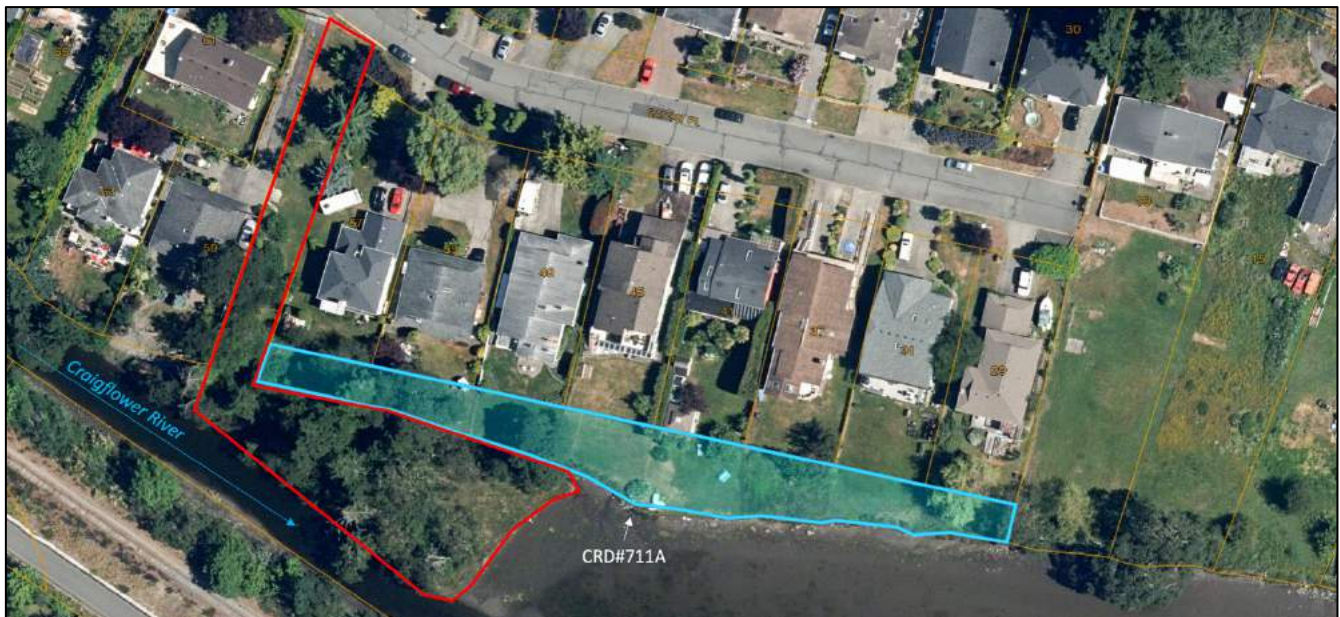
Challenges to restoration: unknown	Possible negative feedback from adjacent homeowners currently using the area for yards, but most direct shoreline lots were already fenced at the boundary.

VR12 – Municipal ROW (red) and shoreline “undeveloped park” (blue).

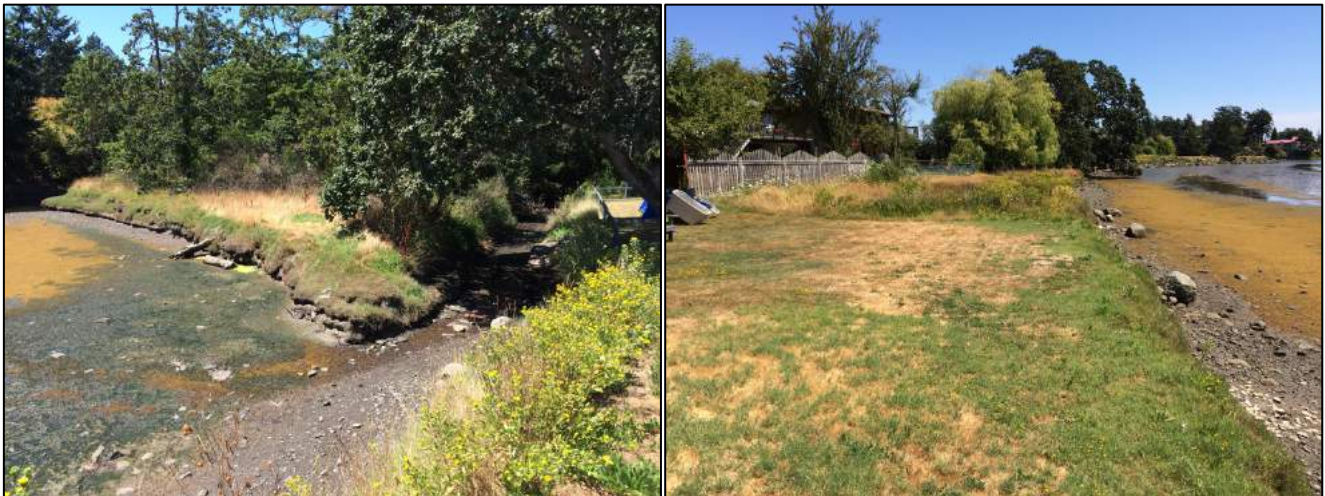
VR12 – Caton Place ROW promontory (left) & shoreline park mix of lawn, native meadow and shoreline trees (right).

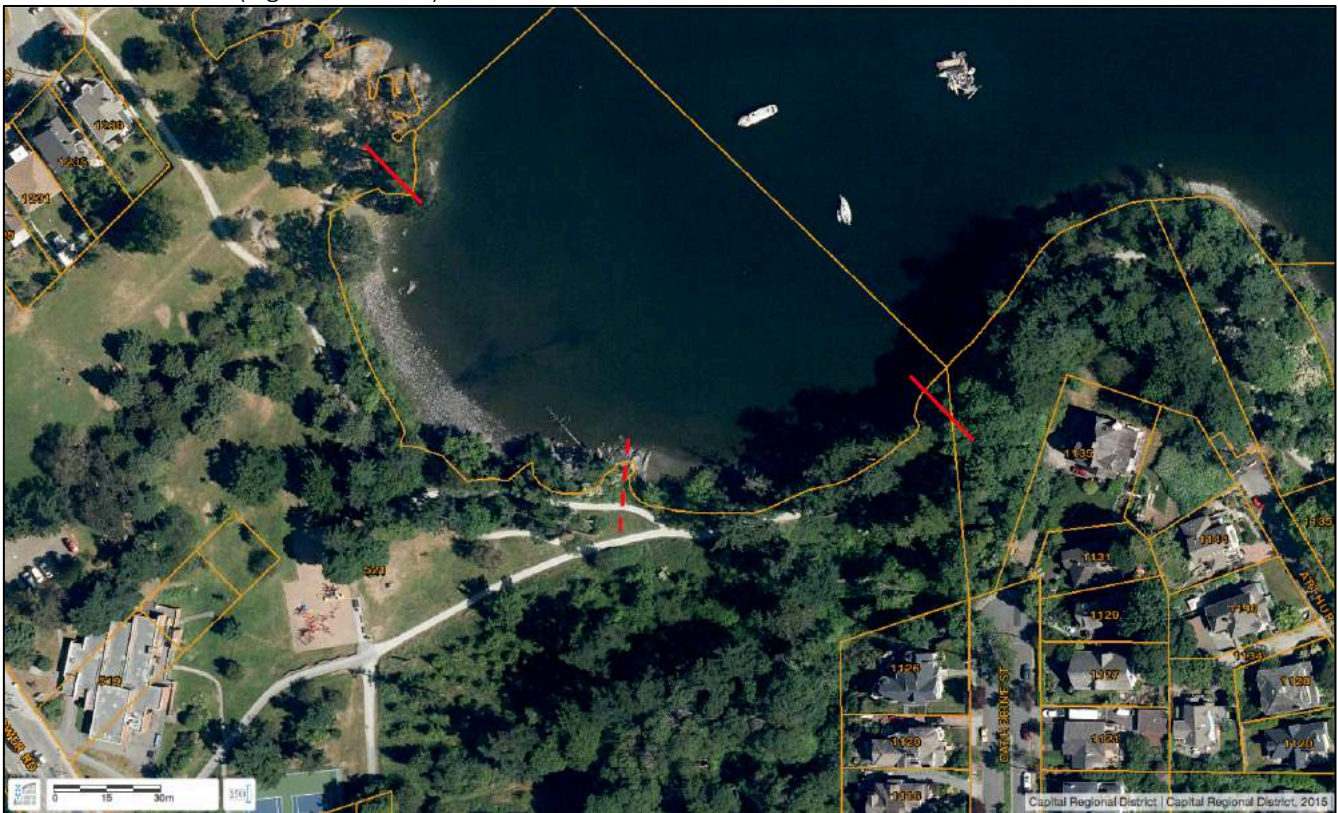
Figure V01 – Potential project shoreline areas marked in red: western cove is main focus.

This shoreline is within a large municipal park, with a shoreline path and recreational facilities (playground, swim dock, Vic West Community Centre). The shoreline has been modified with rip rap, some of which extends into the mudflats of the Selkirk waterway. CRD Discharge #758A is a municipal catchment which extends via a long concrete pipe into the mudflats and has had variable water quality results (bacterial and metals) in the past. CRD Discharge #758 is a smaller surface drain catchment with minimal flow which discharges directly onto the beach and no WQ issues. Some biological slope stabilization was conducted on this shore with a demonstration class under Dave Polster, RPBio (possibly in 2006). The Gorge Swim Fest report (2019) recommended this site as potential beach creation for both swimming and forage fish, along with increased access for personal watercraft recreation. This combined goal could be both an advantage and a challenge. Works could include increased riparian and emergent vegetation, removal of invasive species, installation of green stormwater infrastructure on municipal stormdrain, slope reduction, controlled access for pedestrians, removing riprap on the mudflats, beach nourishment on riprap (west) section of cove which may provide forage fish habitat and cap potential contaminated sediments.

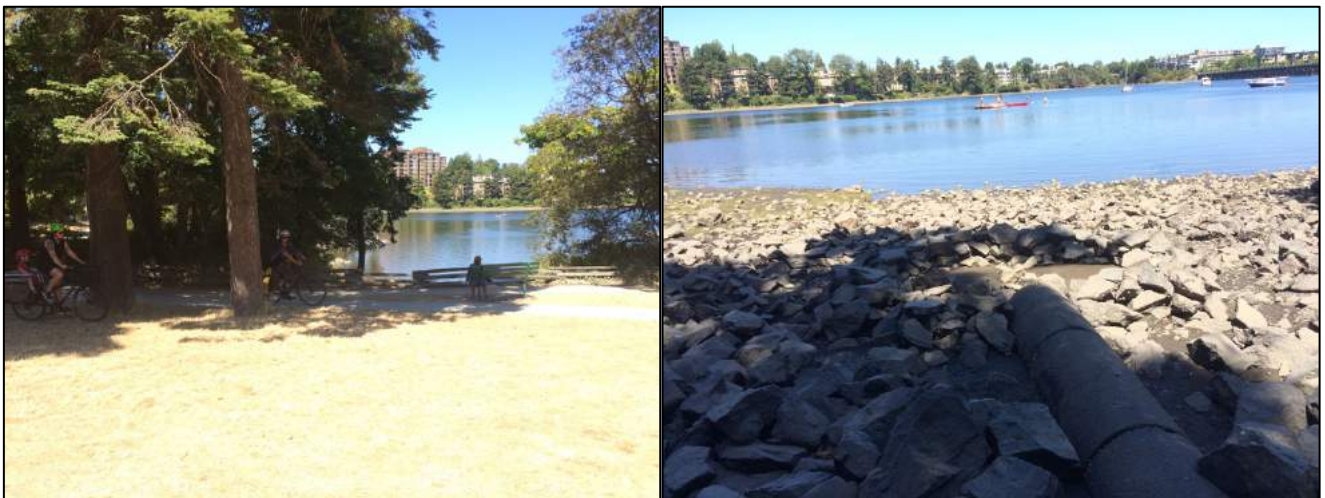
V01 – Lots of room for demonstration raingarden for stormwater filtration (CRD#758A).

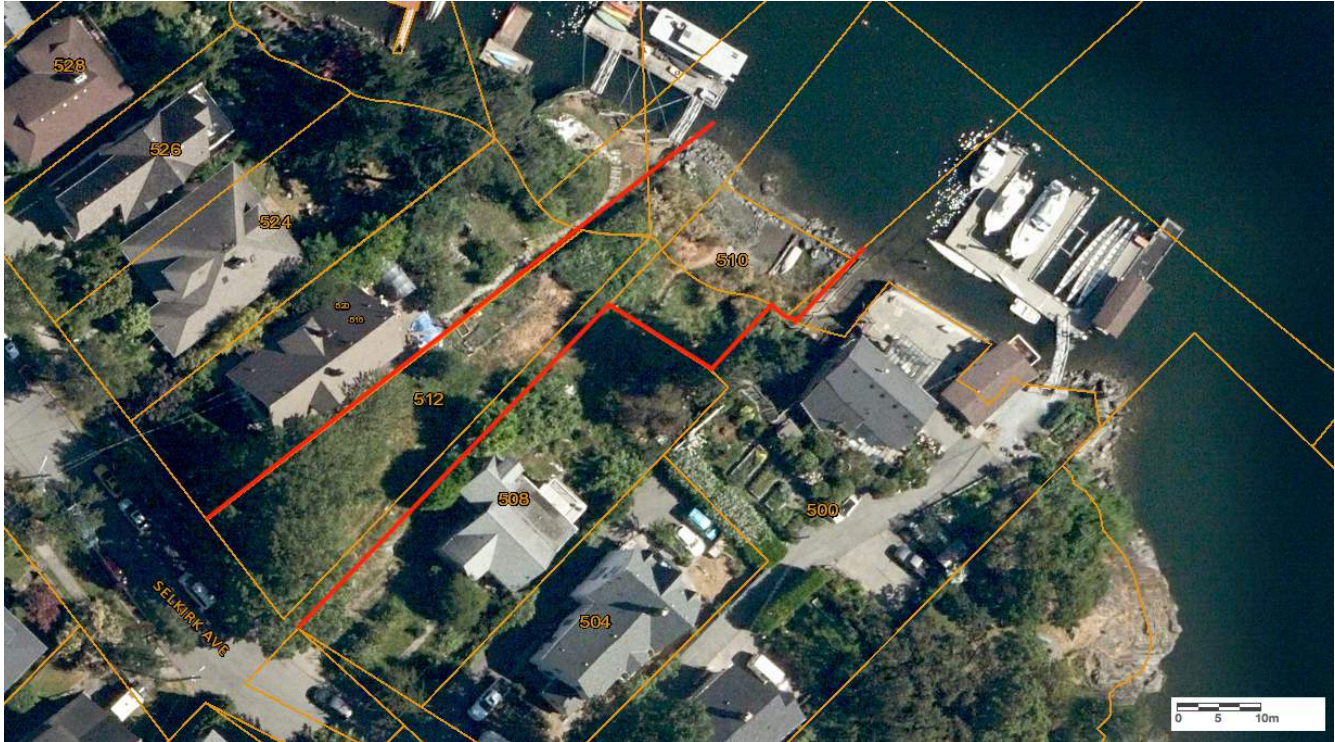
Figure V02 – Potential project shoreline areas marked in red.

In partnership between The Land Conservancy, the CRD and City of Victoria, this CRD ROW and municipal park (created through subdivision of 508 Selkirk Ave) was restored in 2004-2006 using a design created by students in the UVic Restoration of Natural Systems (RNS) program. The project was enabled through the \$250,000 replacement of the CRD sewer crossing the Gorge at this location, with an additional \$50,000 used for the removal of an existing seawall and fill, addition of beach sediments and restoration of natural vegetation along the shore. The continued maintenance of the site has been sporadic and a recent site visit indicates that an ongoing maintenance plan is required to ensure the integrity of the restoration continues. The spread of invasive species in the riparian area (mainly Himalayan blackberry) and the CRD ROW (many) threatens the native species that were installed. A rowboat has been stored on the beach vegetation in the intertidal area for many years should be moved to a location outside of the restoration area. Yearly maintenance of the site could be used as a learning tool for the importance of developing maintenance plans and could include restoration partners, past RNS students involved in the original project concept, and current students of the RNS program. Getting together and viewing the project on a yearly basis could be part education and part reunion for those involved or interested in the project.

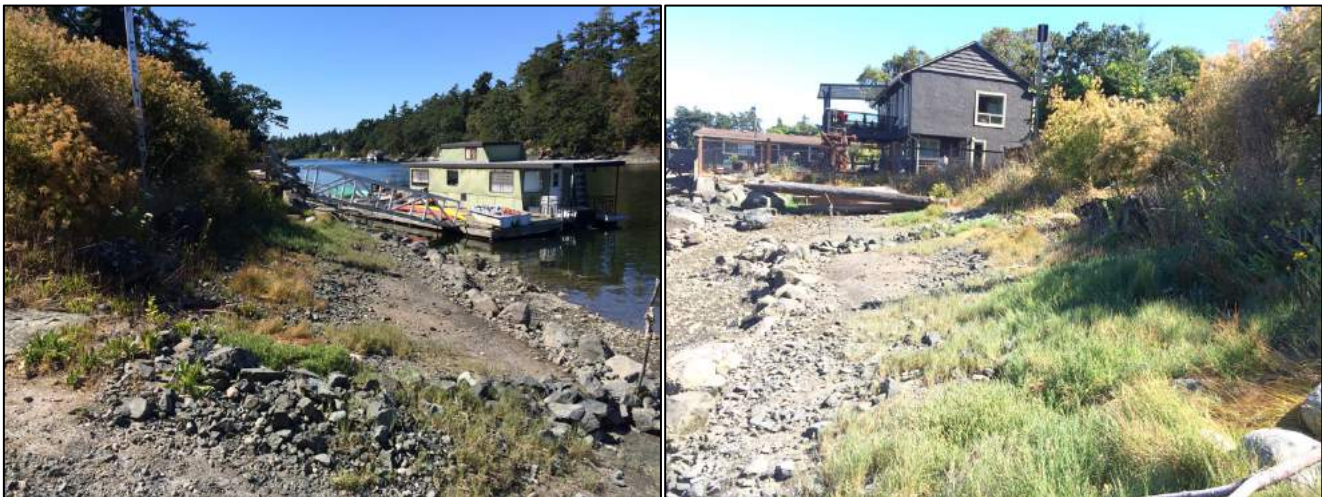
V02 – Previously restored shoreline project involved bulkhead removal, beach creation and shoreline planting.

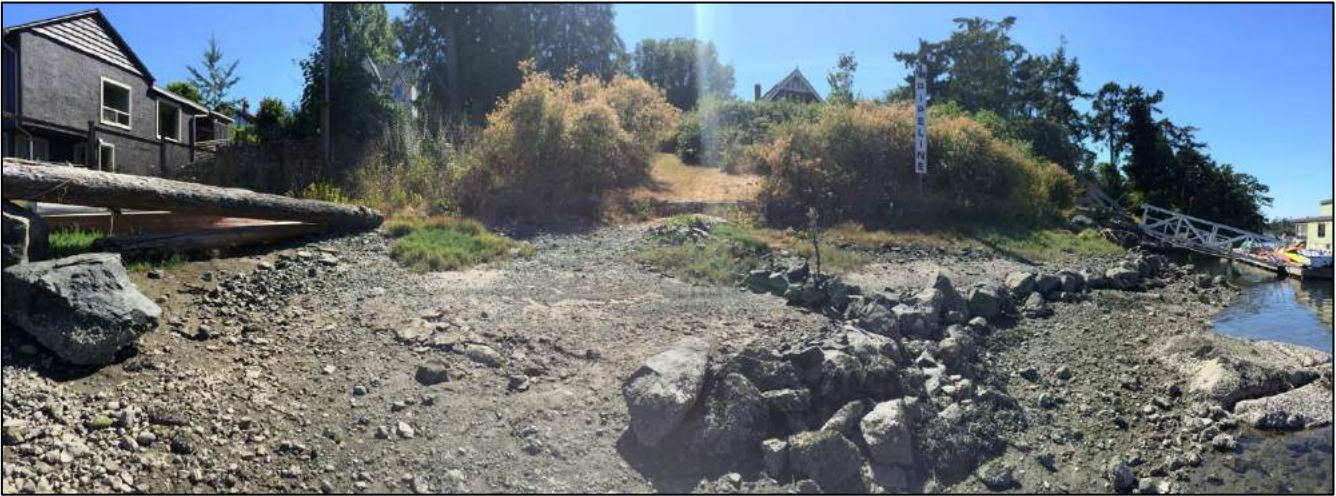
V02 – Previously restored shoreline project involved bulkhead removal, beach creation and shoreline planting.

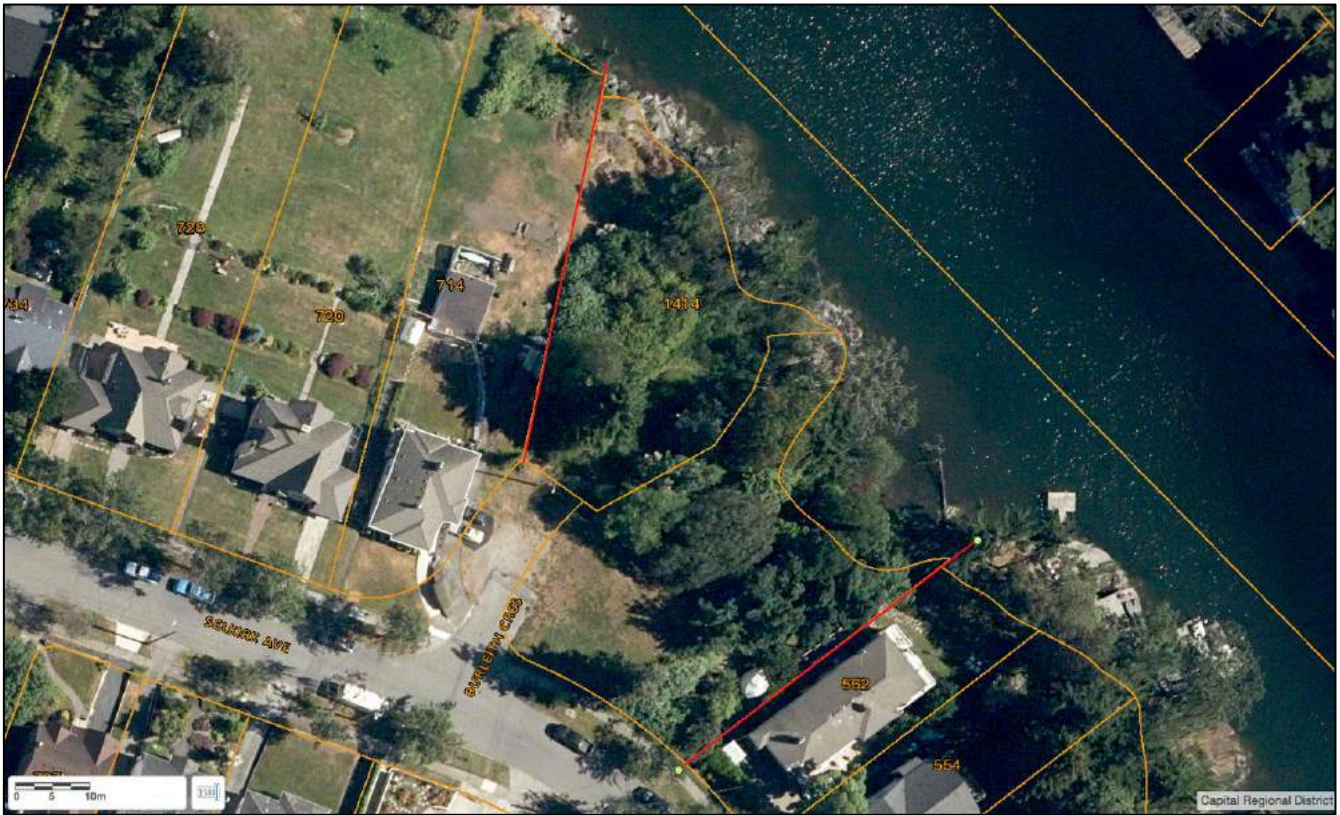
This road end and park include a rocky outcrop shoreline and densely treed pocket cove. A municipal stormdrain (CRD Discharge #757) extends into the cove from a high bank that is composed of fill and construction waste, which has been slumping for a number of decades and dense ivy has caused the collapse of a number of trees in the cove. These factors together have made a more detailed exploration of the cove difficult and the stormdrain can no longer be accessed for sampling. A tree fort can be seen along the shoreline. There may be residential use at the far west of the ROW and there is minor loss of rocky outcrop vegetation due to public access. The site was recommended for restoration by both current and past Victoria staff and it is a site recommended for improved access and restoration by the Gorge Swim Fest report. Whether water access is compatible with habitat enhancement at this location has not been explored. Existing flat pads, potentially for historic picnic tables, are located in the higher reaches of the park (>15 m from shore) on the western edge, but are overgrown with shrubs. Restoration should include the removal of invasive species to protect mature shoreline trees, at a minimum. Additional restoration could include green stormwater infrastructure, some planting along rock outcrops and park currently mowed for private use on west edge, stabilization of failing slopes, and possible community amenities to direct traffic off cliffs and/or add controlled water access.

Figure V03 – Potential project shoreline areas marked in red.

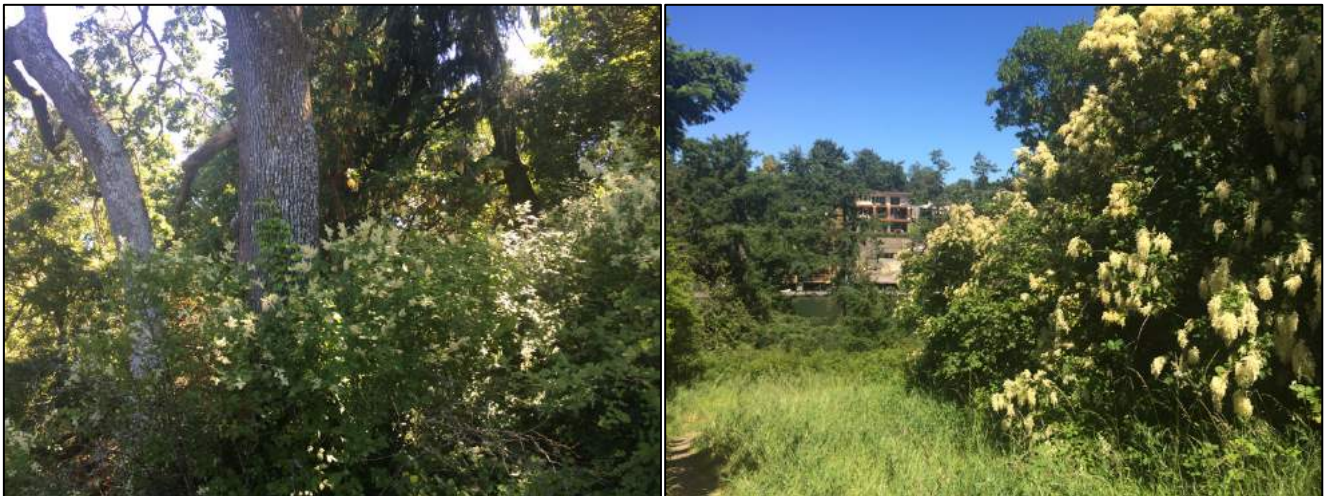
V03 – Mixture of Garry oak species and infrequently mowed path to the shoreline.

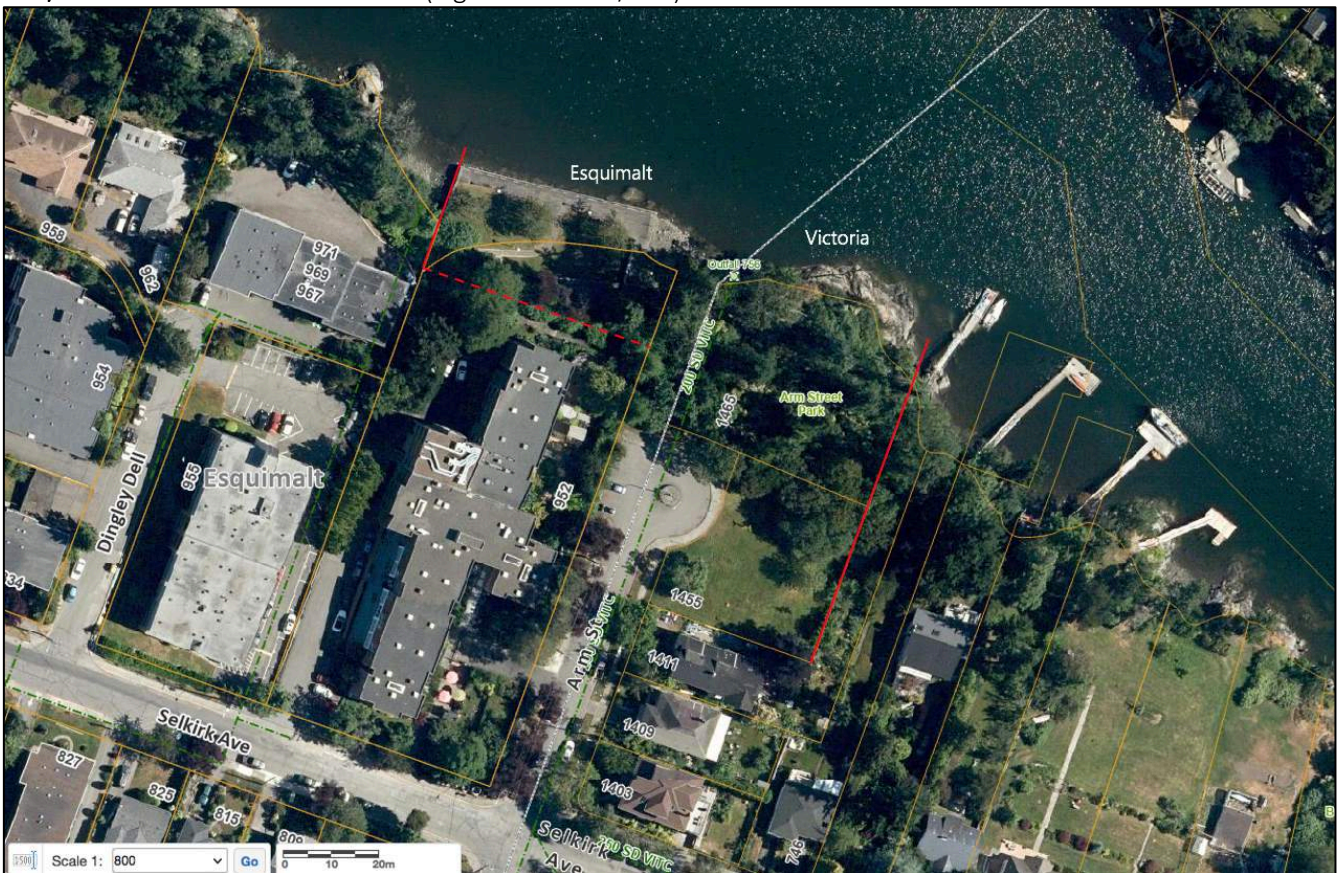
Figure V04/E01 – Potential project shoreline areas marked in red.

This road end and park includes a rocky outcrop shoreline with mature tree and shrub vegetation (Victoria side) and a seawall parklet and pocket cove (Esquimalt side). Municipal stormdrains discharge onto the shoreline at the far west pocket cove (CRD Discharge #754) and at the Arm St. ROW (#756), with an additional non-municipal pipe (#755) located in the seawall. The mature trees have extensive coverage of English ivy along the rocky

shoreline and there is some damage to vegetation adjacent to the east end of the seawall where informal access to the beach has been made. A pathway and benches front the seawall and are well-used by areas residents and the care home adjacent to the park. The site was recommended for improved access and restoration in the Gorge Swim Fest report. Potential improvements include invasive species removal, especially on shoreline trees, and planting of overhanging vegetation on the far west edge of the seawall which would provide more habitat in the pocket cove (where there is no path and would not block the viewscape). Planting could also occur at the informal beach access, perhaps combined with formalised access at the east end of the seawall to prevent repeated trampling. *The Esquimalt portion of the shoreline would not meet the minimum GSSD requirements because of the current seawall.*

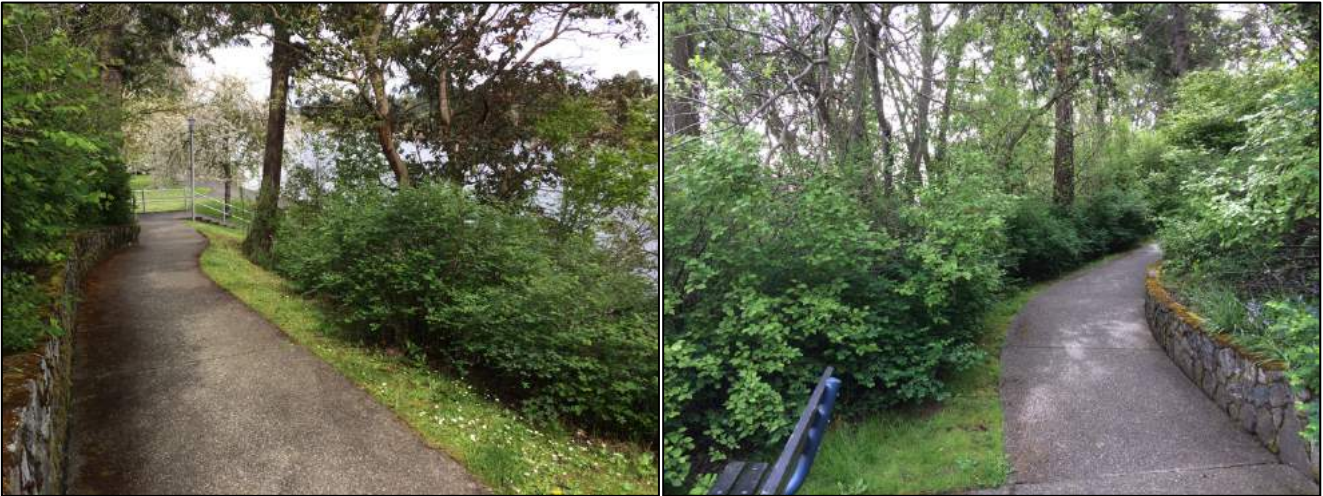
V04/E01 – Arm Park is on the Victoria/Esquimalt border, a mixture of mostly natural shoreline and built up park

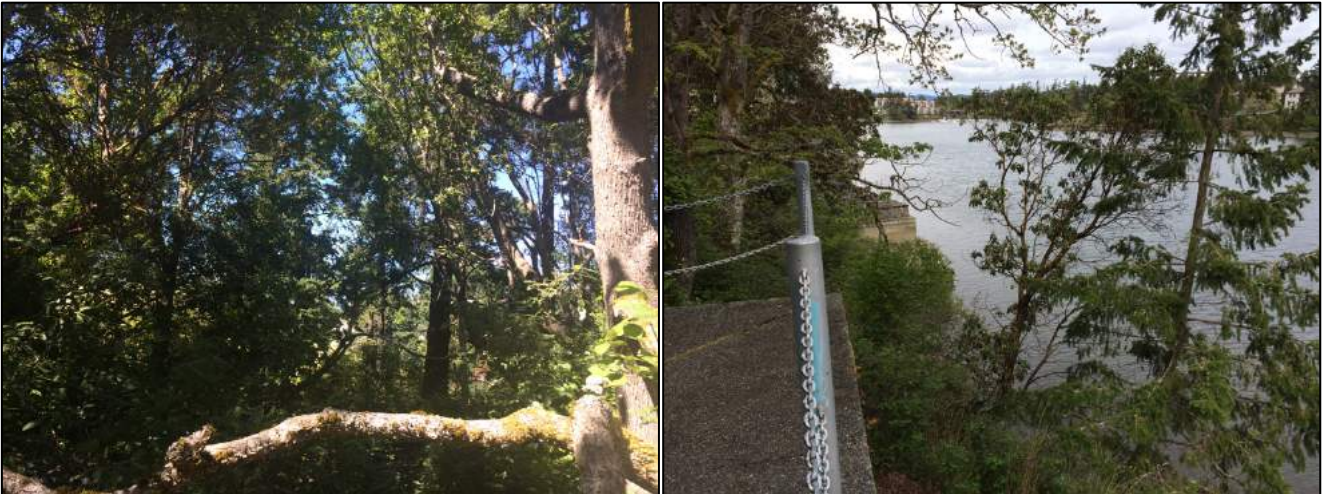
V04/E01 – Native trees & shrubs on a (mostly) natural shoreline (Victoria side).
