Resilient Coasts for Salmon:

Green Shores Feasibility Inventory for the Gorge Waterway and Portage Inlet, Victoria, BC

2 February 2022

Prepared by:
Sara Stallard, BSc., ASCT (#22338), Envr.Tech.
Fish-KW Environmental
Victoria, BC

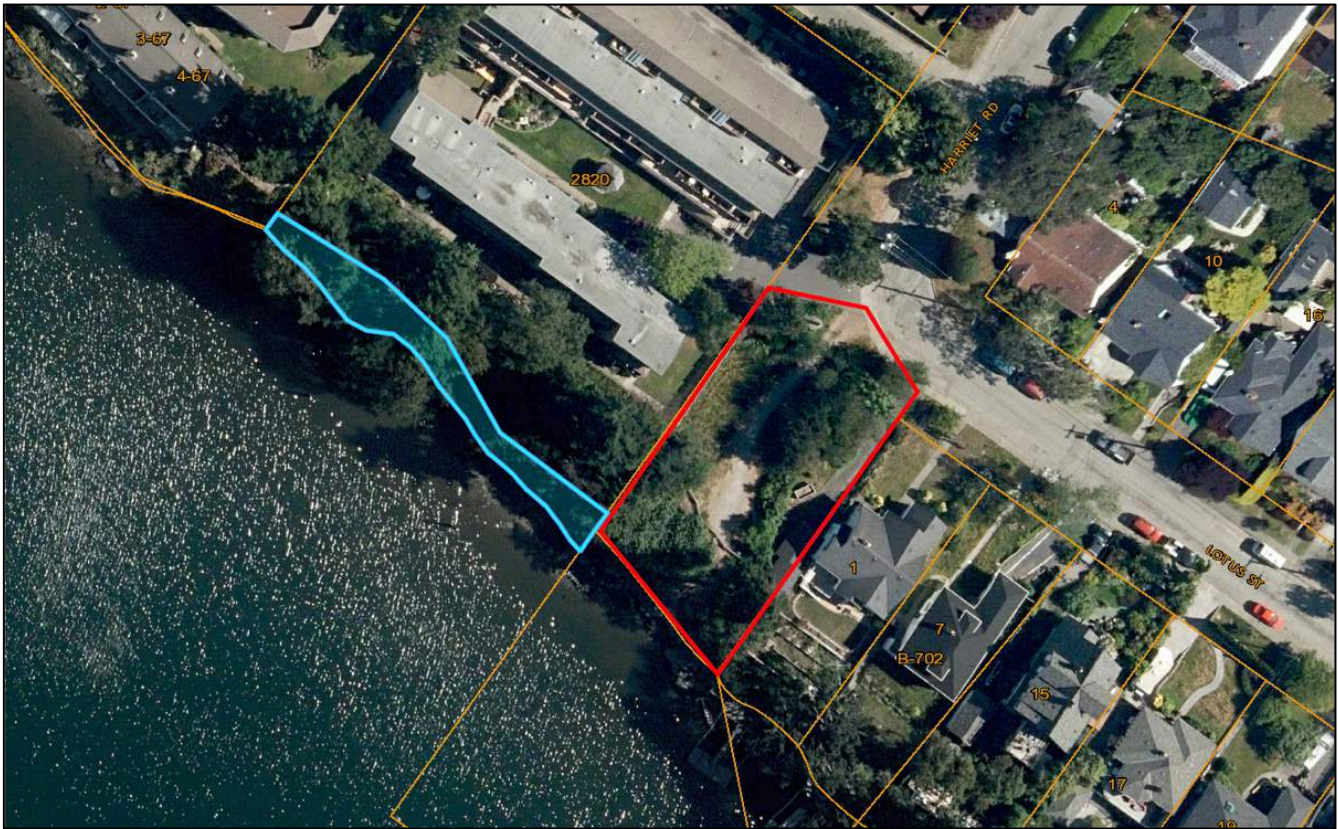
V05 – This municipal & CRD ROW (sewer crossing) was reconstructed after major slope slumping in the last 20 years. Municipal discharge CRD# 650 carries flow from Harriet Rd and discharges at the base of the steep slope. In the park above the slope there is extensive room for the creation of a raingarden to demonstrate filtration of road runoff in stormwater. The slope itself is stabilized with a heavy duty plastic mesh and is covered in Himalayan blackberry. The trees at the top of the slope are the invasive laburnum. The mesh covering allows for vegetation planting, but the original native plants (if any) have been covered by blackberries. Municipal discharge CRD# 650A emanates to the west of the ROW.

S24 – The shoreline to the west of the ROW includes a narrow strip of municipal land as an undeveloped park. It is inaccessible for the most part due to the steep high slope and lack of access. This made a closer site visit by land difficult. It is mostly overhanging vegetation, but heavily covered in invasive species.

Figure V05/S24 – Potential project shoreline areas marked in blue (S24) and red (V05).

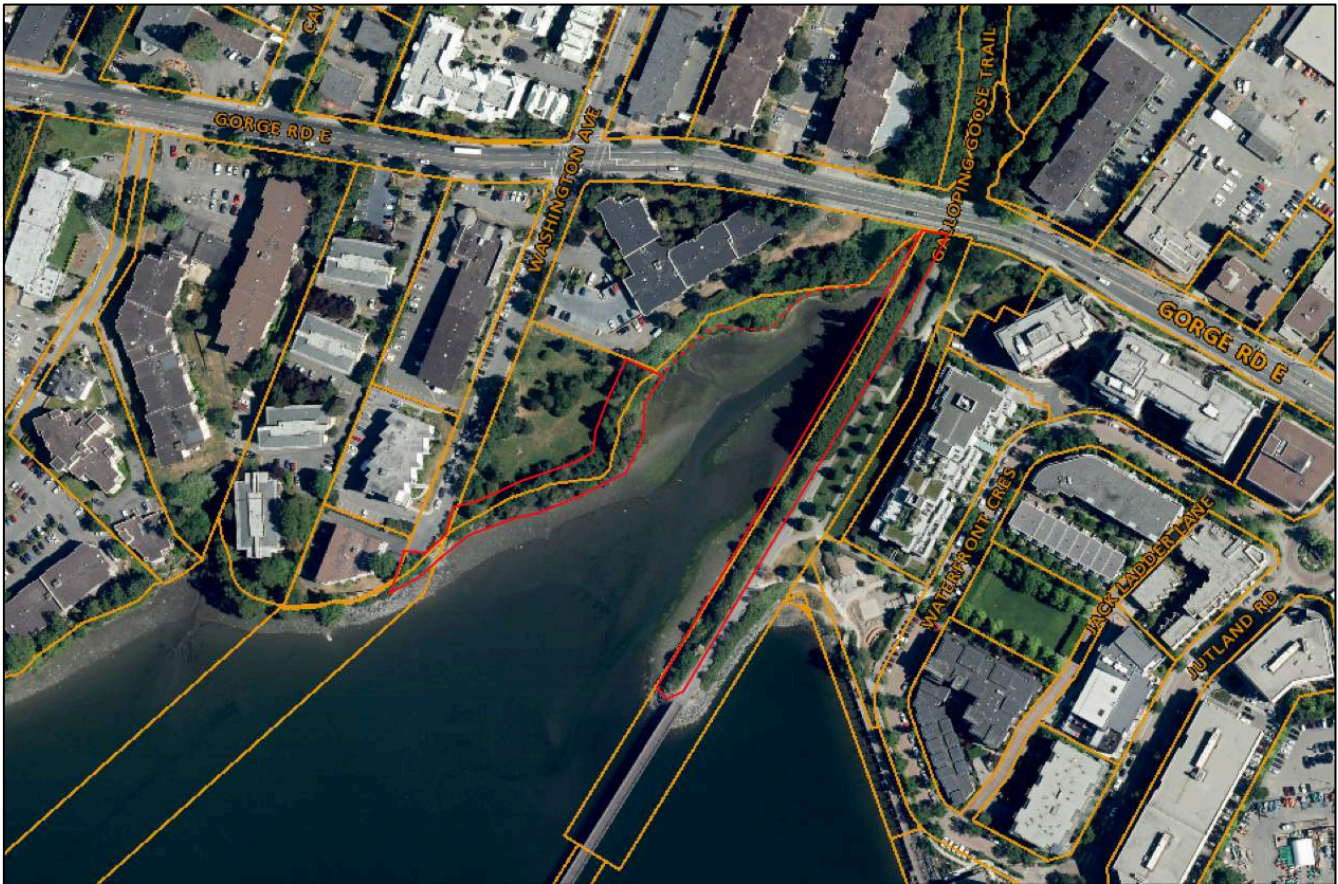
This municipal ROW is a steep bank of boulder sized rip rap and used as an unofficial access to the mudflats. The shoreline is in need of overhanging vegetation and emergent shoreline vegetation, but the shoreline armoring is required for the stability of the road surface and potentially the adjacent building to the west. This road end would not likely meet the GSSD minimum requirements. Municipal discharge CRD# 643 is located at the base of the slope. The top of the slope is part of the roadway.

Figure V06/V07 – Potential project shoreline areas marked in red. Dotted line is private property.

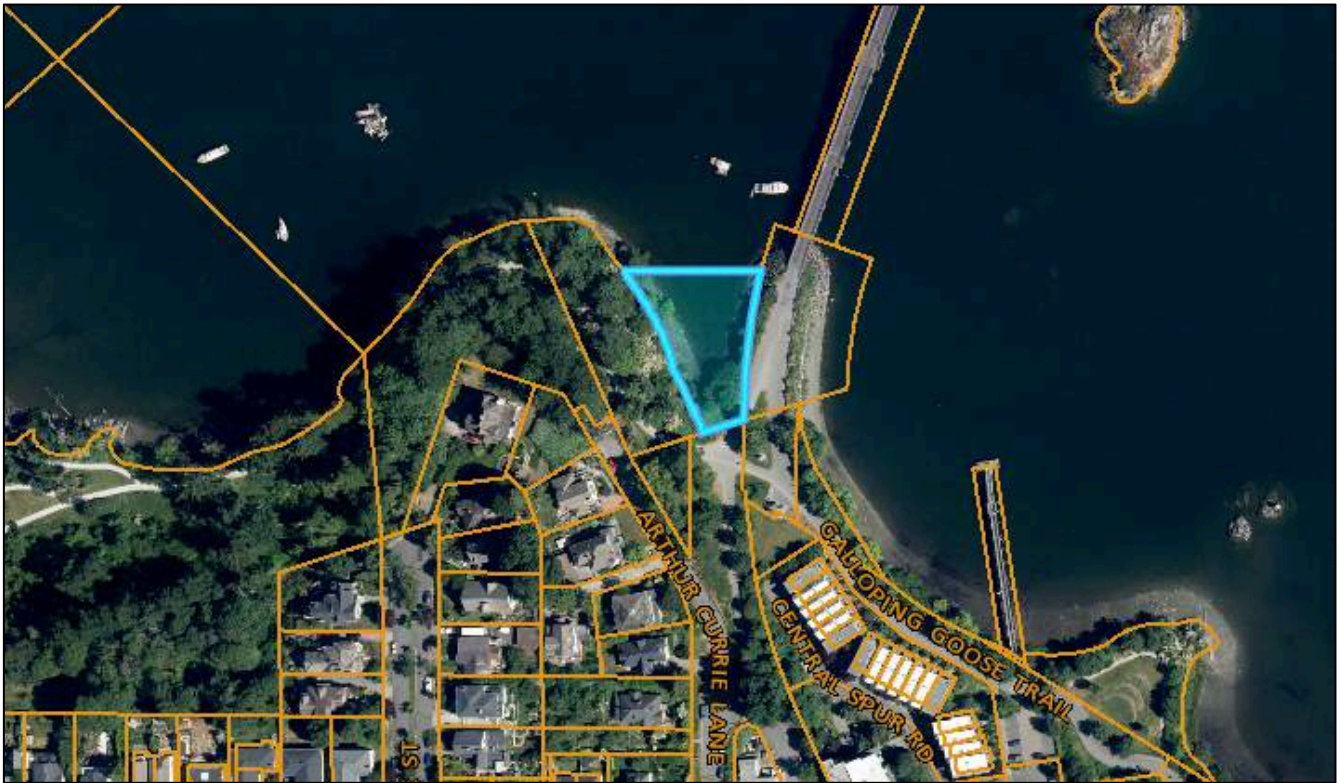
V08 – Arthur Currie Lane & Galloping Goose Regional Trail ROW (Figures 2 & V08)

This pocket cove is located in the municipal ROW of Arthur Currie Lane and Tye Road and is sandwiched between Banfield Park to the west and the CRD Galloping Goose ROW on the east. It has a combination of native and invasive overhanging vegetation, but the invasive vegetation (mainly Himalayan blackberry is taking over. The Goose side of the cove is used as an informal access to the boats anchored in the Selkirk Waterway. CRD# 759 discharges at the head of the cove (moderate bacterial rating).

Figure V08 – Potential Project shoreline areas marked in blue.

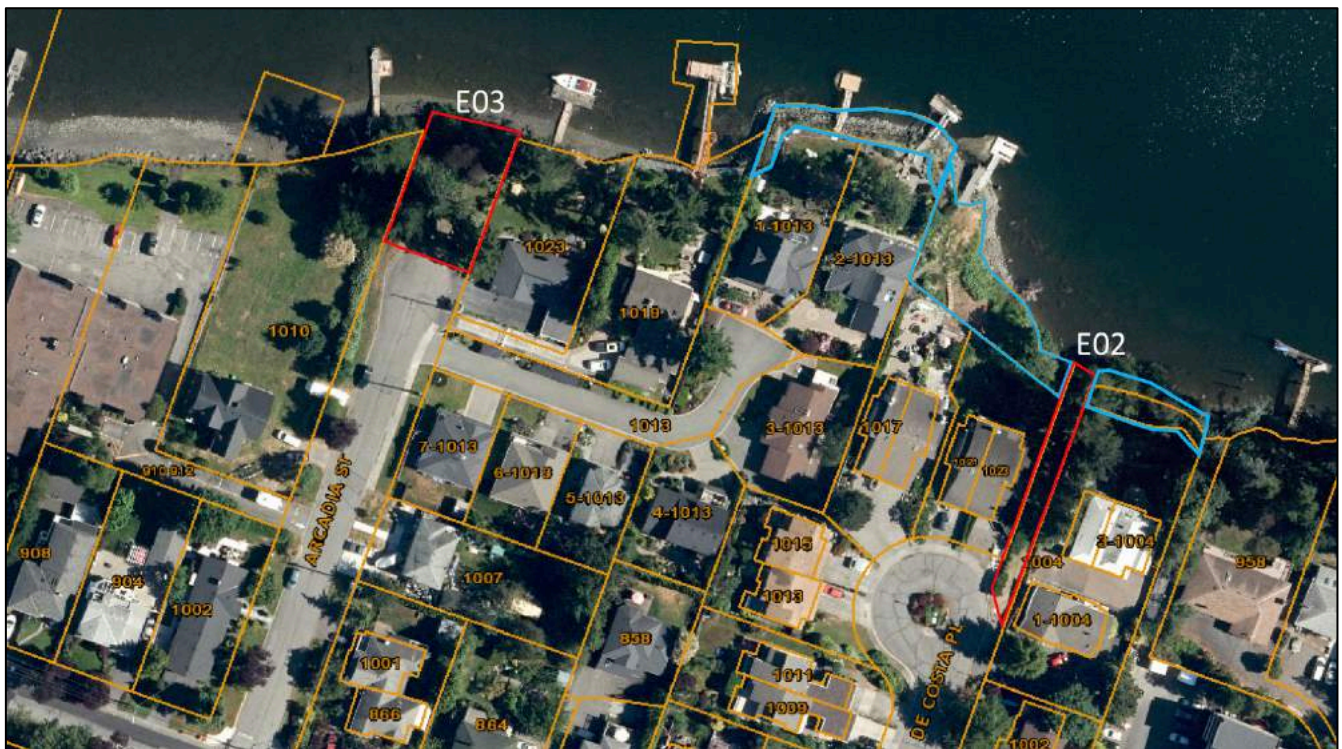
E02 – DeCosta Place ROW, Shoreline of 1004 DeCosta Place (Units 1-3), Shoreline of 1017,1019, 1021, 1023 DeCosta Place & Shoreline of 1013 Arcadia Street (Units 1 & 2)			
Type: Municipal ROW & undeveloped park shoreline	Project length (m): 120 possible	Project area (m ²): 1275 possible	CRD#: 753

Figure E02/E03 – Potential Project shoreline areas marked in red (ROW) and blue (undeveloped park).

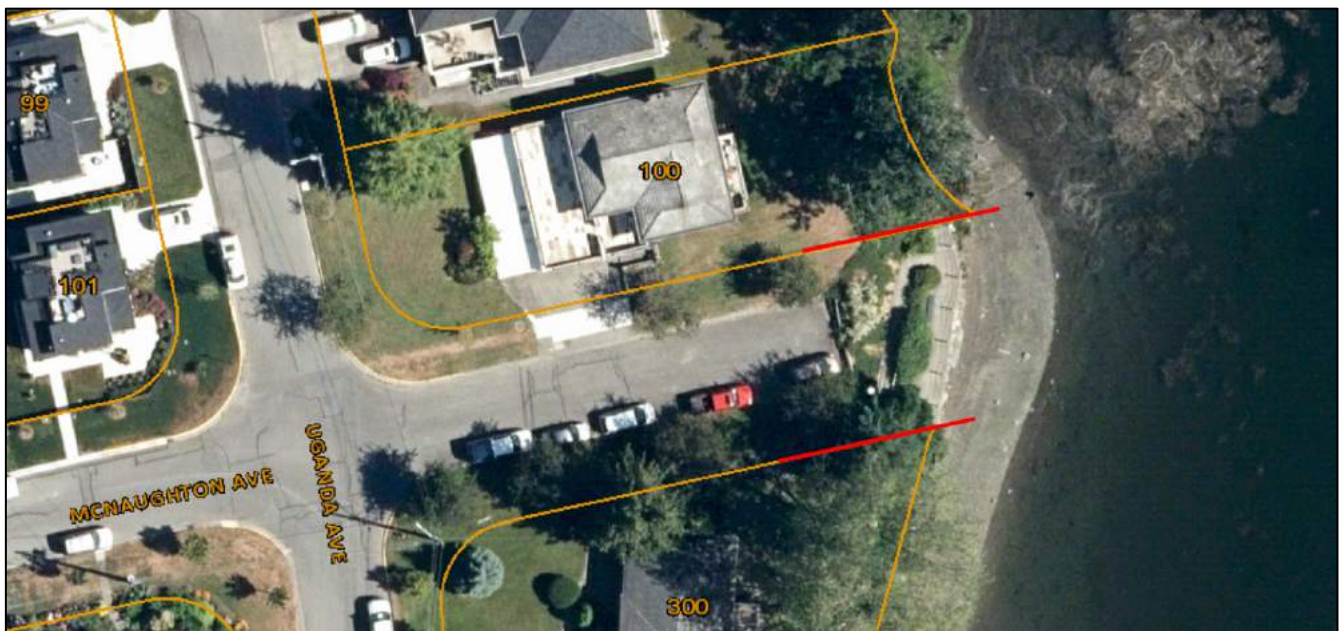
E04 – McNaughton Avenue ROW			
Type: Municipal ROW	Project length (m): 20 possible	Project area (m²): 200 possible	CRD#: 748

This municipal ROW has a seawall parklet and a combination of native and ornamental plantings. There is no designed beach access. Fringe marsh vegetation is scattered along the base of the seawall. The seawall makes this site ineligible for Green Shores unless the seawall was to be removed, which is unlikely. PHOTOS to be added.

Figure E04 – Park boundary in red.

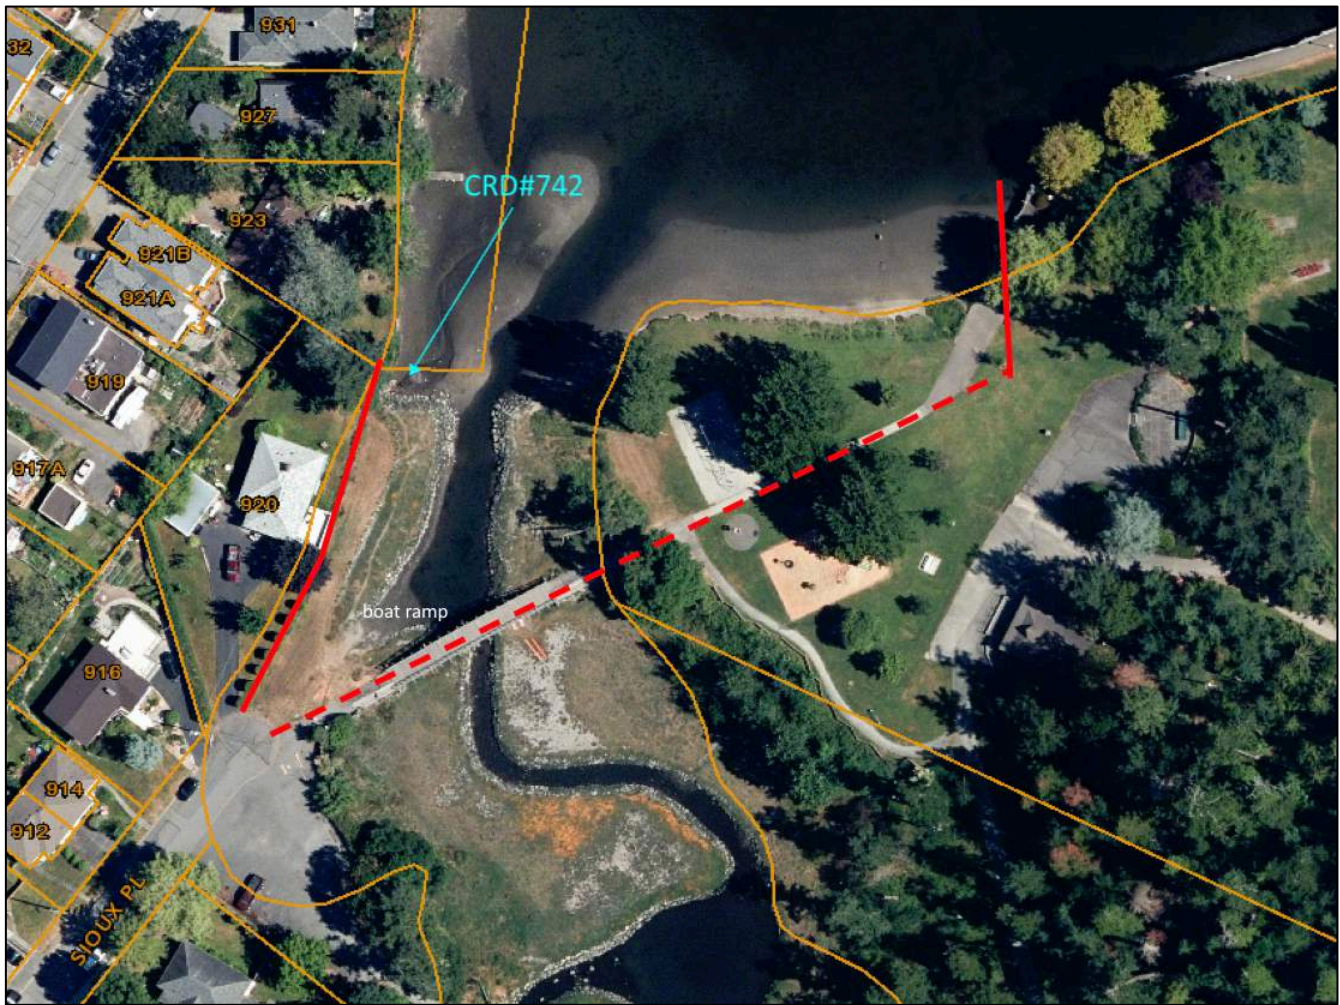
E05 – Gorge Esquimalt Park and Sioux Place ROW (Figures 3 & E05)

There is an existing restoration project occurring in this park by World Fisheries Trust through PSF funding. The restoration is focussed on improving the riparian function of this engineered/daylighted stream created in 2005. Plans include improving fish habitat through the addition of dendritic channels, forage fish beach nourishment and possibly Chum spawning gravel additions (pending extensive channel and water quality monitoring). Additional restoration beyond the current WFT budget could include the planting of shrub and tree vegetation above the intertidal benches on the Sioux Place ROW and along the playground shoreline, increasing intertidal vegetation, fencing, the addition of crush oyster shells to the personal watercraft boat ramp which is currently eroding and the creation of a raingarden to demonstrate filtration of road runoff in stormwater at stormdrain CRD#742. The location is used extensively for community and student environmental education through the WFT and GWAS Gorge Waterway Nature House.

Figure E05 – Potential project areas in red. Entire riparian area of park in current restoration plans by WFT. Discharge path from CRD#742 visible at far left.

E05 – Gorge Esquimalt Park and Sioux Place ROW			
Type: Municipal Park & ROW	Project length (m): variable, up to 200 for smaller scale project, or significantly more depending on extent restored	Project area (m²): variable, up to 3000 for smaller scale project possible, or significantly more depending on extent restored	CRD#: 742 (municipal), 742AA (likely perimeter drain), 744 (creek) [additional pipes discharge into the creek upstream of the potential project site: 742B, 743, 743A, 744A, 744B]
Relative amount of work required: variable Low to High possible	Minor invasive species removal. Extensive planting of riparian vegetation, including overhanging shrubs and trees possible. Shoreline height (0.7-1.1 m) would allow creation of dendritic channels for juvenile salmonids. A portion of the ROW on the west shoreline could be used for a raingarden to demonstrate filtration of road runoff in stormwater for discharge CRD# 742. Beach nourishment for forage fish on main beach (upper right) possible. Crushed oyster shell could be used for boat access to control erosion and filter road runoff.

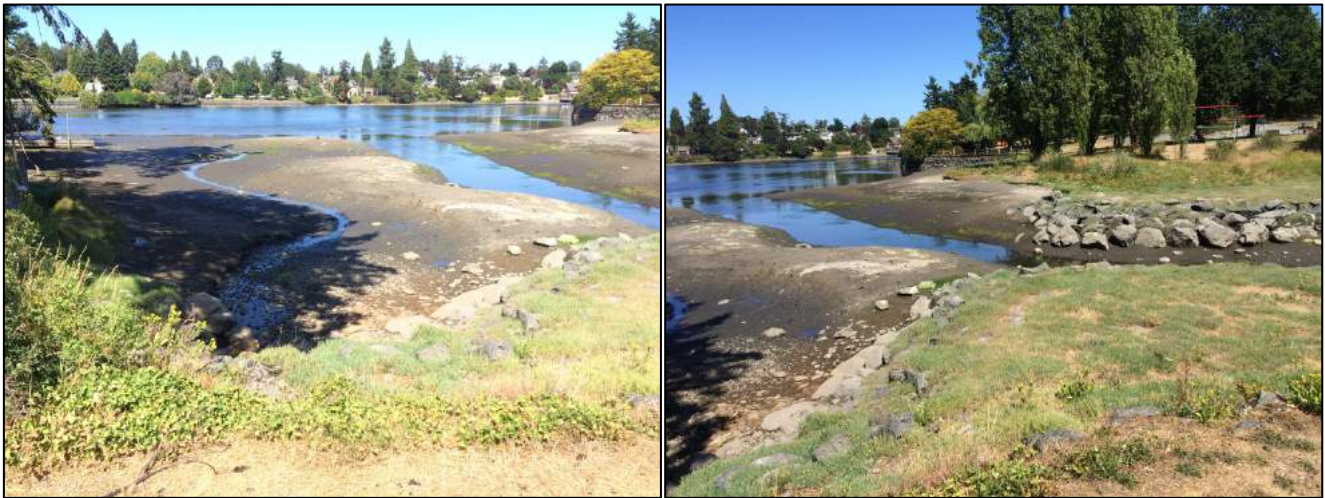
E05 – Sioux Place stormwater drainage CRD#742 and previous restoration efforts.

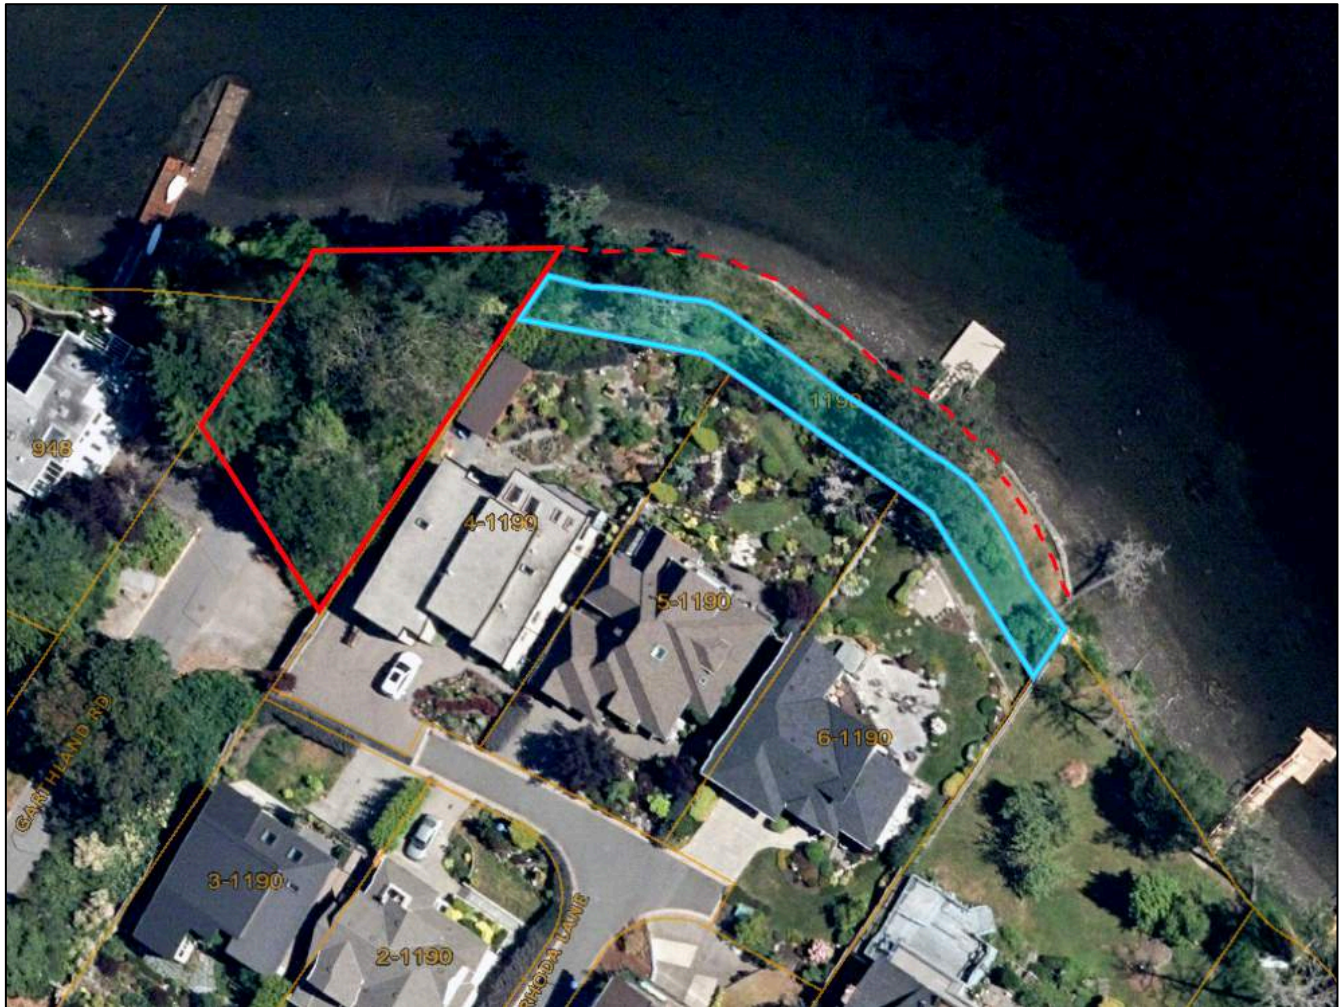
E08 – Garthland Road ROW & Shoreline of 1190 Rhoda Lane (Units 4-6)			
Type: Municipal ROW	Project length (m): 26 (ROW) + 65 ('park') = 90	Project area (m²): variable	CRD#: 737

This ROW is vegetated in mature trees overhanging the shoreline and has a fringe of emergent vegetation on narrow benches. It has some invasive vegetation. A narrow path goes through the ROW and along the adjacent “undeveloped park”, which is partially vegetated and partially used as an extension of the neighbouring lots, including a hardened shoreline and a dock. There may not be a current priority to address these undeveloped parks by the municipality. There may be an archeological site (shell midden) at the east edge of the ROW.

Figure E08 – ROW generally vegetated (red), with “undeveloped park” (blue) and filled shoreline with seawall (red dashed line).

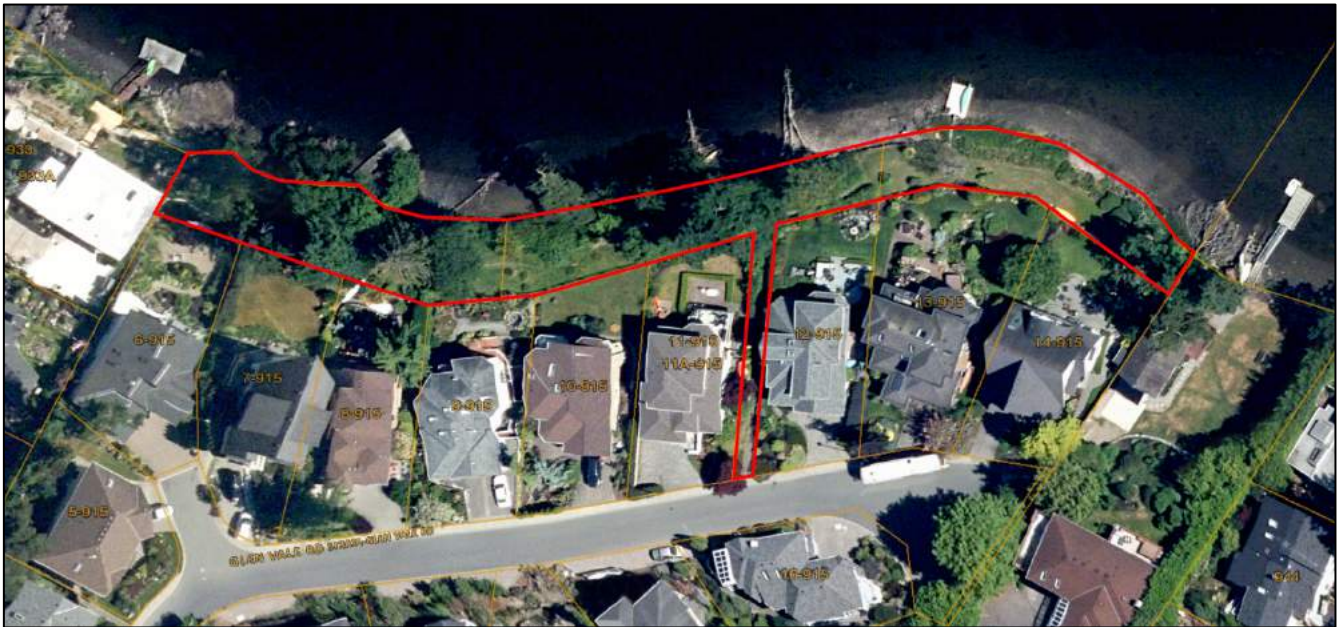
E09– Glen Vale Road ROW/park			
Type: Municipal ROW & undeveloped park	Project length (m): 160	Project area (m²): variable, up to 1700	CRD#: 736A

This combination of ROW and “undeveloped park” contains a mixture of mature trees overhanging the shoreline, mowed shoreline sections and has a fringe of emergent vegetation on narrow benches. The west portion is mowed along the fence line, with trees and pruned shrubs along the shoreline. The area is fenced off along the property lines of the adjacent properties, but also has a private dock and stored personal watercraft on the banks. The street is part of a strata and is not maintained by the municipality; it is unknown whether the mowing maintenance is done by the municipality, though it may be done by the local homeowners. There may not be a current priority to address these undeveloped parks by the municipality.

Figure E09 – The areas in red are listed as park and/or ROW.

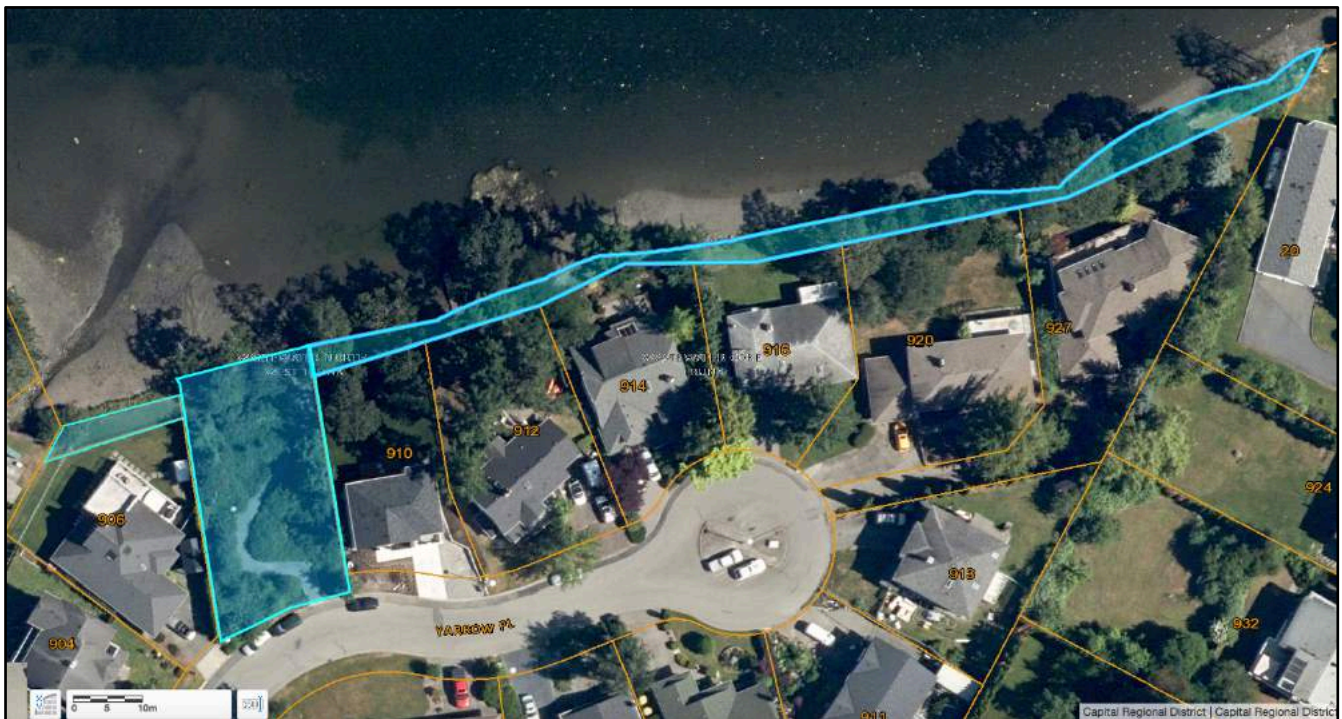
E15 – Yarrow Place ROW & Shoreline of 906-927 Yarrow Place			
Type: Municipal ROW	Project length (m): 180	Project area (m ²): 800	CRD#: 726A, 726B

There is an existing large restoration project here in the ROW with raingardens and mature native vegetation. The trees overhang the shoreline and the planting density is high. The restoration was undertaken by GWAS and the municipality in 2006 and the growth has been excellent. The neighbouring shoreline (east and west) is composed of a narrow municipal “undeveloped park” subdivided from the adjacent properties. The shoreline segments are for the most part being used by the adjacent property owners and are mostly landscaped matching the adjacent residential properties, with some of them fully vegetated with overhanging mature trees on the shoreline. The ROW was visited, but the adjacent properties were not, with the exception of 910 Yarrow which could be viewed from the ROW and appeared to be newly planted with native vegetation for part of the shoreline. GWAS approached a number of the homeowners in 2006 and some accepted free planting plans; however, it is not known if there was any follow up on these sites. Despite there not being a current priority to address these undeveloped parks by the municipality, this area seems like a good opportunity for ongoing homeowner education and further voluntary restoration.

Figure E15 – Previously restored ROW and “undeveloped parks” along the adjacent shorelines east and west (in blue). Shoreline parcel widths 2-4 m.
